# SAFETY RECALL

## Pittsburgh Automotive AC Manifold Gauge Set Item Number 62707

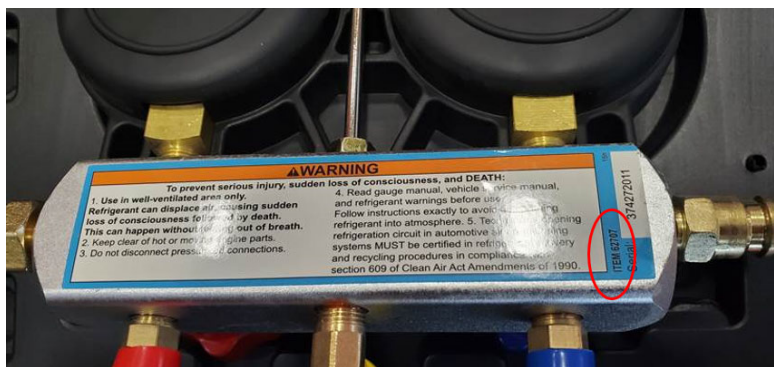
THIS RECALL ONLY CONCERNS SELECT BATCHES OF AC MANIFOLD GAUGE SET ITEM NUMBER 62707. The affected units were produced between March 23, 2020 and May 17, 2020. The AC Manifold Gauge Set item number 62707 can be identified by checking the item number found on the label on the back of each AC Manifold Gauge Set. The affected batch codes are: 374272013, 374272014, 374272015 and 374272020.

**If you have one of these items, STOP USING THESE AC MANIFOLD GAUGE SETS IMMEDIATELY. DO NOT RETURN THE ITEM TO THE STORE.** Request replacement labels and instructions by visiting:
