SUBJECT: Safety Recall 21S05

Certain 2005-2014 Mustang, 2005-2006 Ford GT, 2004-2011 Ranger, 2006-2012 Fusion and MKZ/Zephyr, 2006-2011 Milan, and 2007-2010 Edge and MKX Vehicles
 Airbag Module Inspection and Replacement

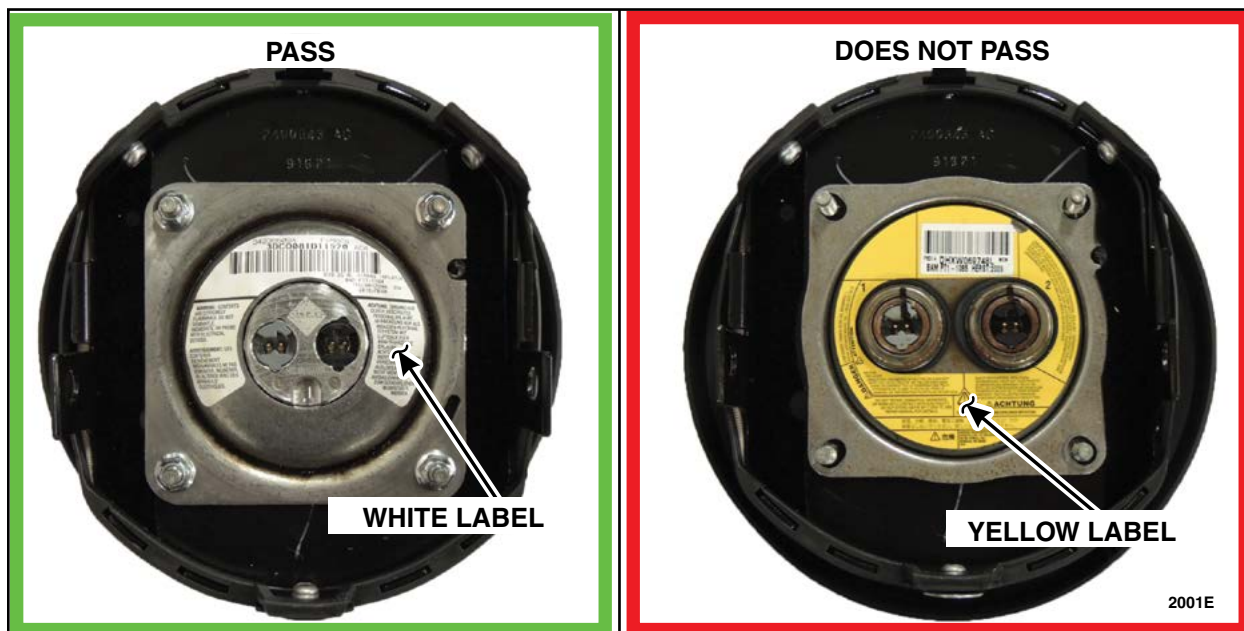
FIGURE 1

No - **DOES NOT PASS** - Proceed to Driver Airbag Module or Inflator Replacement per MY below.

NOTE: If the label **cannot** be read or is missing entirely, perform the Driver Airbag Module or Inflator Replacement per MY above.

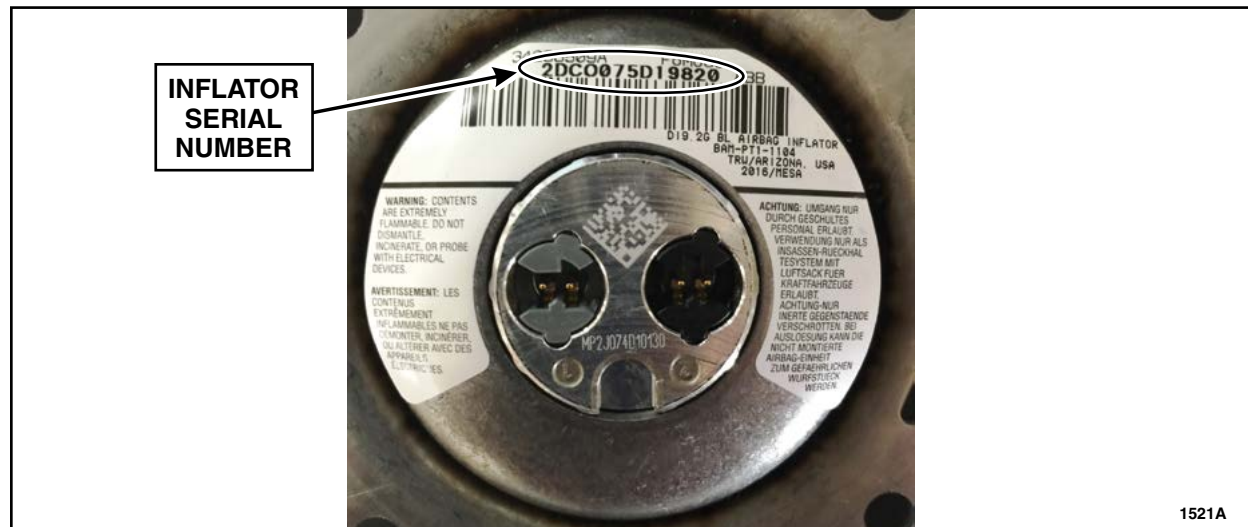
FIGURE 2

1. Record the 13 character serial number of the *new* airbag inflator on the repair order. The inflator is pre-installed in the *new* airbag module. See Figure 2.

3. Record the 13 character serial number of the *new* airbag inflator on the repair order. See Figure 2.

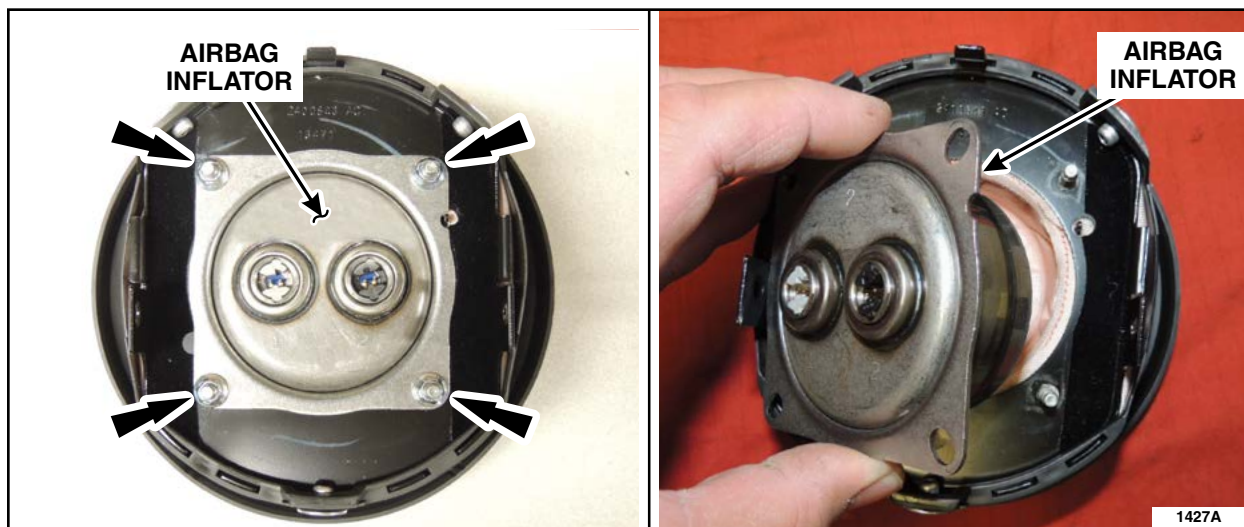
FIGURE 3

1. Remove and discard the four airbag inflator retaining nuts from the driver side airbag. See Figure 3.
2. **NOTE:** In order to verify the correct airbag inflator is installed, mark the old airbag inflator with a felt tip marker prior to removal.

Remove the airbag inflator and set aside for return shipping. See Figure 3.

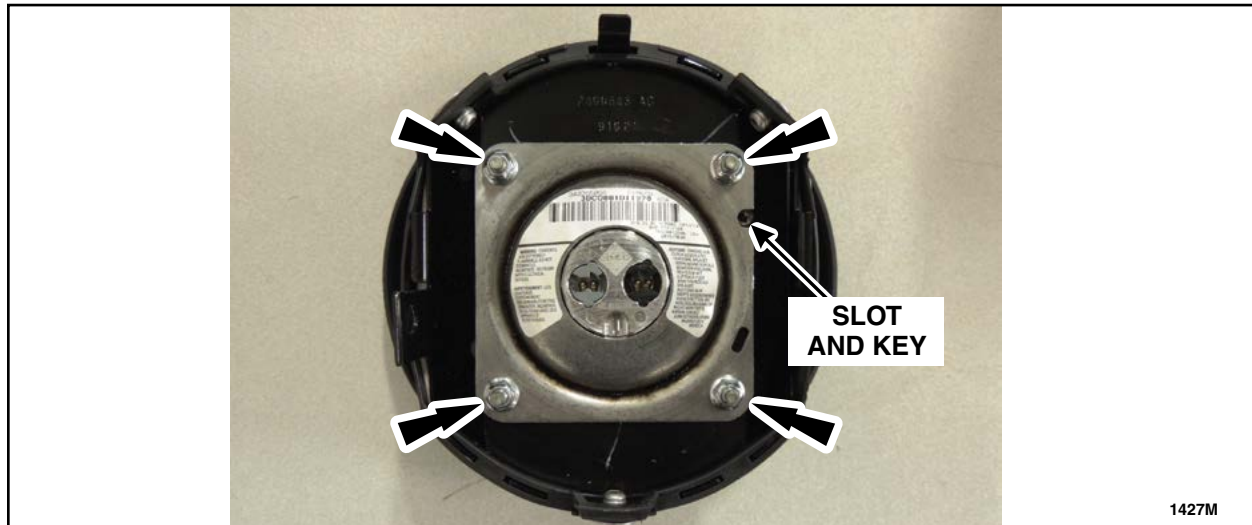
FIGURE 4

4. Align the key on the driver airbag with the slot on the *new* inflator. Install the *new* inflator into the driver airbag. See Figure 4.

5. Install four *new* airbag inflator nuts onto the driver airbag. See Figure 4.

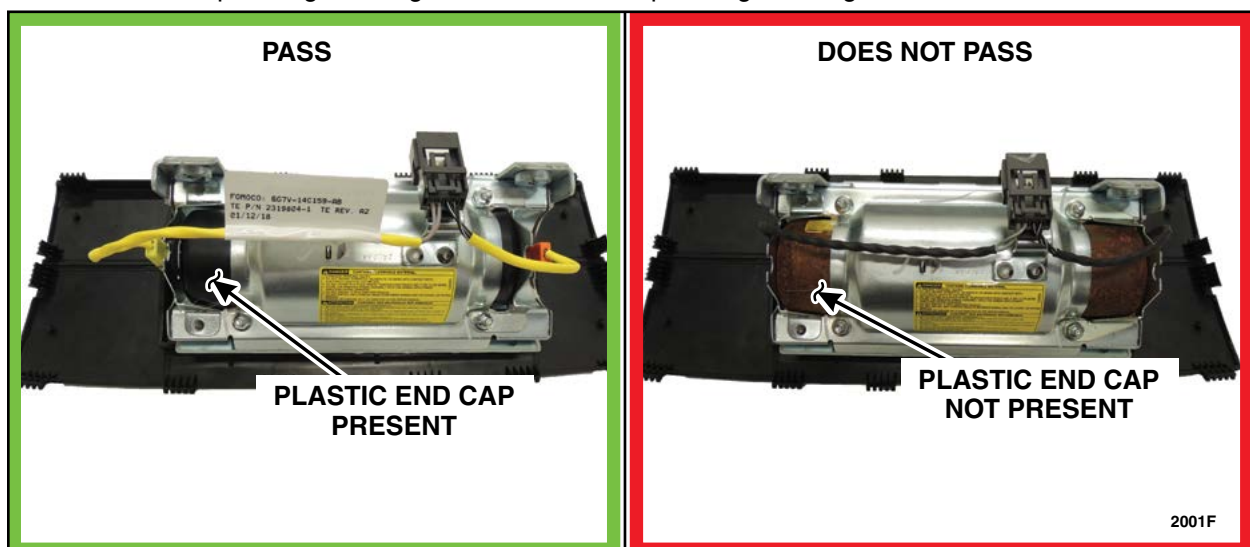
FIGURE 5

NOTE: 2008 MY passenger airbag module shown, all passenger airbag modules similar.

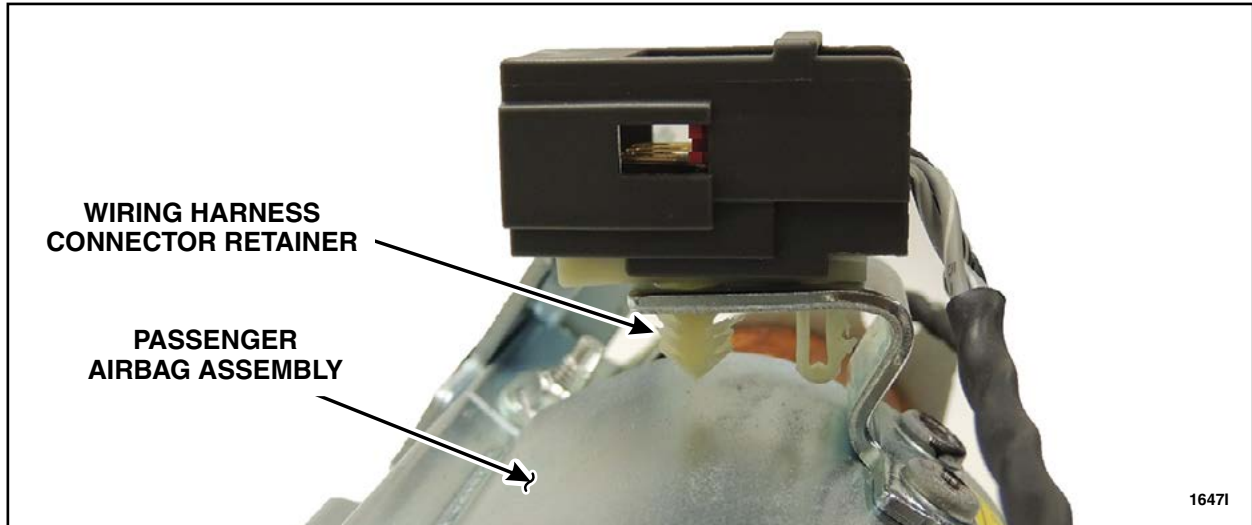
FIGURE 6

1. Remove the wiring harness connector retainer from the passenger airbag assembly. See Figure 6.

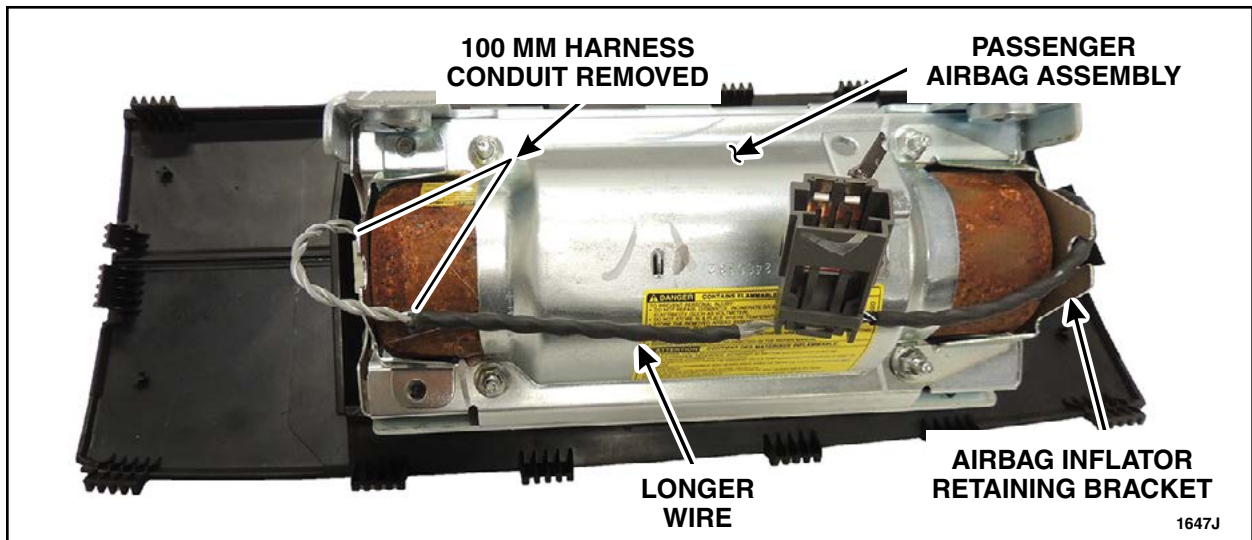
FIGURE 7

NOTE: Carry out this Step on the longer wire on the end opposite of the airbag inflator retaining bracket. See Figure 7.

2. Remove approximately 100 mm (3.93 in) of the conduit from the passenger airbag assembly wire harness. See Figure 7.

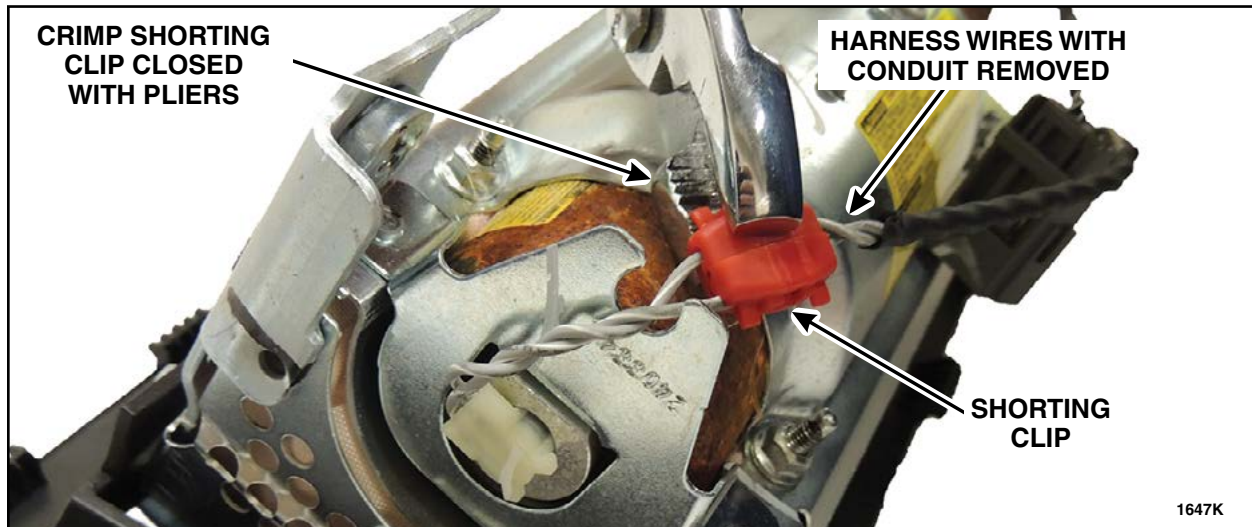
FIGURE 8

3. Position the shorting clip onto the harness wires, and crimp the shorting clip together one side at a time using pliers. See Figure 8.

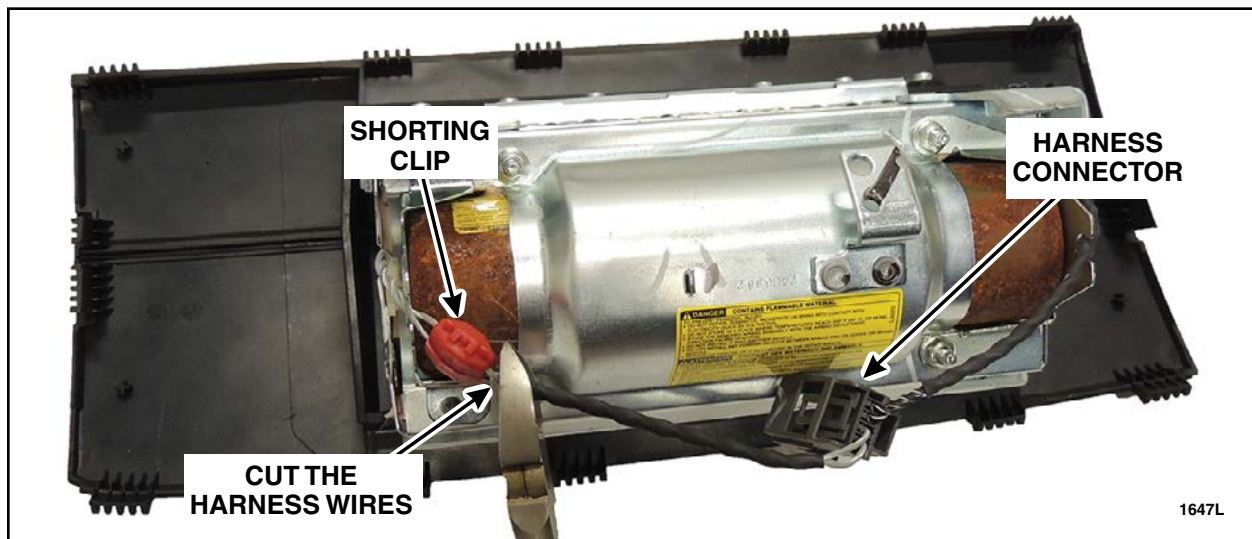
FIGURE 9

4. Cut the harness wires between the shorting clip and the harness connector. See Figure 9.

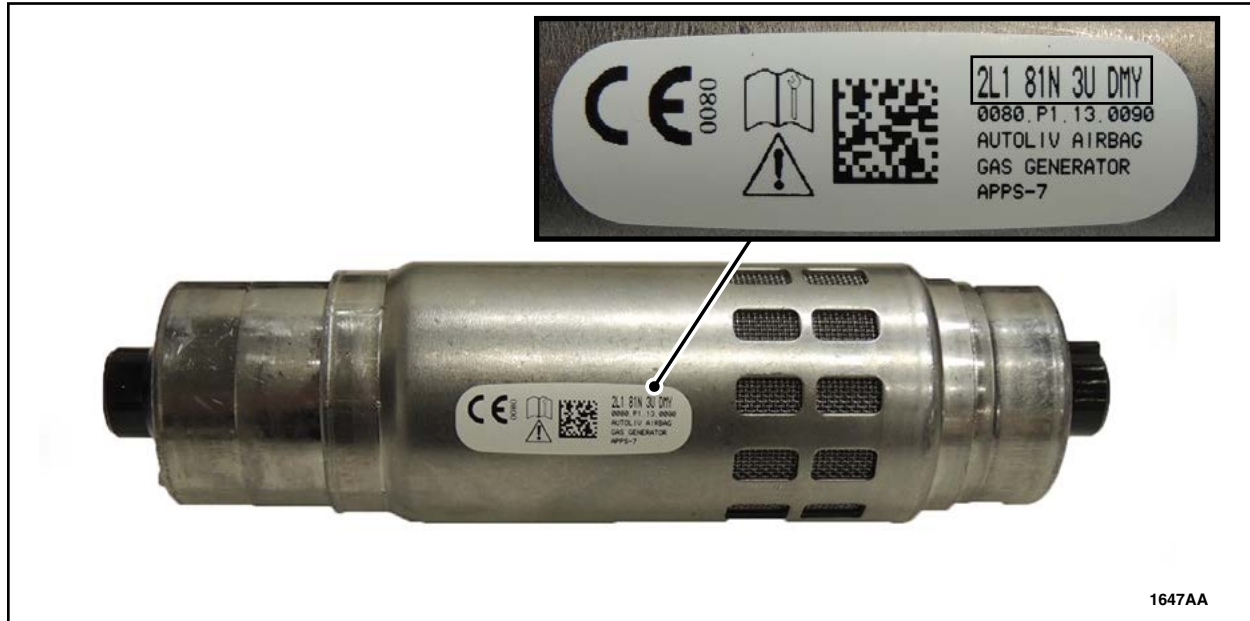
FIGURE 12

7. Record the 11 character serial number of the *new* airbag inflator on the repair order. See Figure 12.

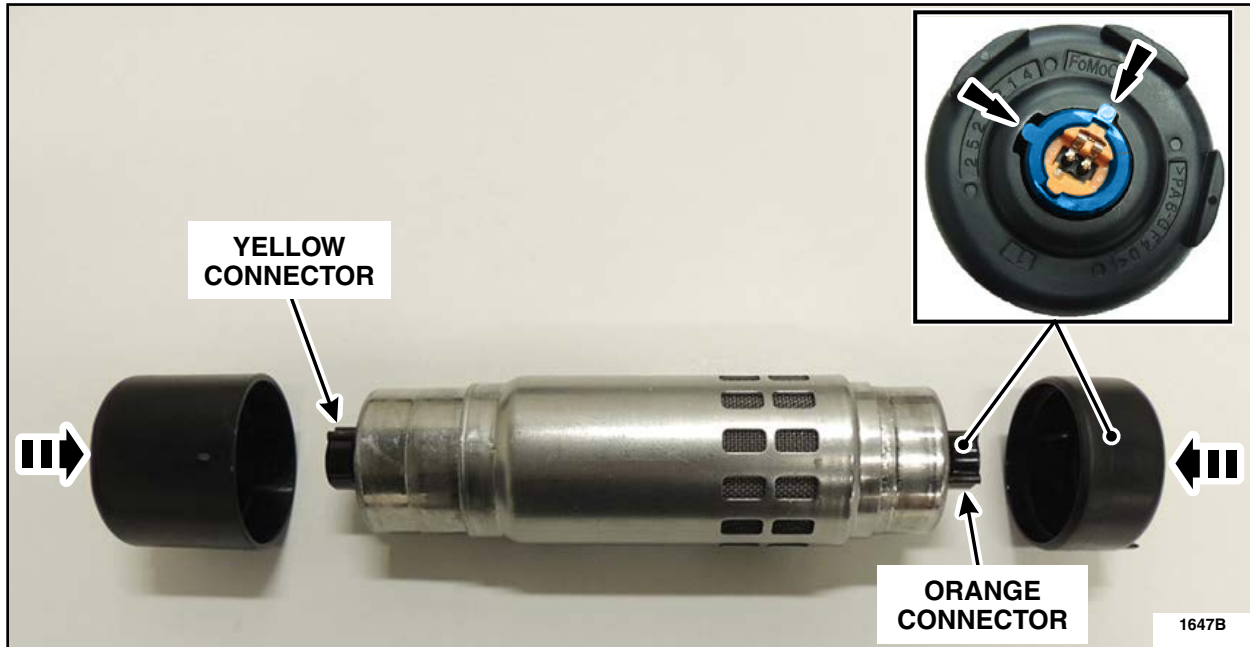
FIGURE 13

Install both *new* inflator end caps making sure the alignment feature on the cap nearest the inflator retaining bracket is properly oriented. See Figure 13.

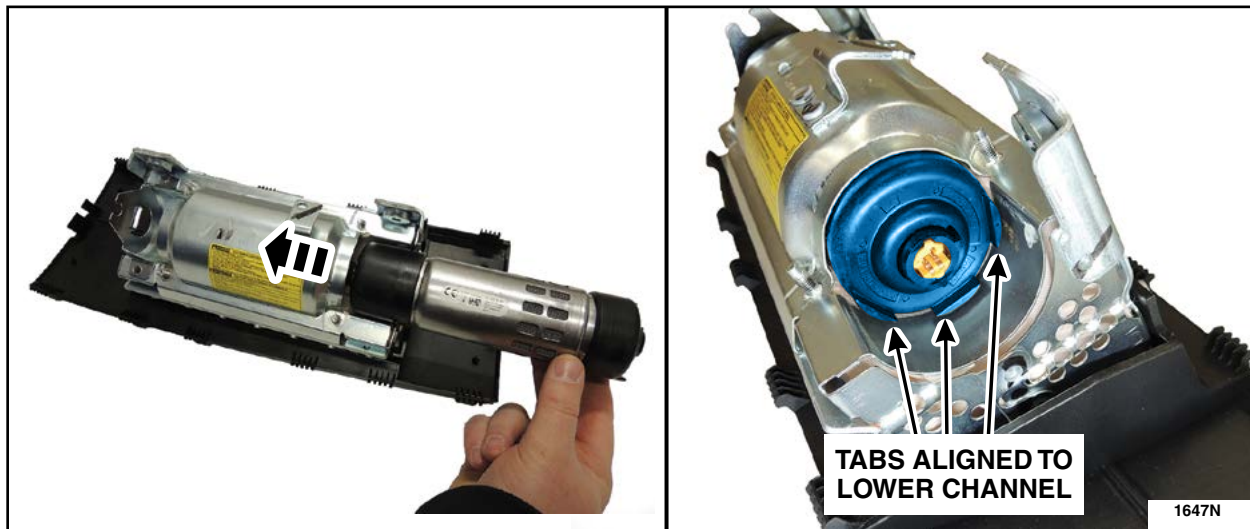
FIGURE 14

9. Install the inflator into the passenger airbag assembly with the orange connector end facing out. Align the three tabs on the cap nearest the inflator retaining bracket with the airbag module lower channel (facing down). See Figure 14.

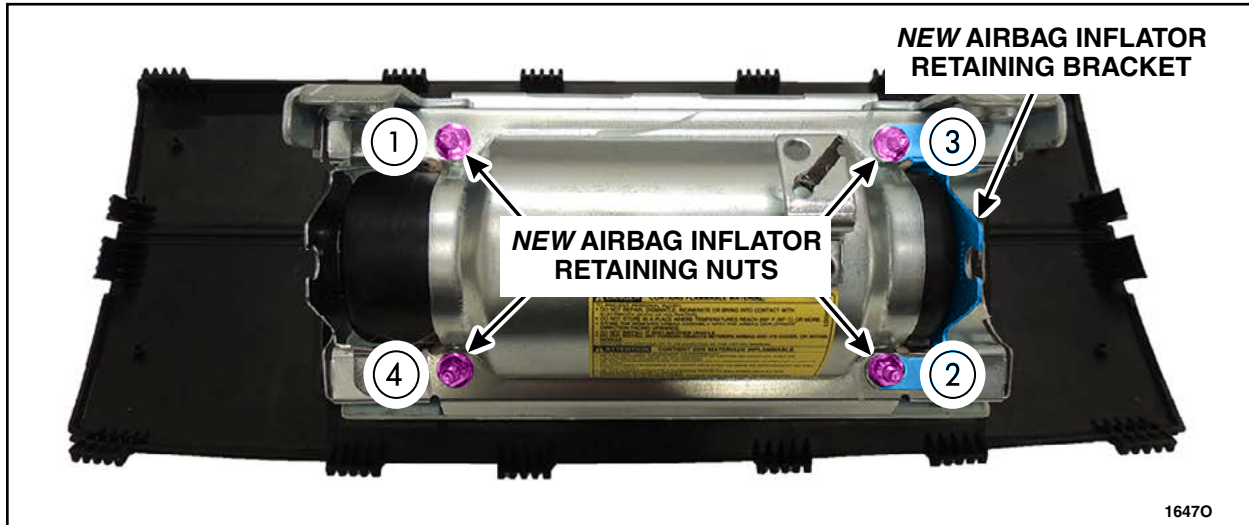
FIGURE 15

10. Install the *new* passenger airbag inflator retaining bracket and *new* nuts. See Figure 15.

- Torque the *new* retaining nuts in the sequence shown below to 4 Nm (35 lb.in).

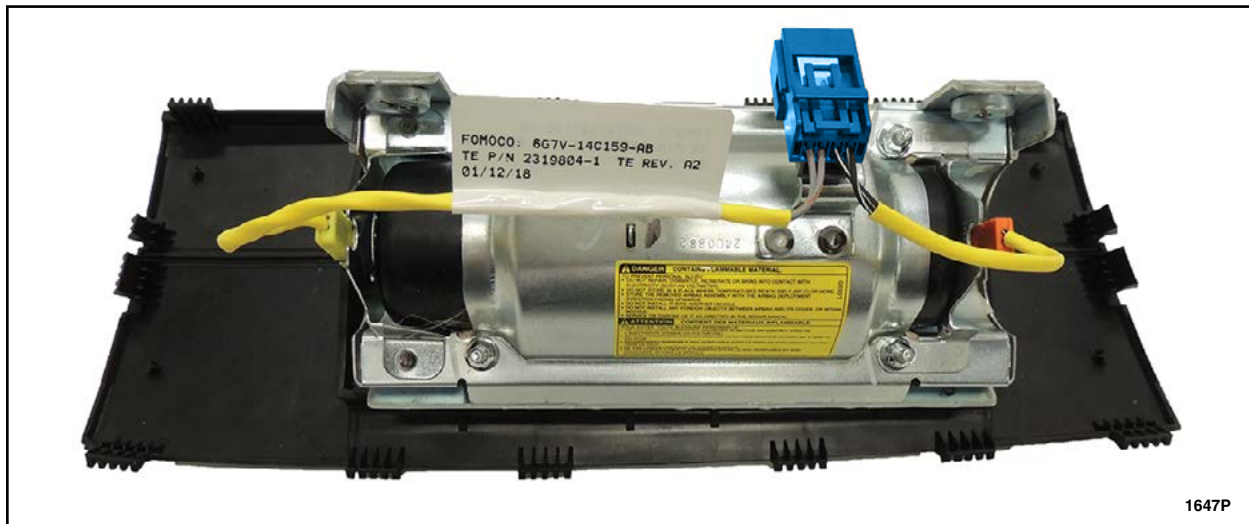
FIGURE 16

11. Align the T-shape index on both the wiring harness electrical connector and the airbag inflator. Install the *new* wiring harness onto the passenger airbag module and connect to both sides of the inflator. See Figure 16.

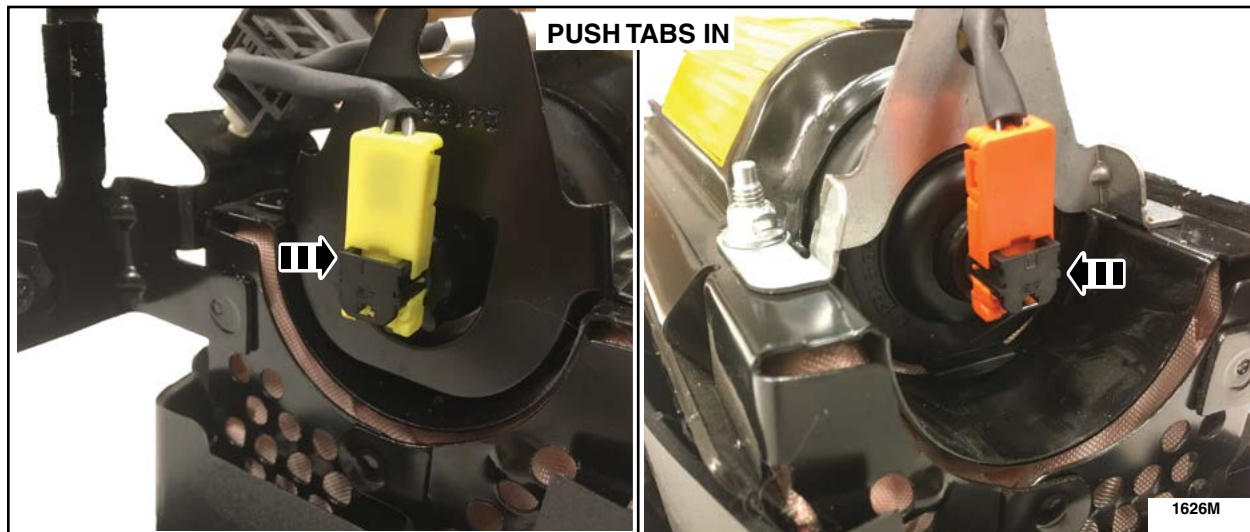
FIGURE 17

NOTE: Pull gently on the wiring harness to ensure it is properly seated.

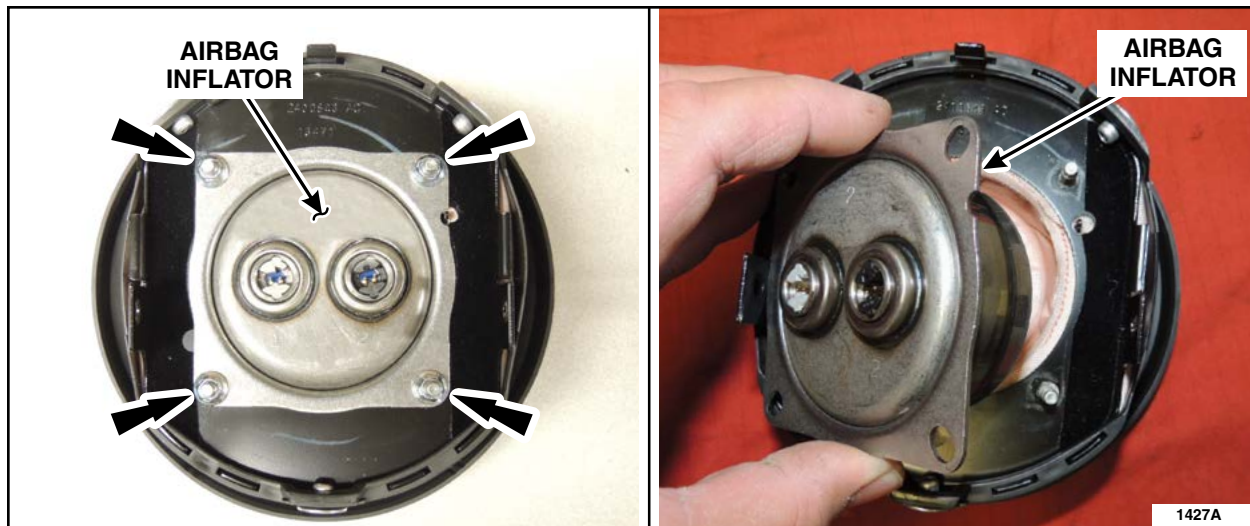
FIGURE 2

Remove the airbag inflator and set aside for return shipping. See Figure 2.

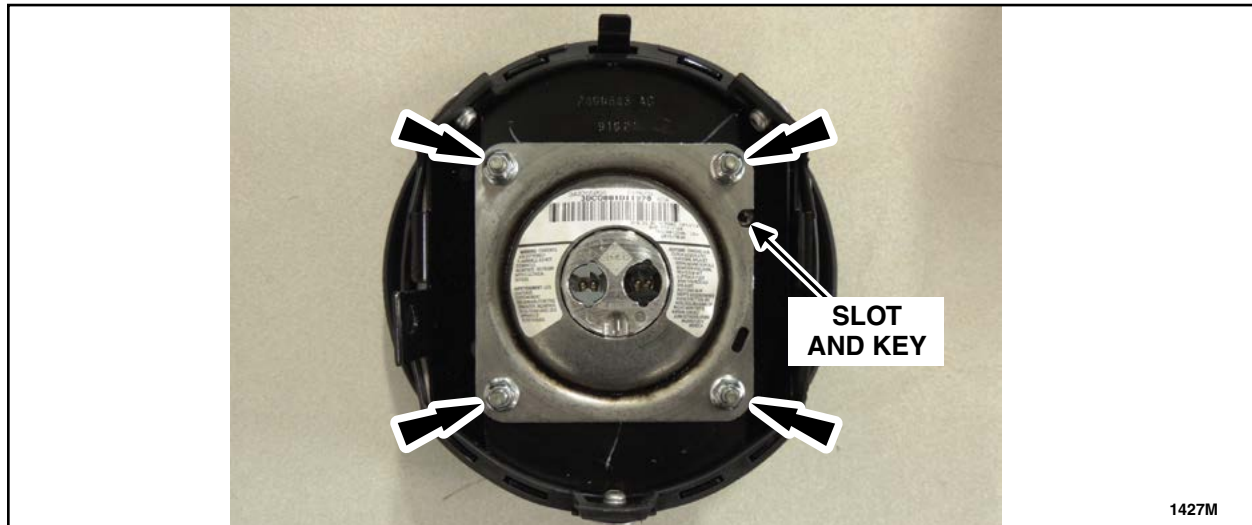
FIGURE 4

4. Align the key on the driver airbag with the slot on the *new* inflator. Install the *new* inflator into the driver airbag. See Figure 4.

5. Install four *new* airbag inflator nuts onto the driver airbag. See Figure 4.

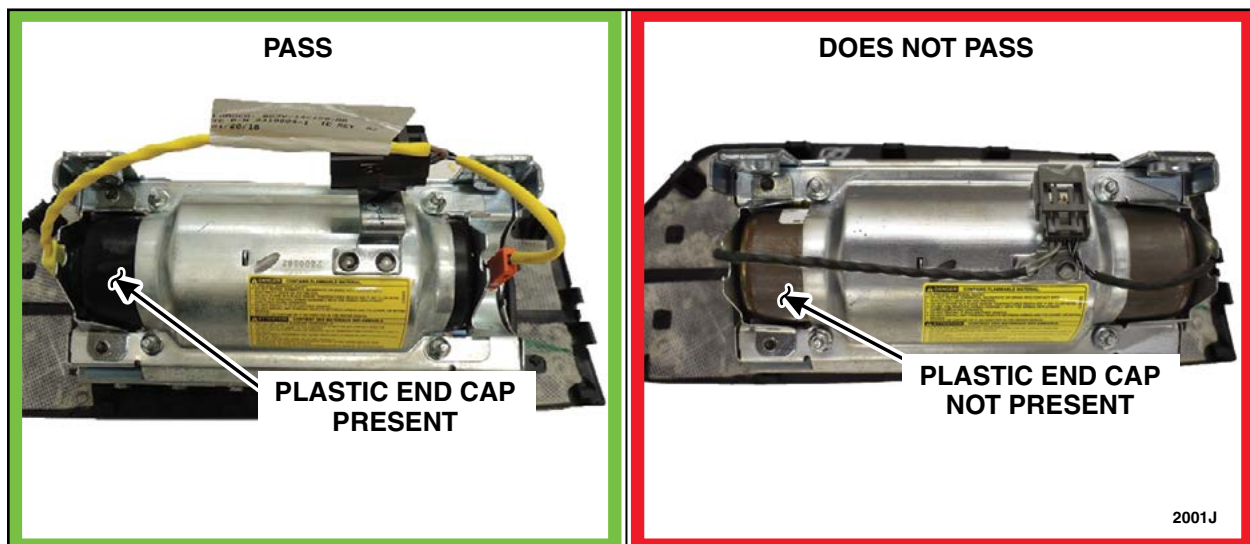
FIGURE 5

1. Remove the passenger airbag from the vehicle. Please follow the WSM procedures in Section 501-20.
2. Set the airbag face down onto a surface that will not scratch or damage the airbag face.
3. Inspect the passenger airbag inflator end for the presence of a plastic end cap as shown in Figure 5. Is the plastic end cap present on the airbag inflator?

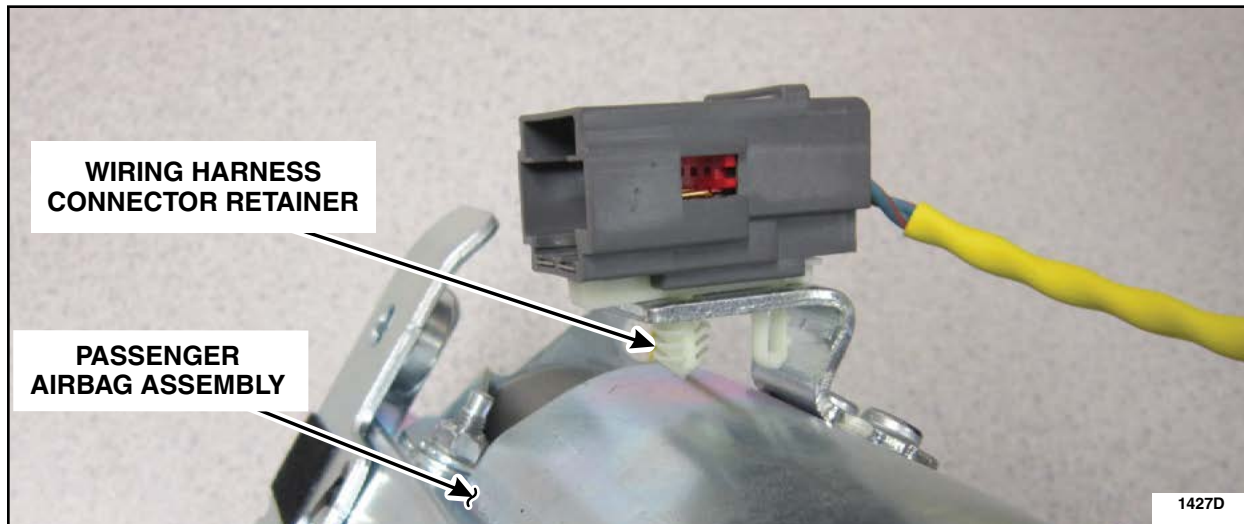
FIGURE 6

1. Remove the wiring harness connector retainer from the passenger airbag assembly. See Figure 6.

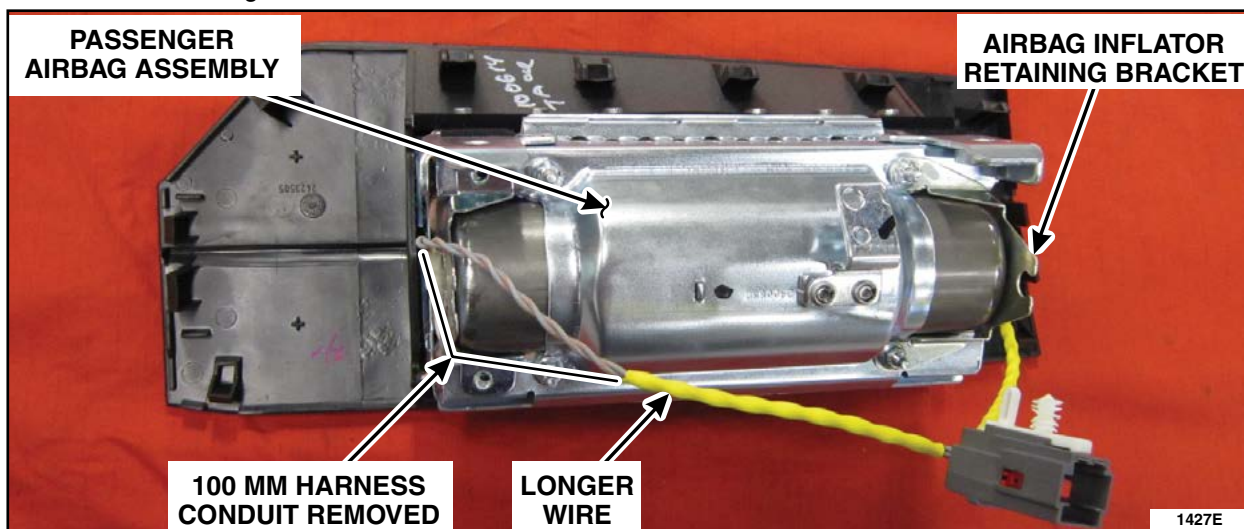
FIGURE 7

NOTE: Carry out this Step on the longer wire on the end opposite of the airbag inflator retaining bracket. See Figure 7.

2. Remove approximately 100 mm (3.93 in) of the conduit from the passenger airbag assembly wire harness. See Figure 7.

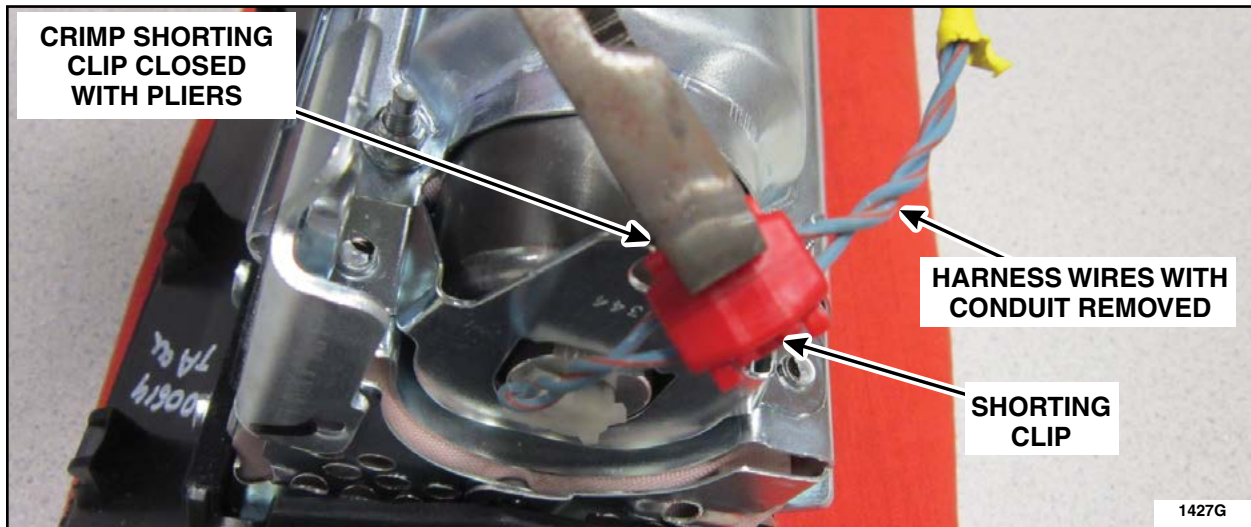
FIGURE 8

3. Position the shorting clip onto the harness wires, and crimp the shorting clip together one side at a time using pliers. See Figure 8.

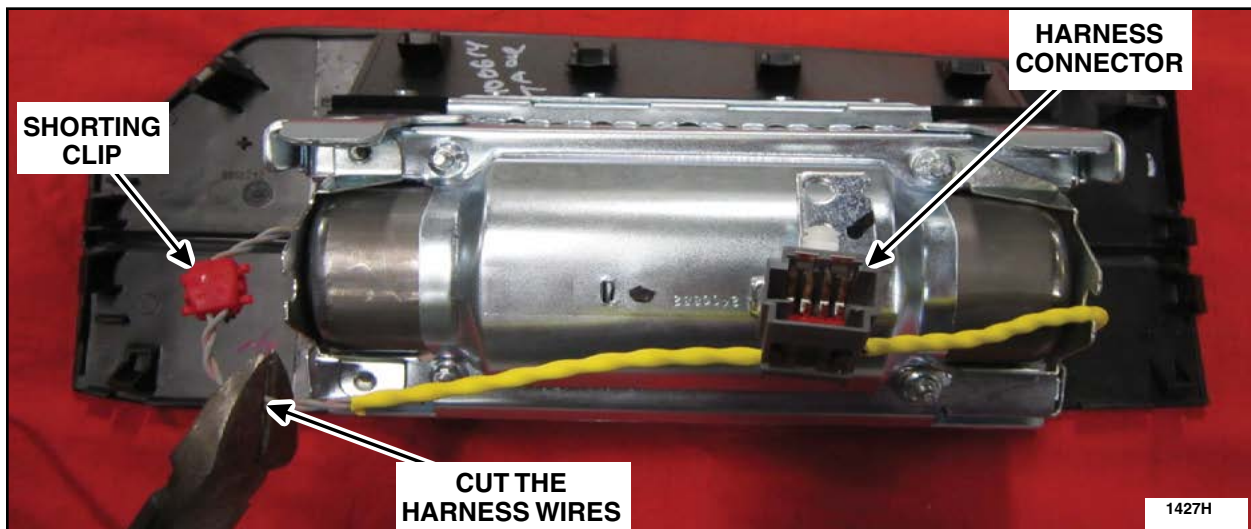
FIGURE 9

4. Cut the harness wires between the shorting clip and the harness connector. See Figure 9.

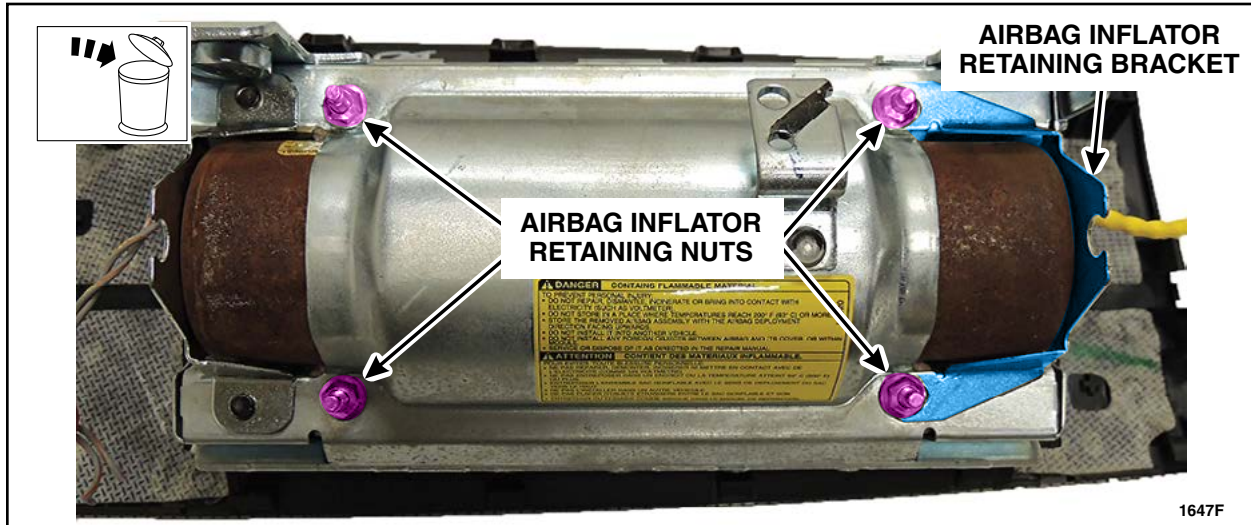
FIGURE 10

5. Remove and discard the four passenger airbag inflator retaining bracket nuts and the retaining bracket. See Figure 10.

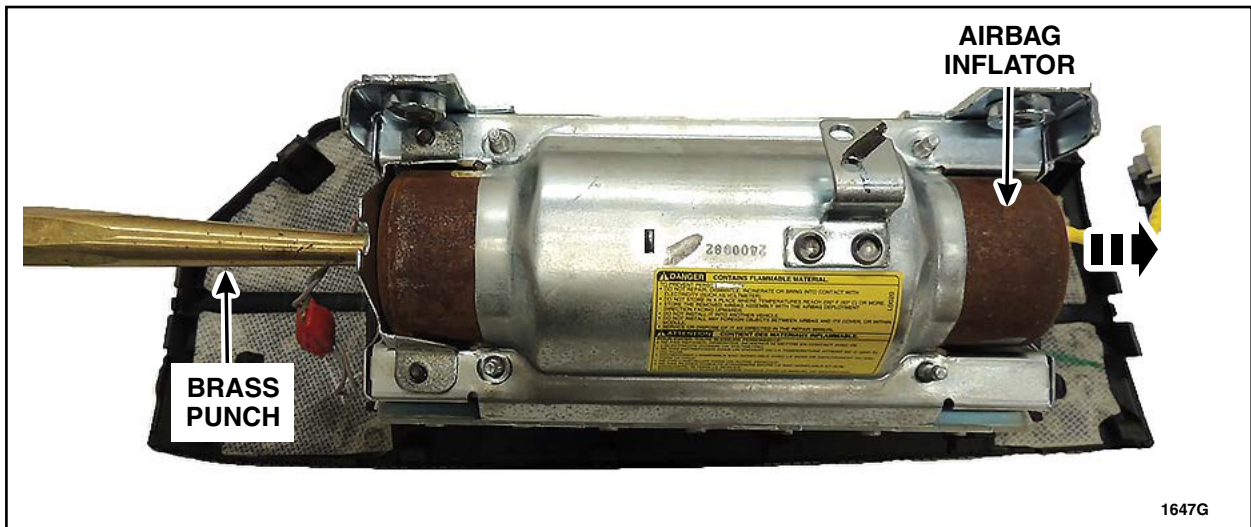
FIGURE 11

6. With an assistant holding the passenger airbag assembly, remove the inflator from the assembly by pushing outward on the inflator. Set the airbag inflator aside for return shipping. See Figure 11.
 - If required, use of a brass punch is permitted (only at the location shown) to free the inflator from its mounted position.

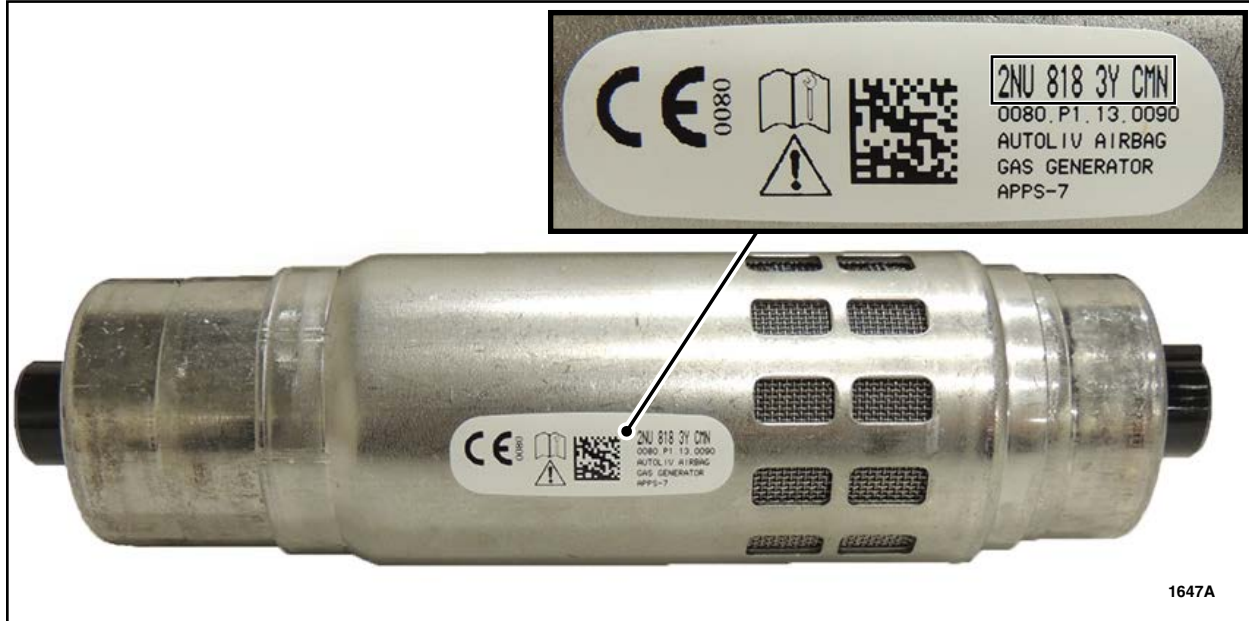
FIGURE 12

7. Record the 11 character serial number of the *new* airbag inflator on the repair order. See Figure 12.

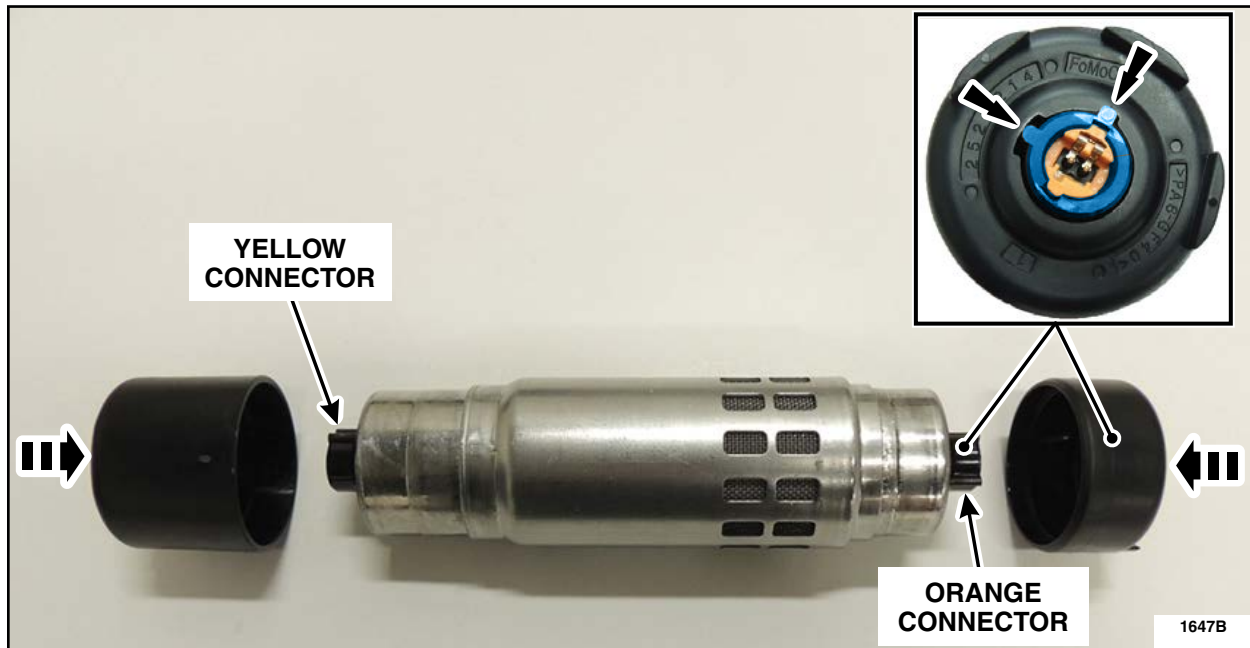
FIGURE 13

Install both *new* inflator end caps making sure the alignment feature on the cap nearest the inflator retaining bracket is properly oriented. See Figure 13.

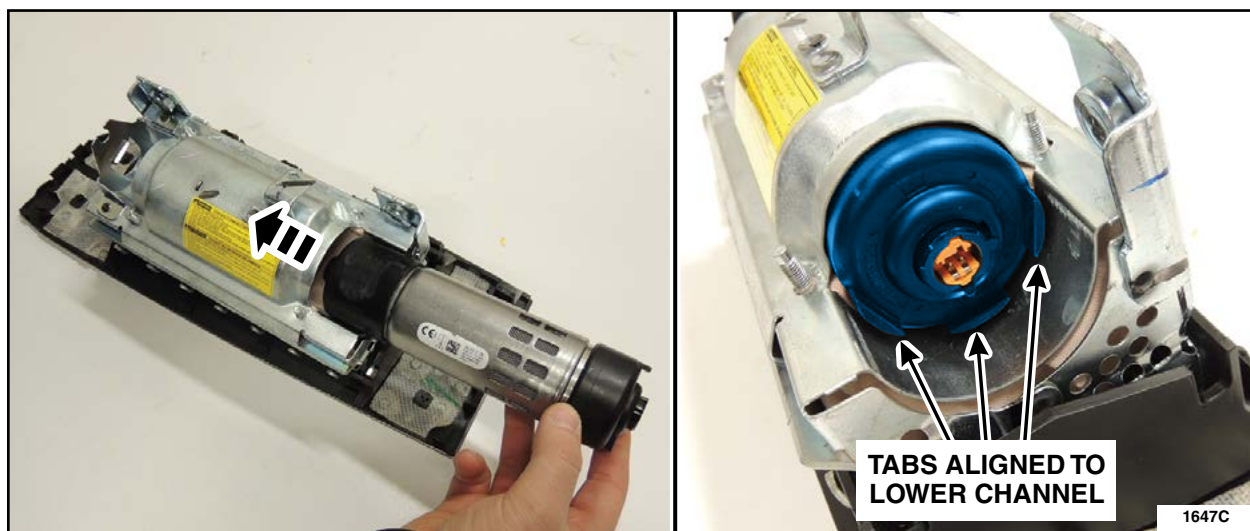
FIGURE 14

9. Install the inflator into the passenger airbag assembly with the orange connector end facing out. Align the three tabs on the cap nearest the inflator retaining bracket with the airbag module lower channel (facing down). See Figure 14.

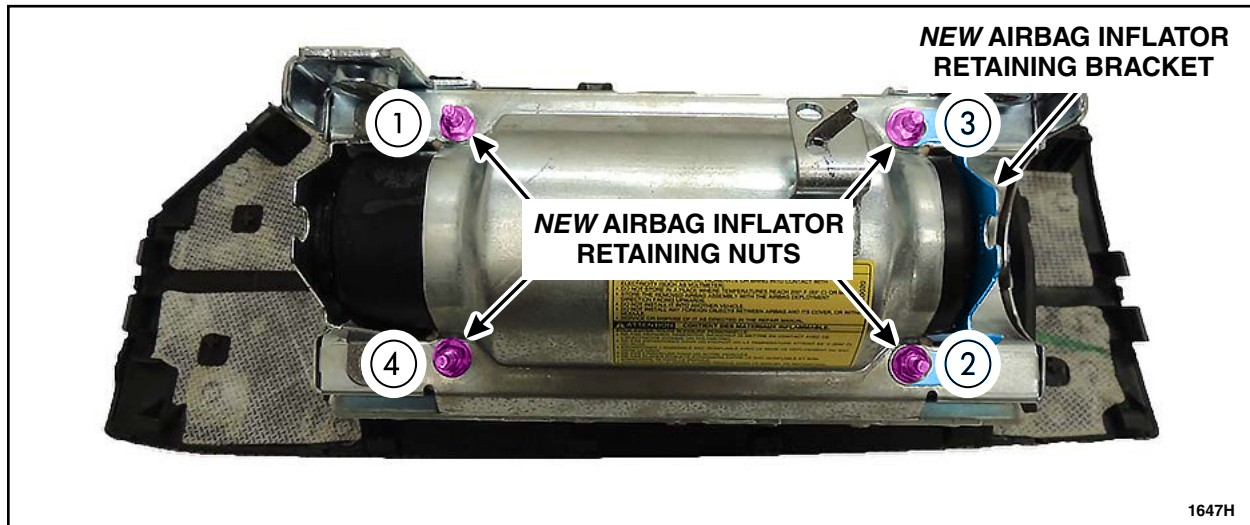
FIGURE 15

10. Install the *new* passenger airbag inflator retaining bracket and *new* nuts. See Figure 15.

- Torque the new retaining nuts in the sequence shown below to 4 Nm (35 lb.in).

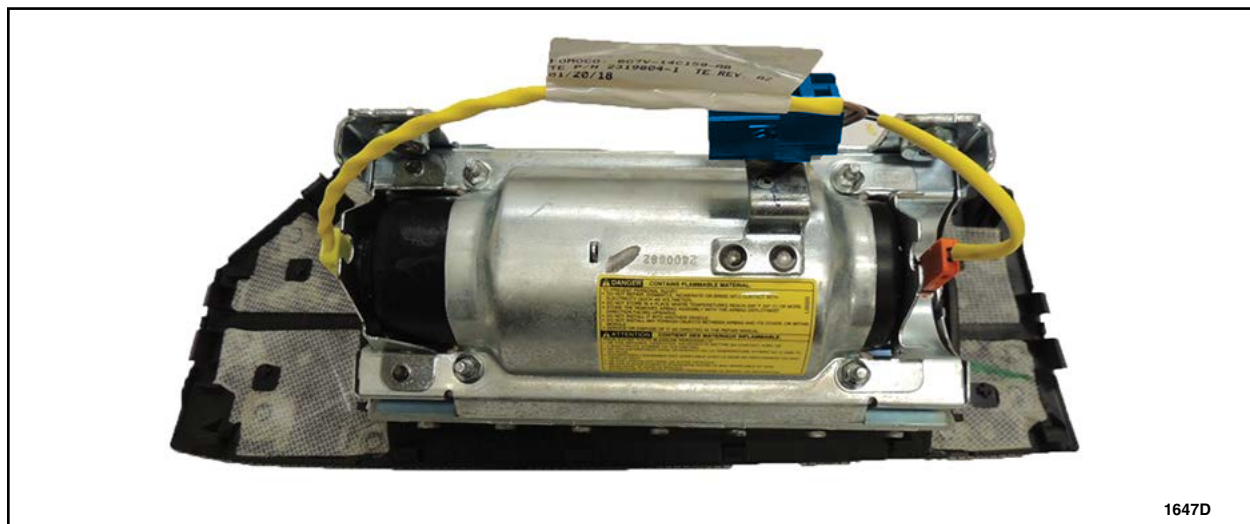
FIGURE 16

11. Align the T-shape index on both the wiring harness electrical connector and the airbag inflator. Install the *new* wiring harness onto the passenger airbag module and connect to both sides of the inflator. See Figure 16.

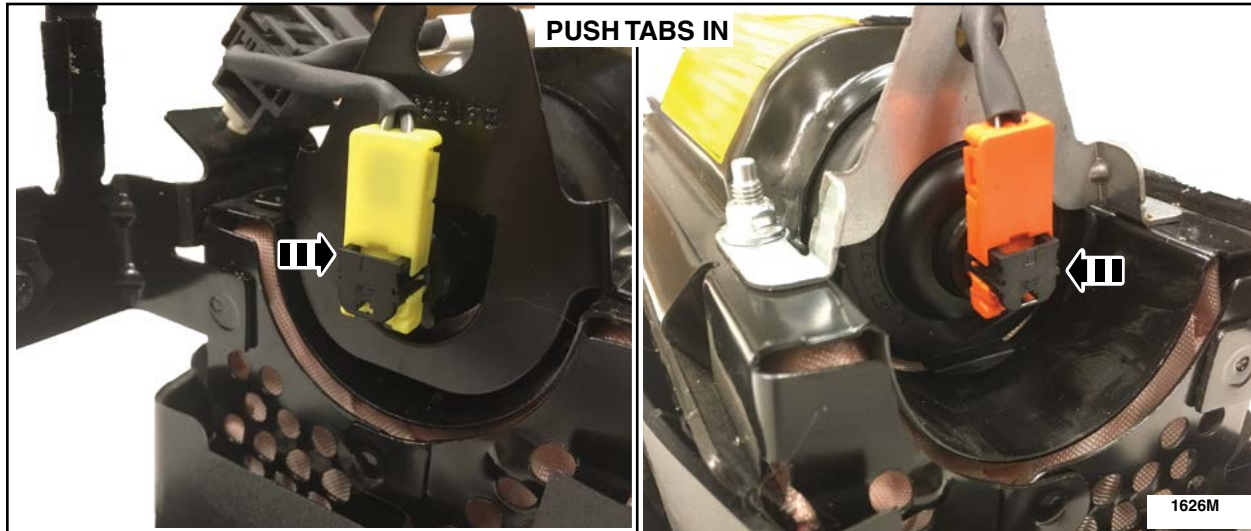
FIGURE 17

NOTE: Pull gently on the wiring harness to ensure it is properly seated.

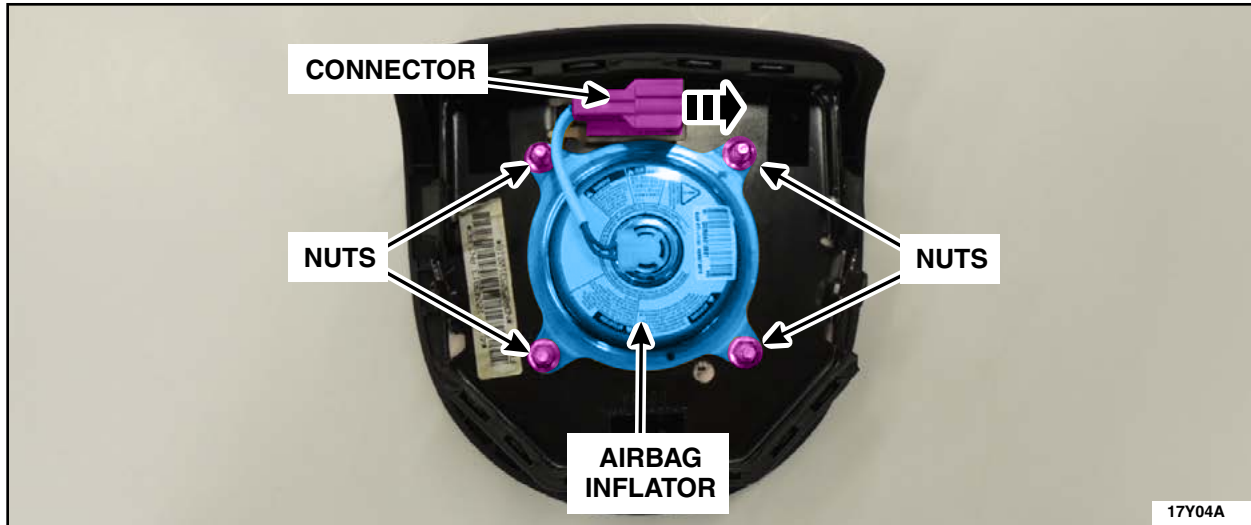
FIGURE 2

1. Release the retaining tab and slide the driver airbag inflator connector off of the tang. See Figure 2.
2. Remove and discard the four airbag inflator retaining nuts from the driver side airbag. See Figure 2.
