SUBJECT: Safety Recall 21S05

Certain 2005-2014 Mustang, 2005-2006 Ford GT, 2004-2011 Ranger, 2006-2012 Fusion and MKZ/Zephyr, 2006-2011 Milan, and 2007-2010 Edge and MKX Vehicles
 Airbag Module Inspection and Replacement

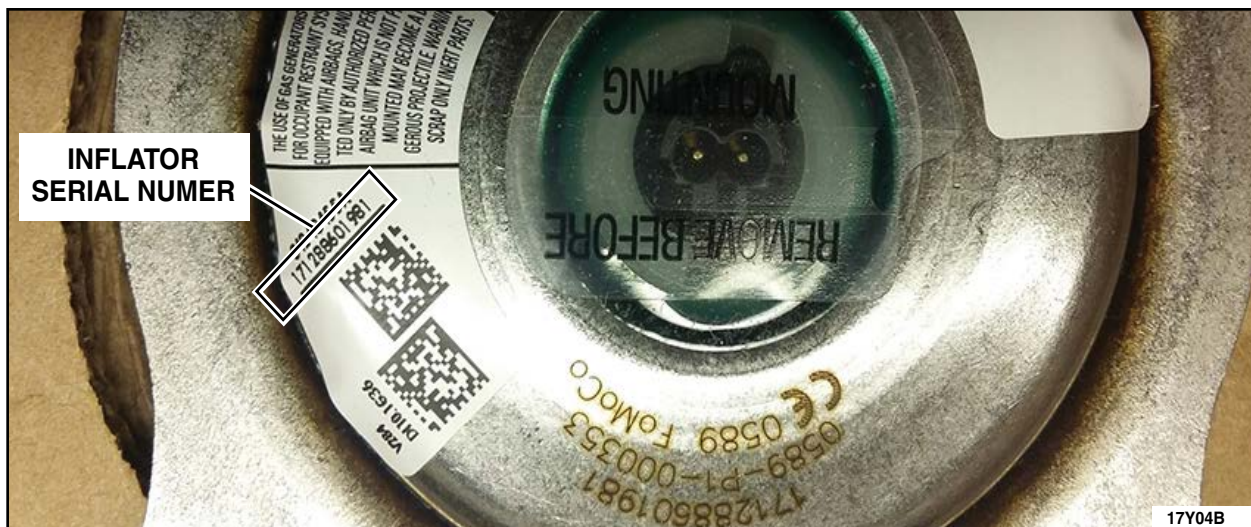
FIGURE 3

Record the 12 character serial number of the *new* driver airbag inflator on the repair order. See Figure 3.

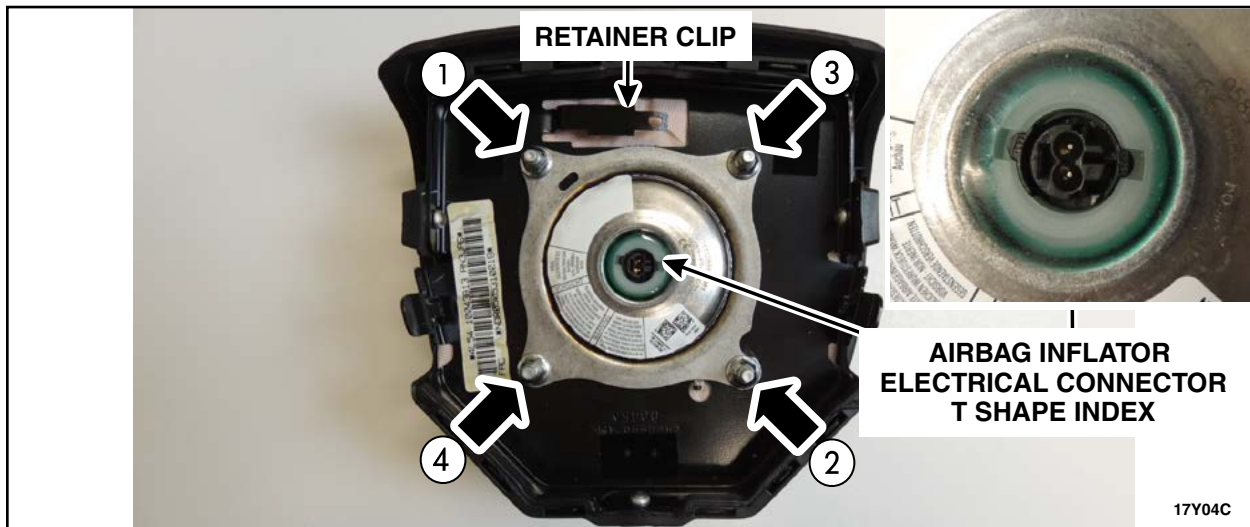
FIGURE 4

- Tighten to 6.5 Nm (57 lb-in) in the specified sequence.

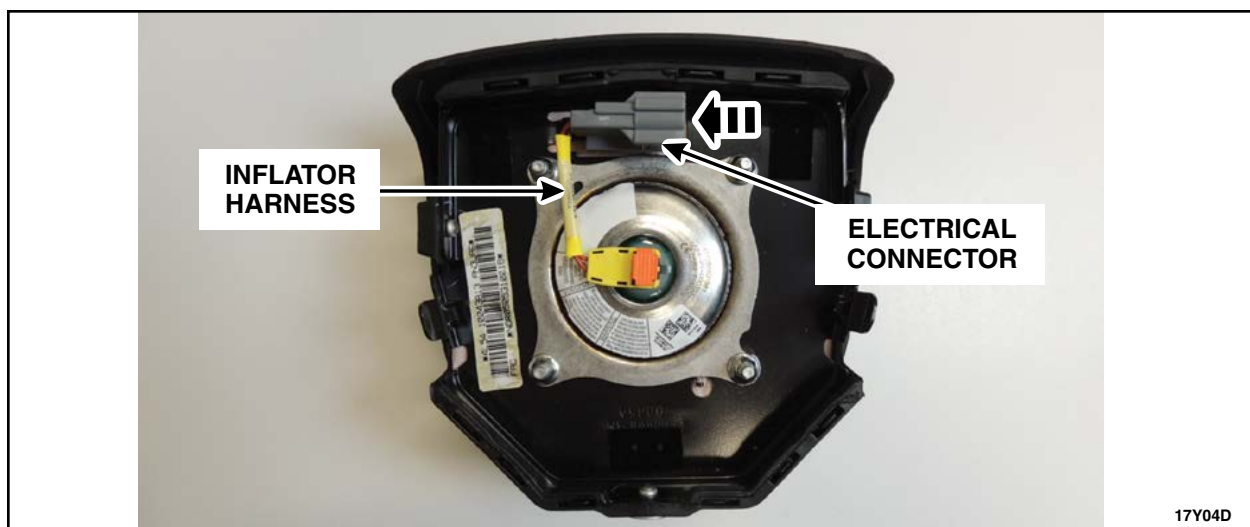
FIGURE 5

6. Align the T-shape index on both the wiring harness electrical connector and the airbag inflator, connect the *new* airbag wiring harness to the inflator module and fully seat the orange tab. See Figure 5.
7. Ensure the connection between the wiring harness electrical connector and the airbag inflator by pulling gently on the wiring harness to ensure it is properly seated. See Figure 5.
8. Slide the airbag inflator connector onto the tang. See Figure 5.

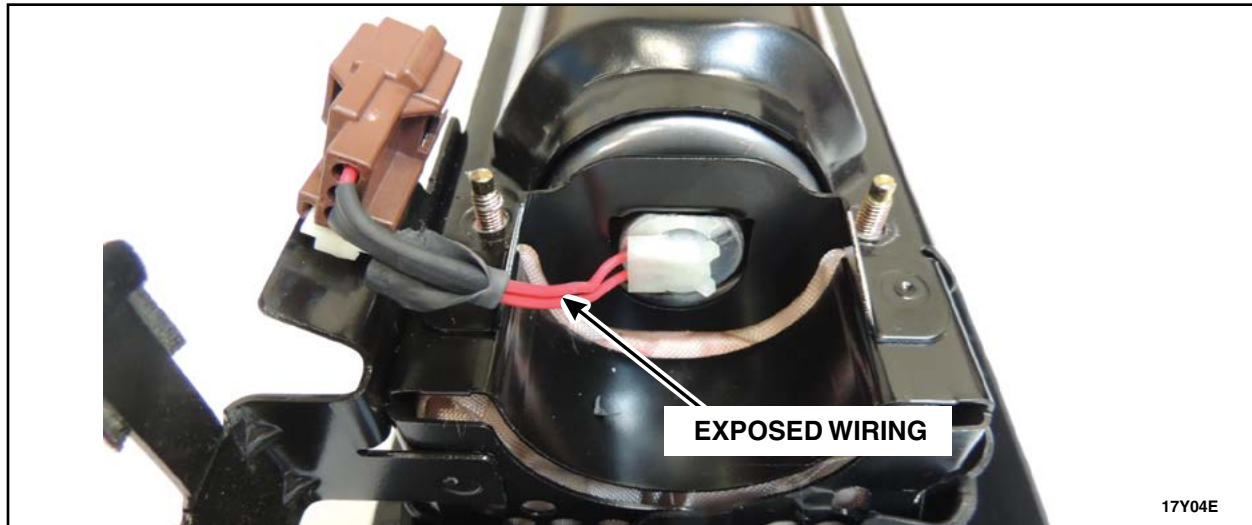
FIGURE 7

1. Cut and peel back wiring sleeve to expose inflator wiring. See Figure 7.

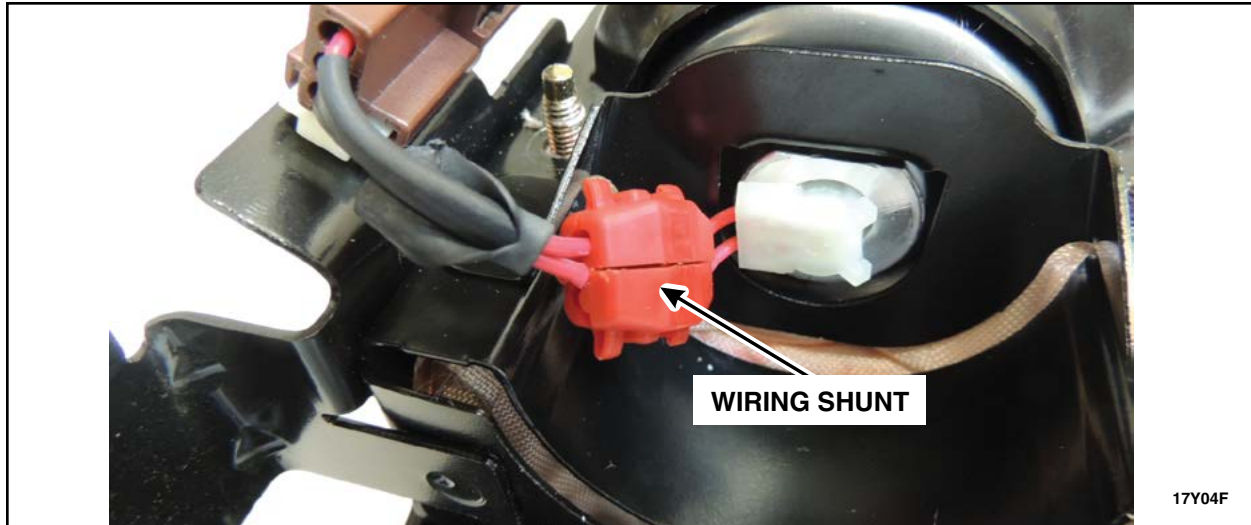
FIGURE 8

2. Install a wiring shunt between the inflator wiring connector and the inflator body, this will cause the inflator to become inert. See Figure 8.

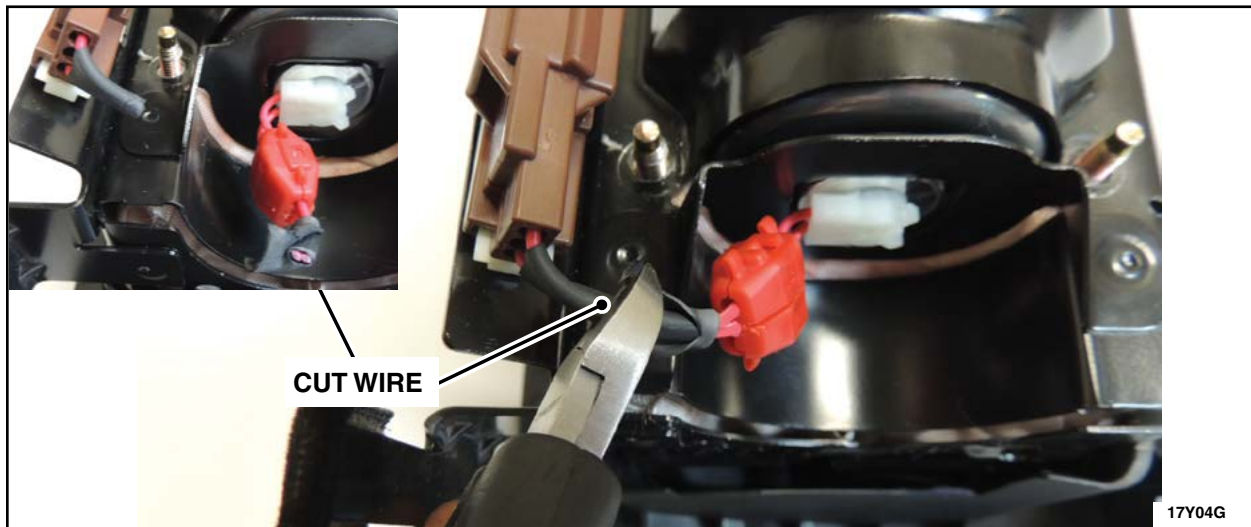
FIGURE 9

3. Cut the inflator wiring between connector and the shunt. See Figure 9.

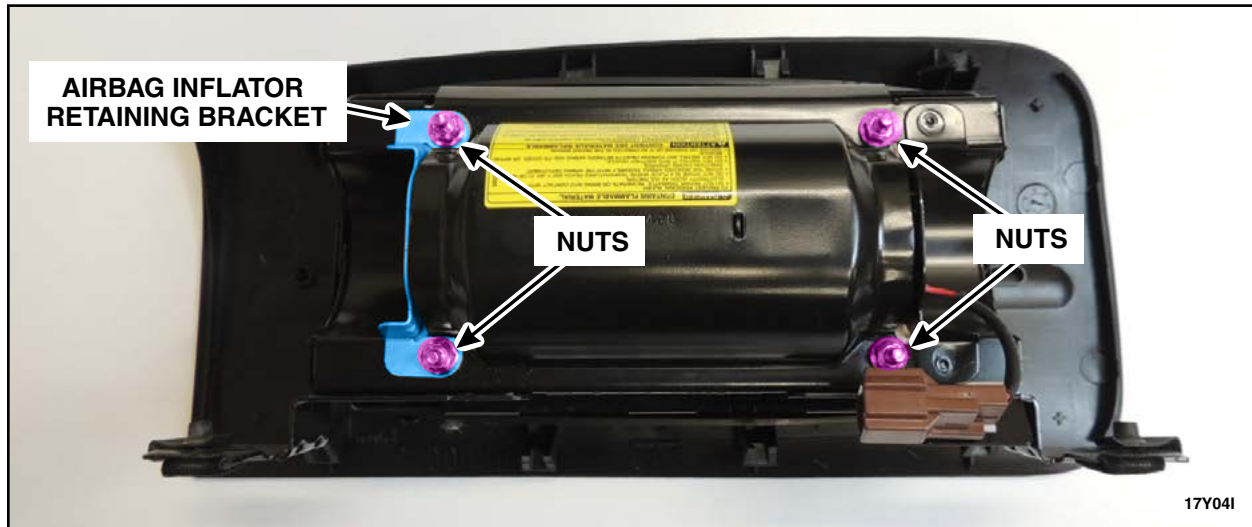
FIGURE 10

4. Remove and discard the four airbag inflator retaining nuts and the bracket. See Figure 10.

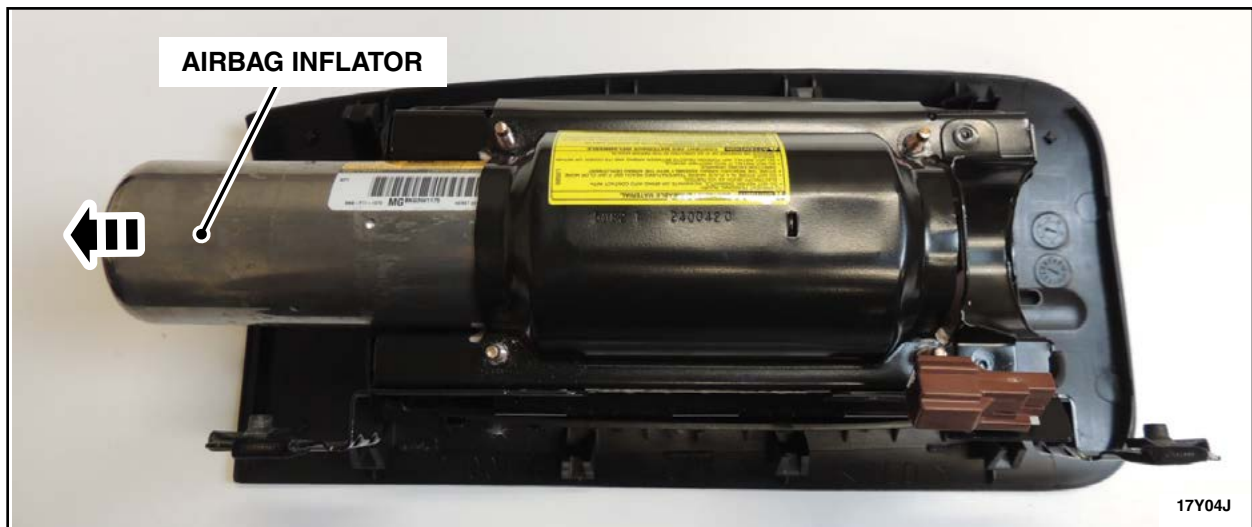
FIGURE 11

⚠ WARNING: Do not allow any debris on or around the airbag once the inflator is removed.

5. With an assistant holding the airbag assembly, remove the inflator from the airbag assembly by pushing outward on the inflator. See Figure 11.

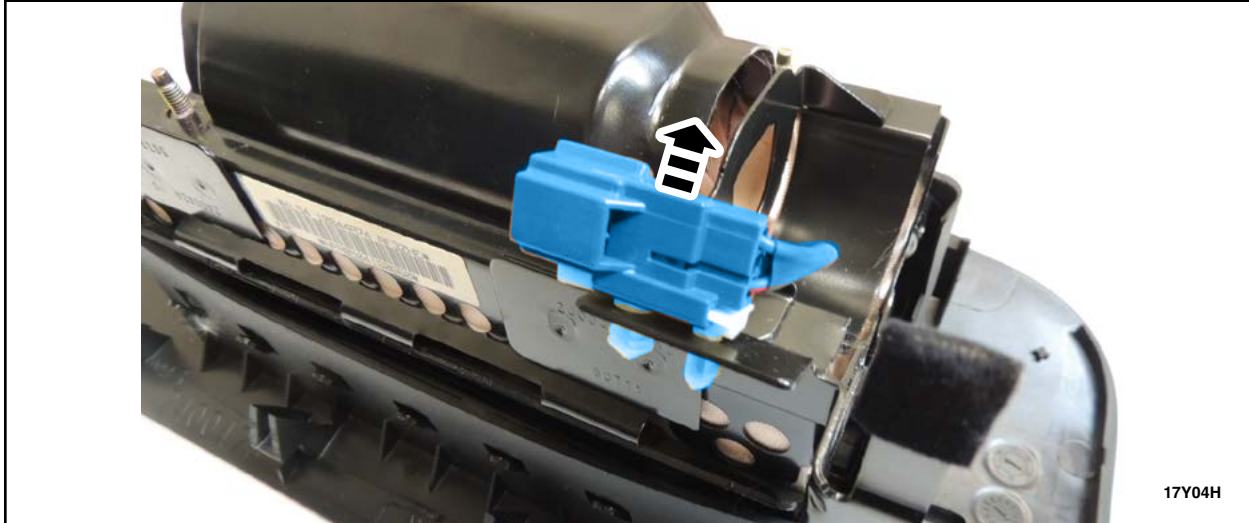
FIGURE 12

6. Remove the airbag inflator harness electrical connector. See Figure 12.

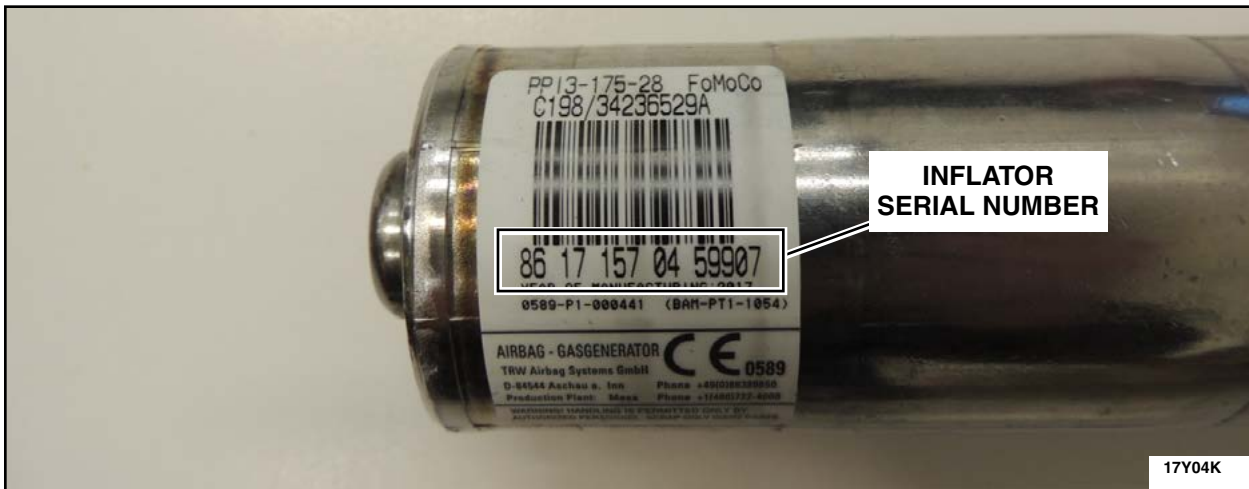
FIGURE 13

Record the 14 character serial number of the *new* passenger airbag inflator on the repair order. See Figure 13.

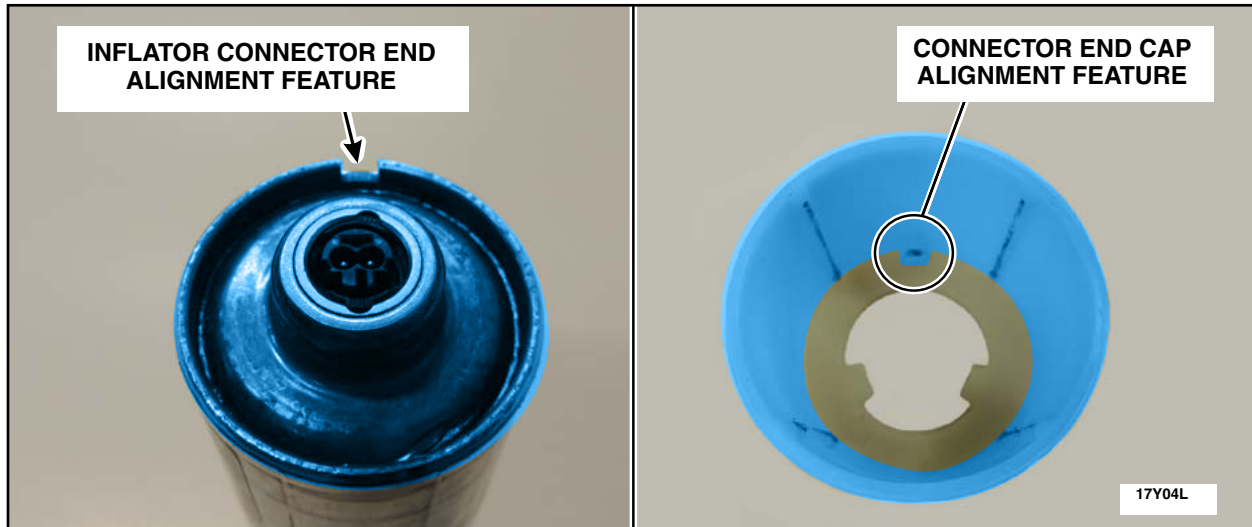
FIGURE 14

Align and install both *new* inflator end caps. See Figure 14 and 15.

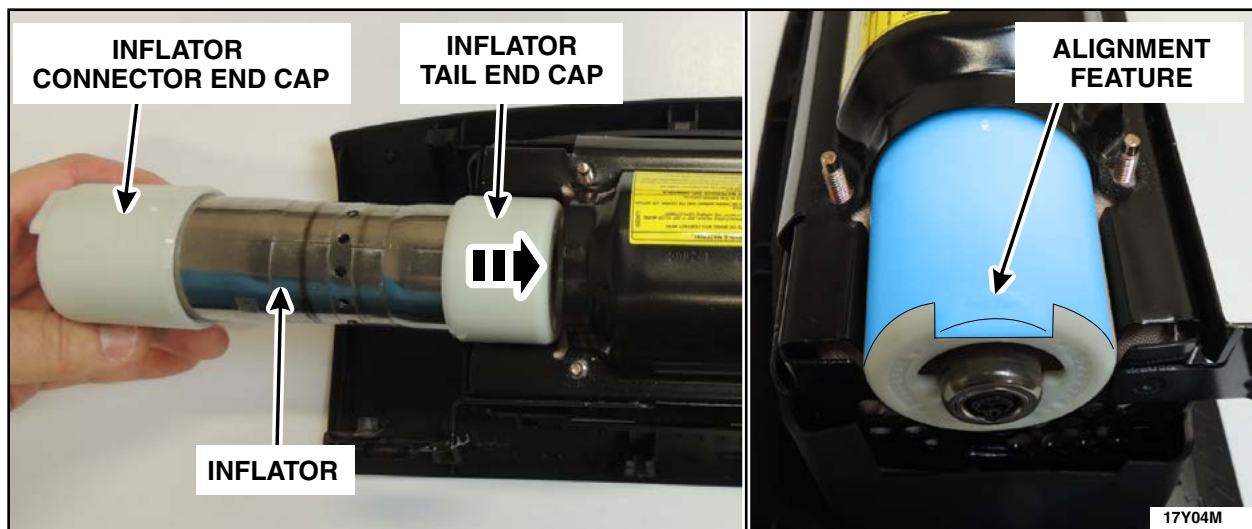
FIGURE 15

9. Install inflator into air bag assembly with connector end facing out, so that the alignment feature is aligned directly facing up. See Figure 15.

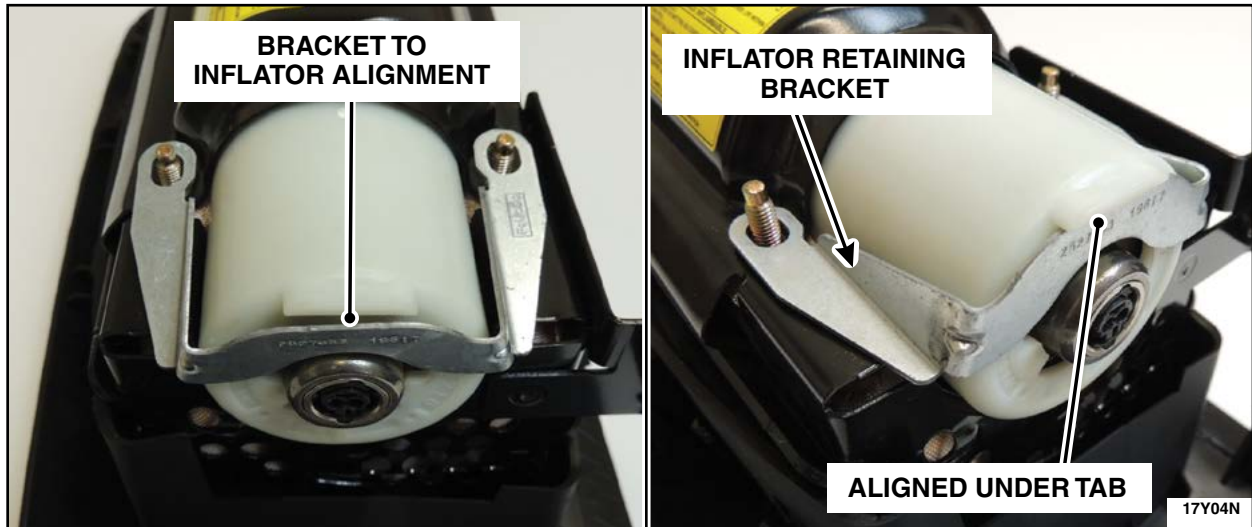
FIGURE 16

10. Align and Install the *new* inflator retaining bracket. See Figure 16.

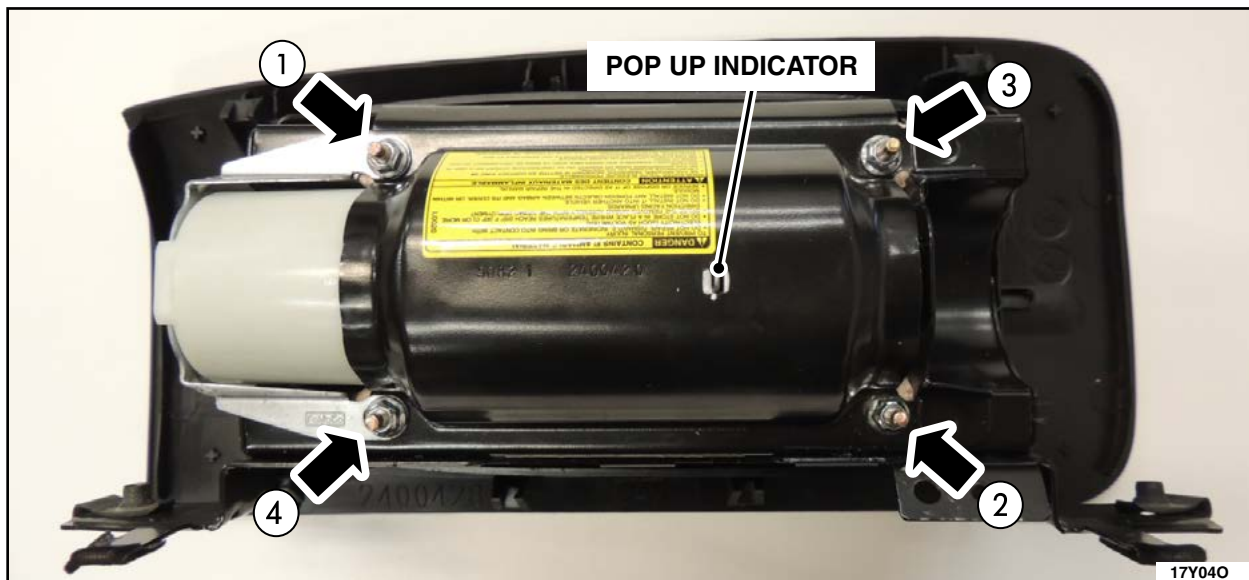
FIGURE 17

11. Install four *new* nuts. Assure pop-up indicator on air bag assembly is present. See Figure 17.

- Tighten to 3.9 Nm (35 lb-in) in the specified sequence.

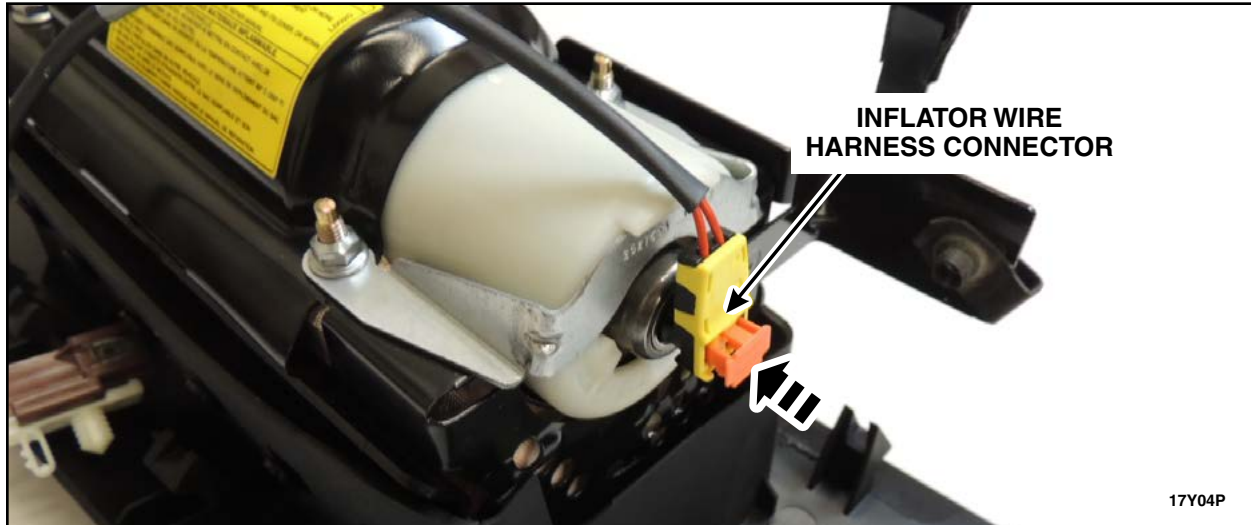
FIGURE 18

12. Align the T-shape index on both the wiring harness electrical connector and the airbag inflator, connect the *new* airbag wiring harness to the inflator module and fully seat the orange tab. See Figure 18.
13. Ensure the connection between the wiring harness electrical connector and the airbag inflator by pulling gently on the wiring harness to ensure it is properly seated. See Figure 18.

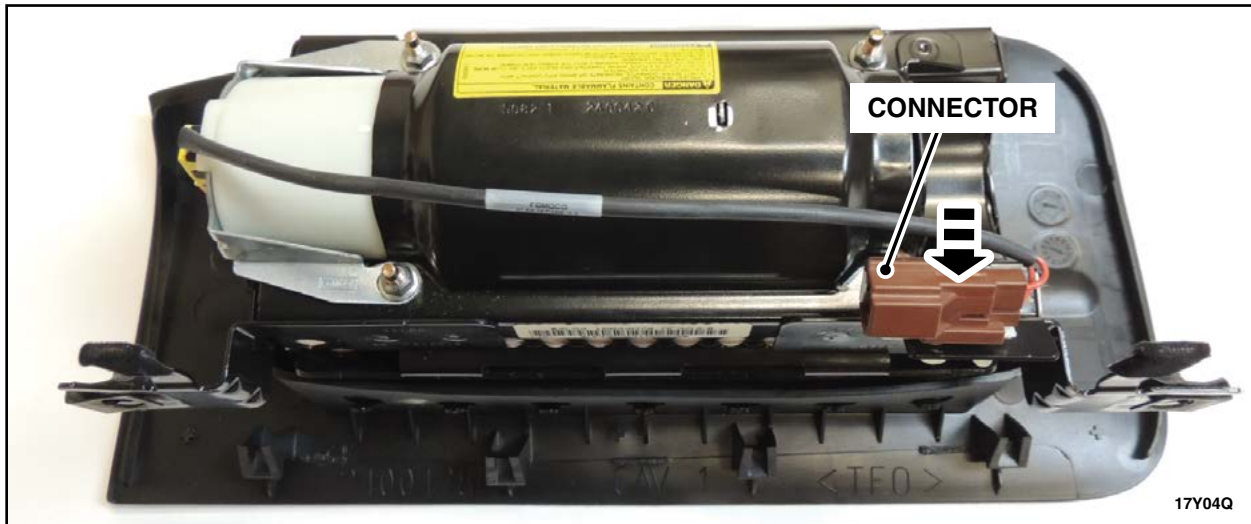
FIGURE 19

14. Install inflator harness connector to the air bag assembly bracket. See Figure 19.

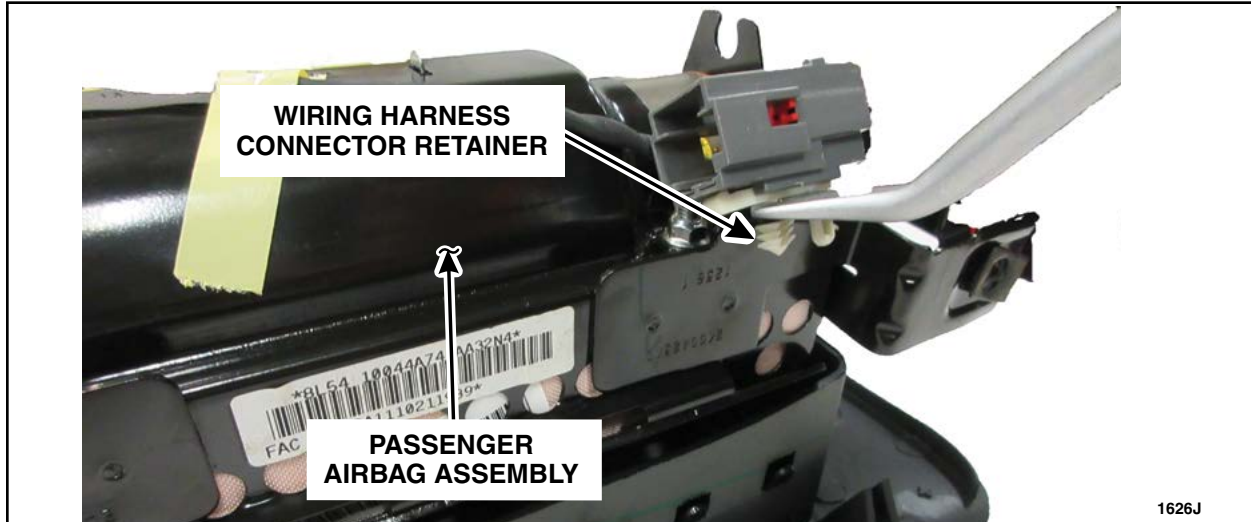
FIGURE 2

1. Remove the wiring harness connector retainer from the passenger airbag assembly. See Figure 2.

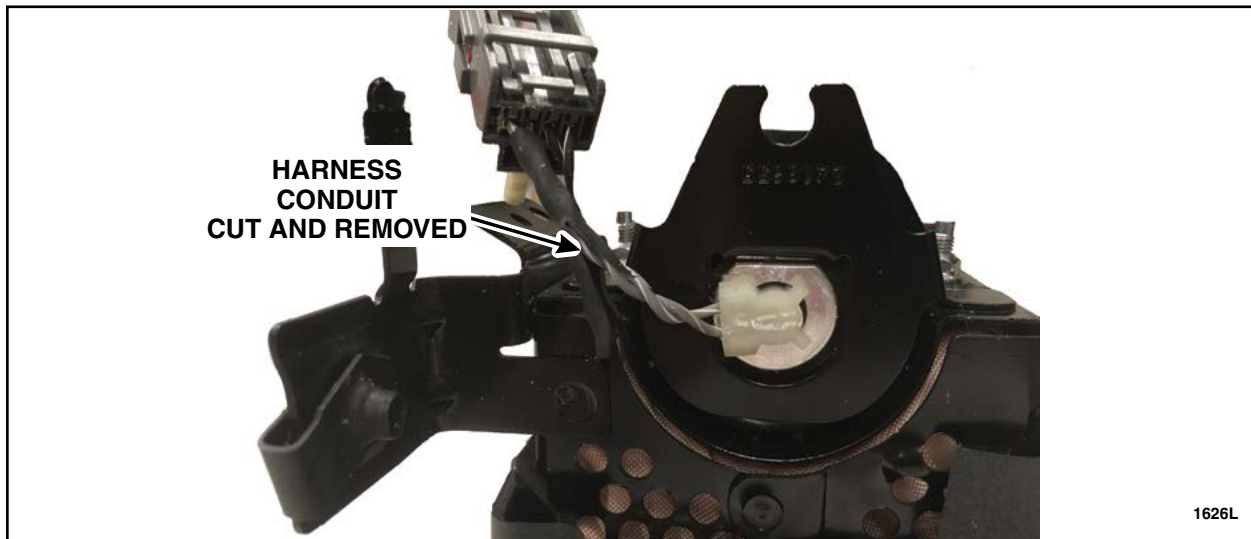
FIGURE 3

NOTE: Carry out this Step on the shorter wire on the end opposite of the airbag inflator retaining bracket. See Figure 3.

2. Remove the conduit from the passenger airbag assembly wire harness in the area shown. See Figure 3.

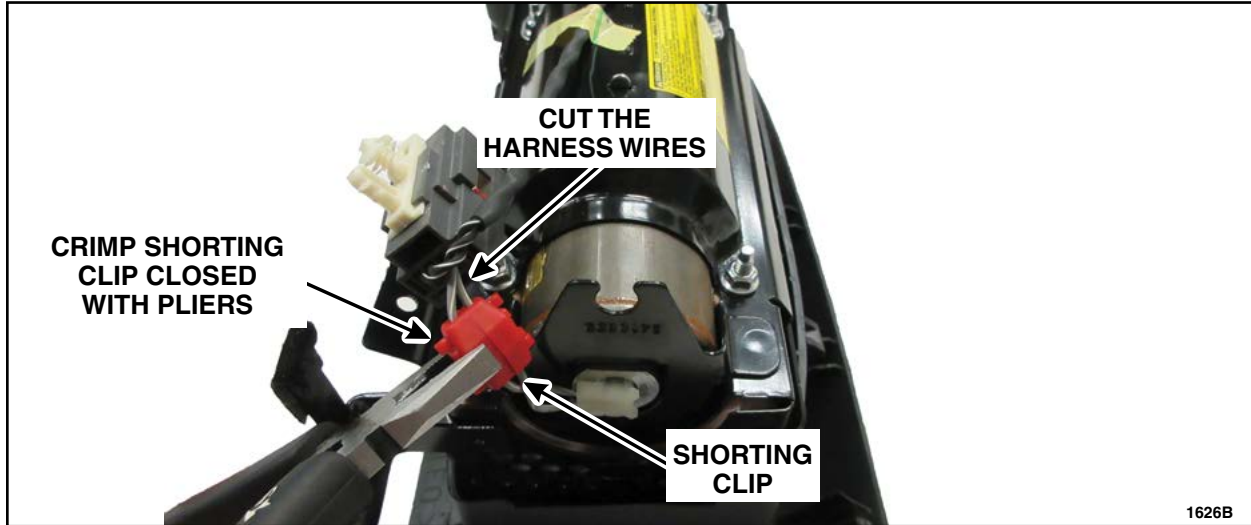
FIGURE 4

3. Position the shorting clip onto the harness wires, and crimp the shorting clip together one side at a time using pliers. See Figure 4.
4. Cut the harness wires between the shorting clip and the harness connector. See Figure 4.

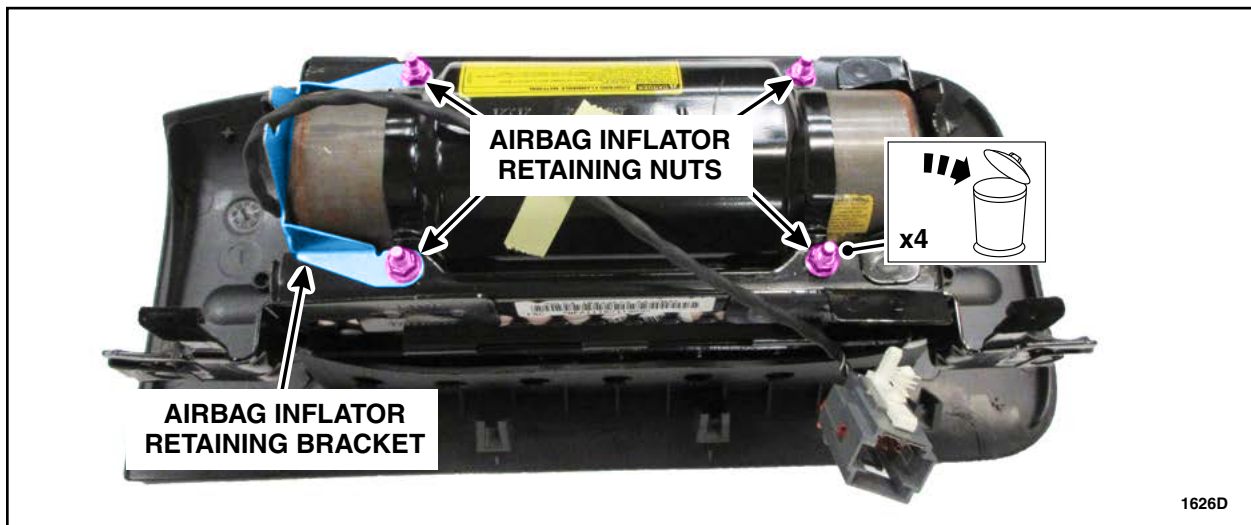
FIGURE 5

5. Remove and discard the four passenger airbag inflator retaining bracket nuts and the retaining bracket. See Figure 5.

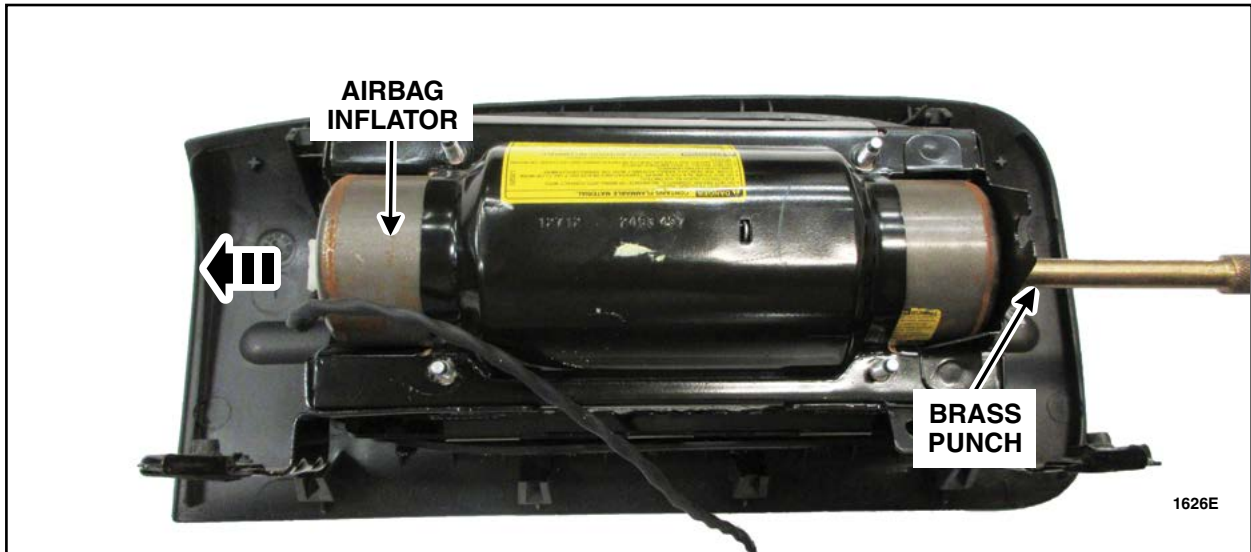
FIGURE 6

6. With an assistant holding the passenger airbag assembly, remove the inflator from the assembly by pushing outward on the inflator. Set the airbag inflator aside for return shipping. See Figure 6.
 - If required, use of a brass punch is permitted (only at the location shown) to free the inflator from its mounted position.

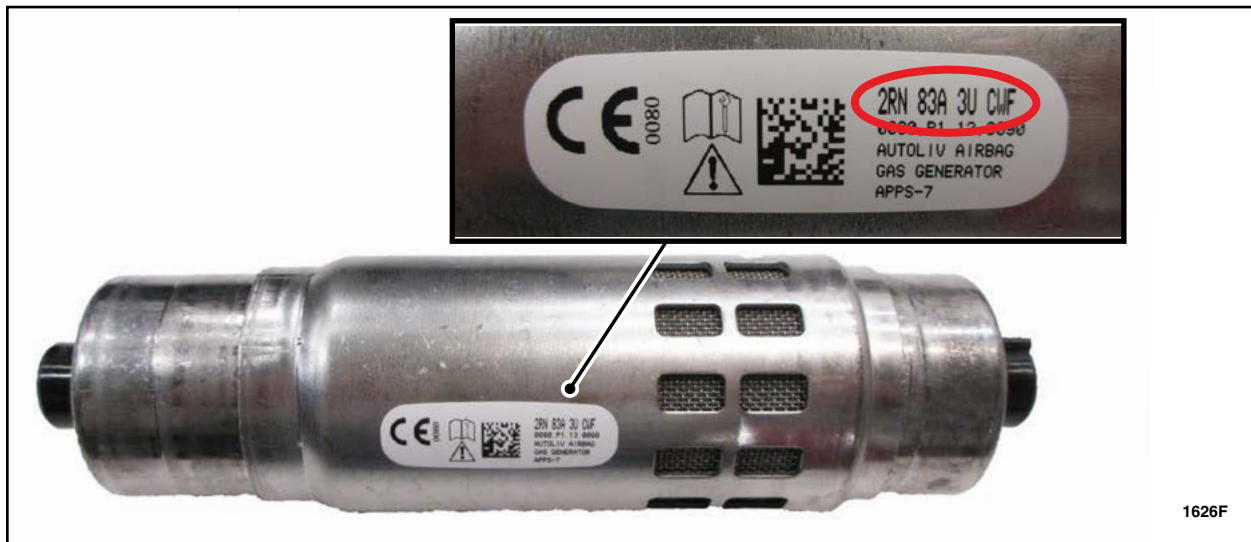
FIGURE 7

NOTE: The serial number of the *new* airbag inflator must be provided to Ford for the warranty claim to be processed.

7. Record the 11 character serial number of the *new* airbag inflator on the repair order. See Figure 7.

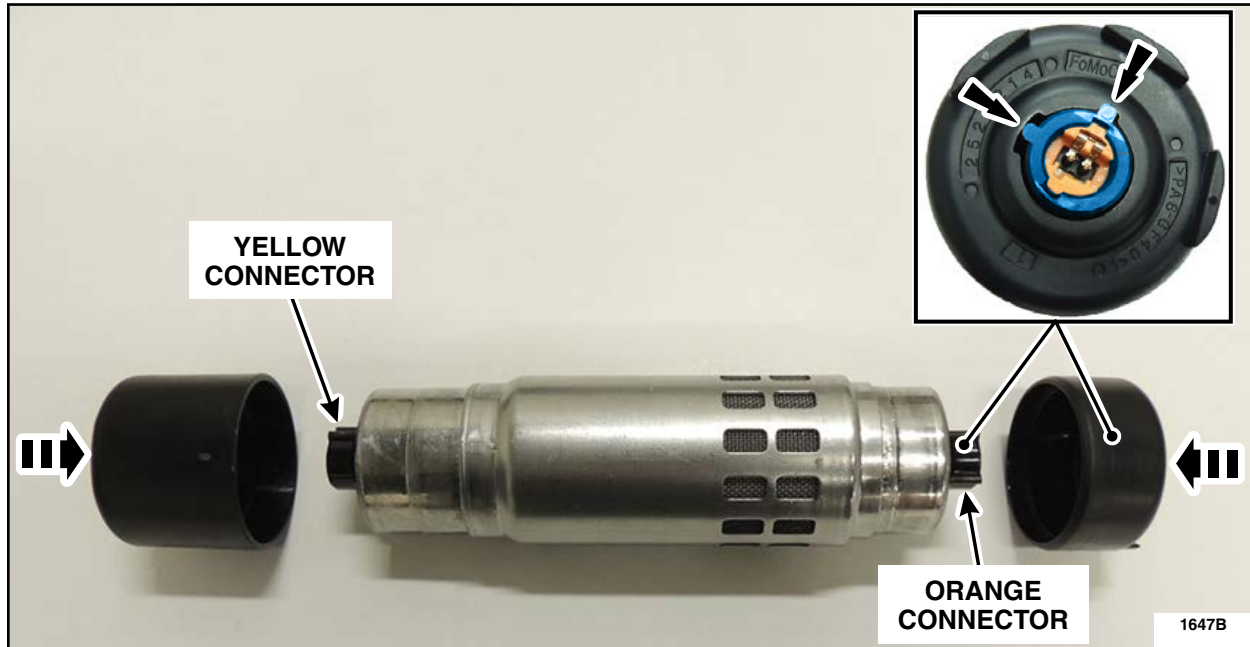
FIGURE 8

Install both *new* inflator end caps making sure the alignment feature on the cap nearest the inflator retaining bracket is properly oriented. See Figure 8.

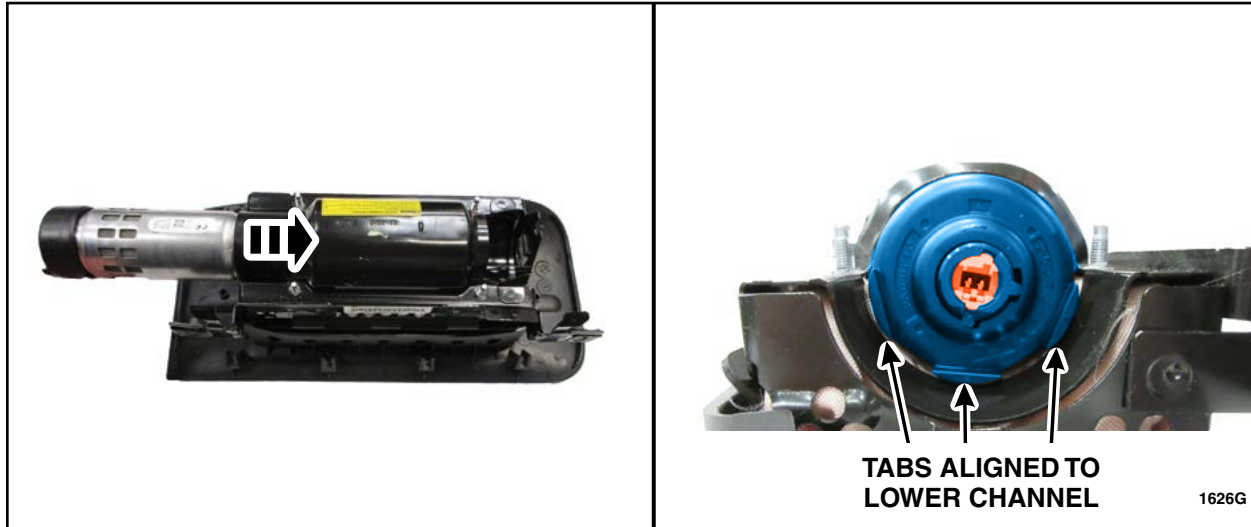
FIGURE 9

9. Install the inflator into the passenger airbag assembly with the orange connector end facing out. Align the three tabs on the cap nearest the inflator retaining bracket with the airbag module lower channel (facing down). See Figure 9.

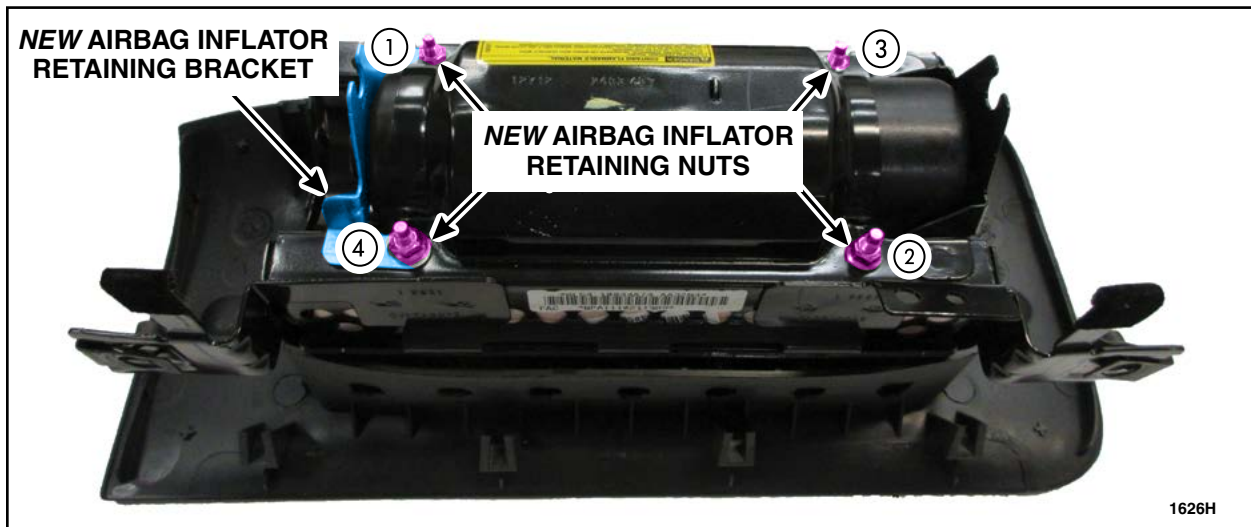
FIGURE 10

NOTE: If the inflator retaining bracket is unable to be installed, ensure the inflator tail end cap is fully seated.

- Torque the *new* retaining nuts in the sequence shown below. Tighten to 4 Nm (35 lb in).

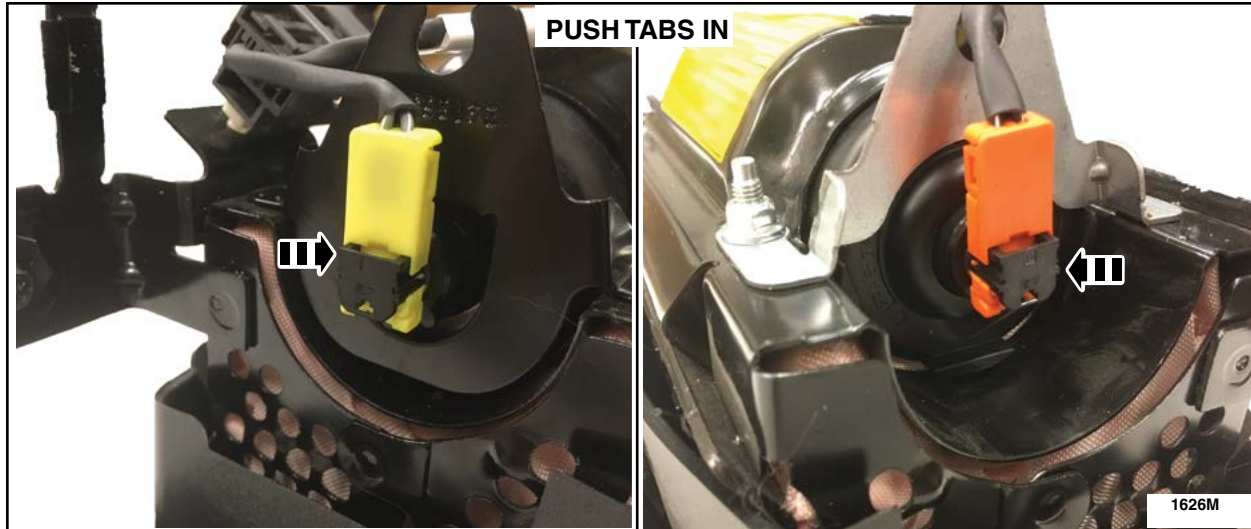
FIGURE 11

NOTE: Pull gently on the wiring harness to ensure it is properly seated.

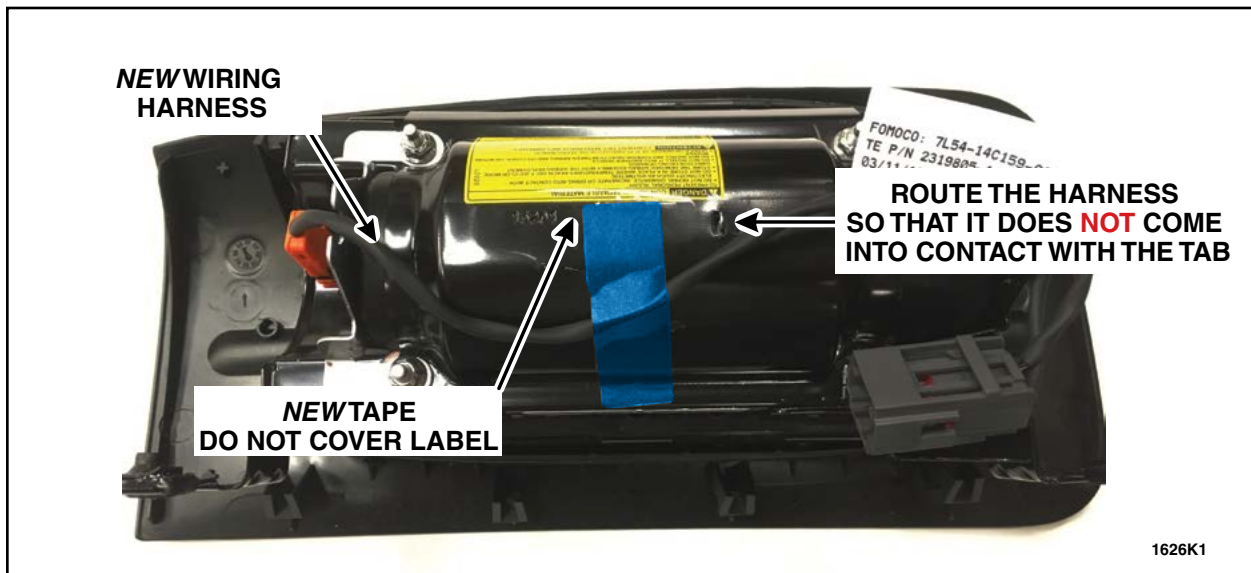
FIGURE 12

12. Install the *new* tape to the wiring harness and airbag assembly, do not cover the airbag warning label with the *new* tape. For correct placement See Figure 12.

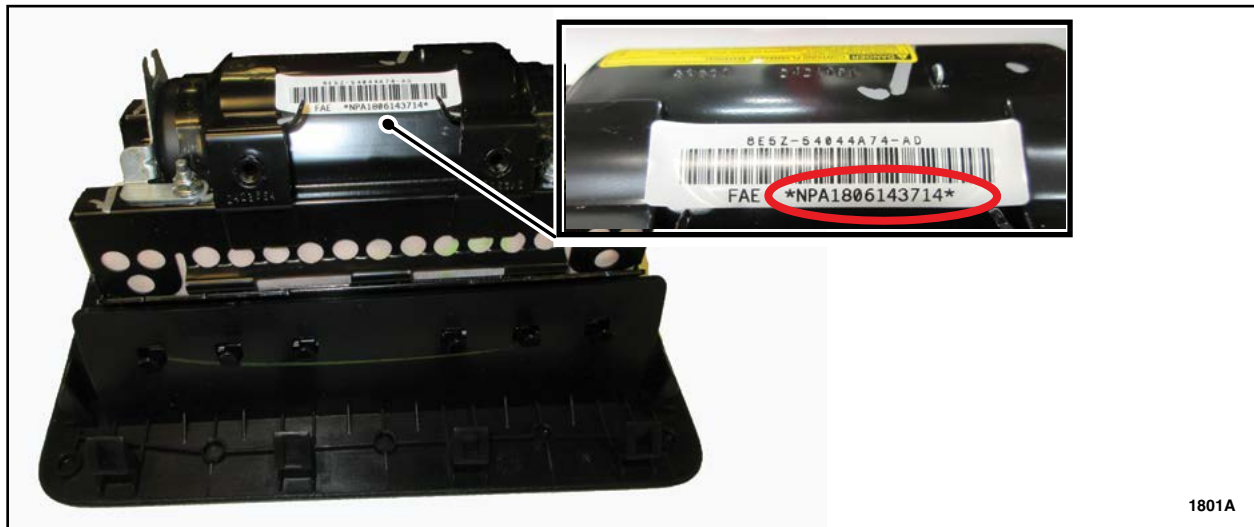
FIGURE 1

1. Record the 13 character serial number of the *new* airbag module on the repair order. See Figure 1.
2. Replace the passenger airbag module. Please follow the Workshop Manual procedures in Section 501-20.
3. Package the replaced airbag module in the *new* part box and provide to the appropriate dealership personnel for part returns.

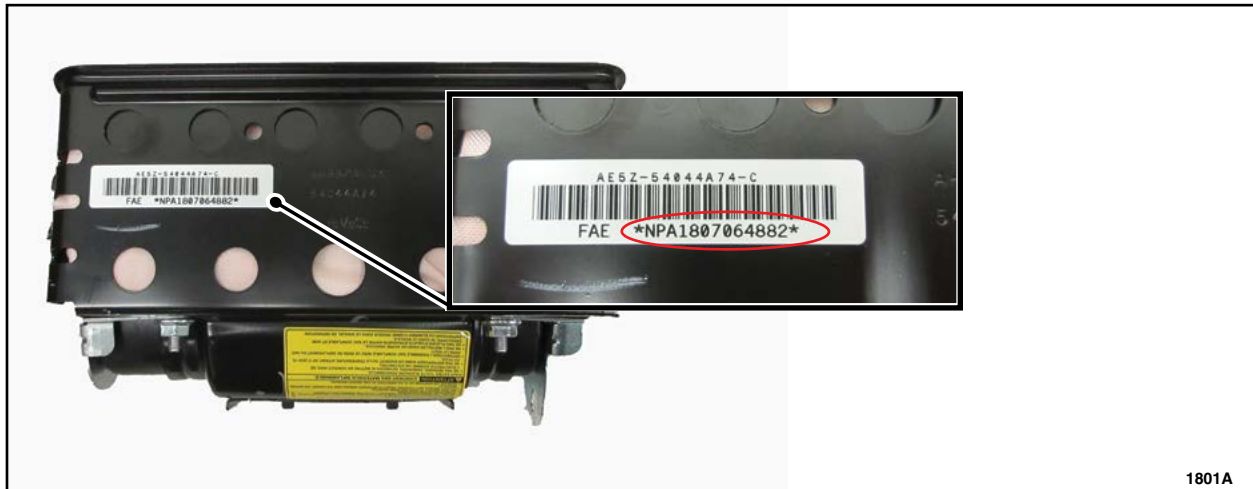
FIGURE 2

1. Record the 13 character serial number of the *new* airbag module on the repair order. See Figure 2.

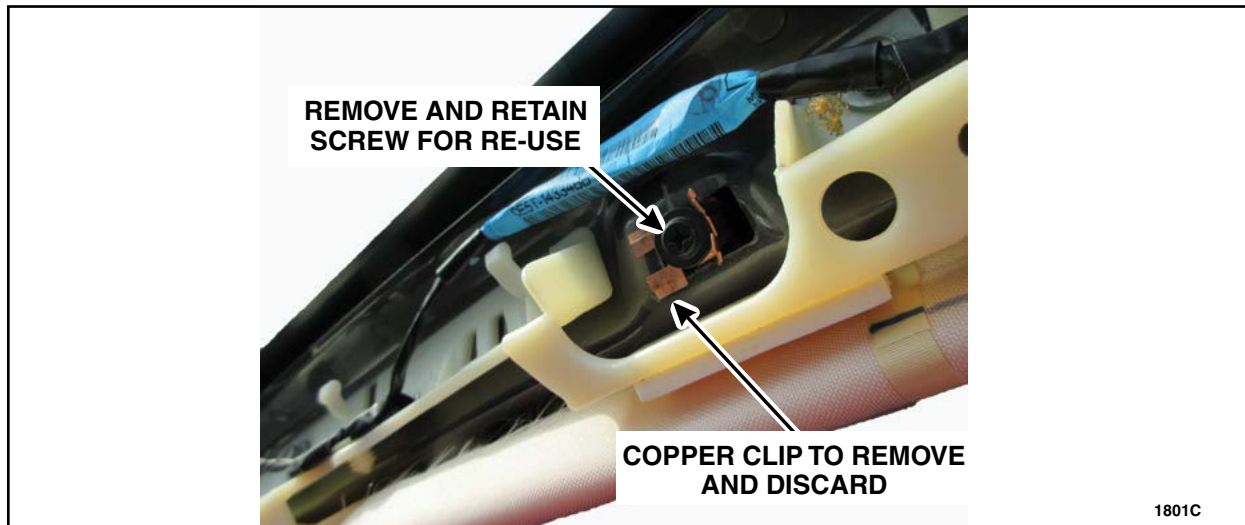
FIGURE 4

3. Remove and discard the top A-Pillar clip from the body. See Figure 4.

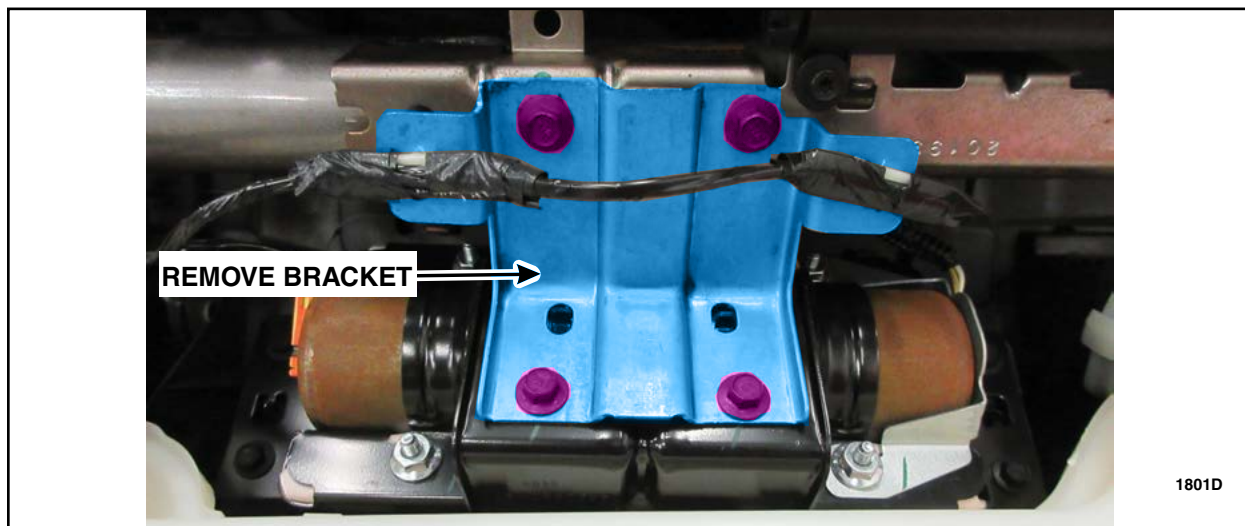
FIGURE 5

- Remove the instrument panel crossmember-to-airbag module bracket. See Figure 5.
- Torque to 80 lb. in (9 Nm).

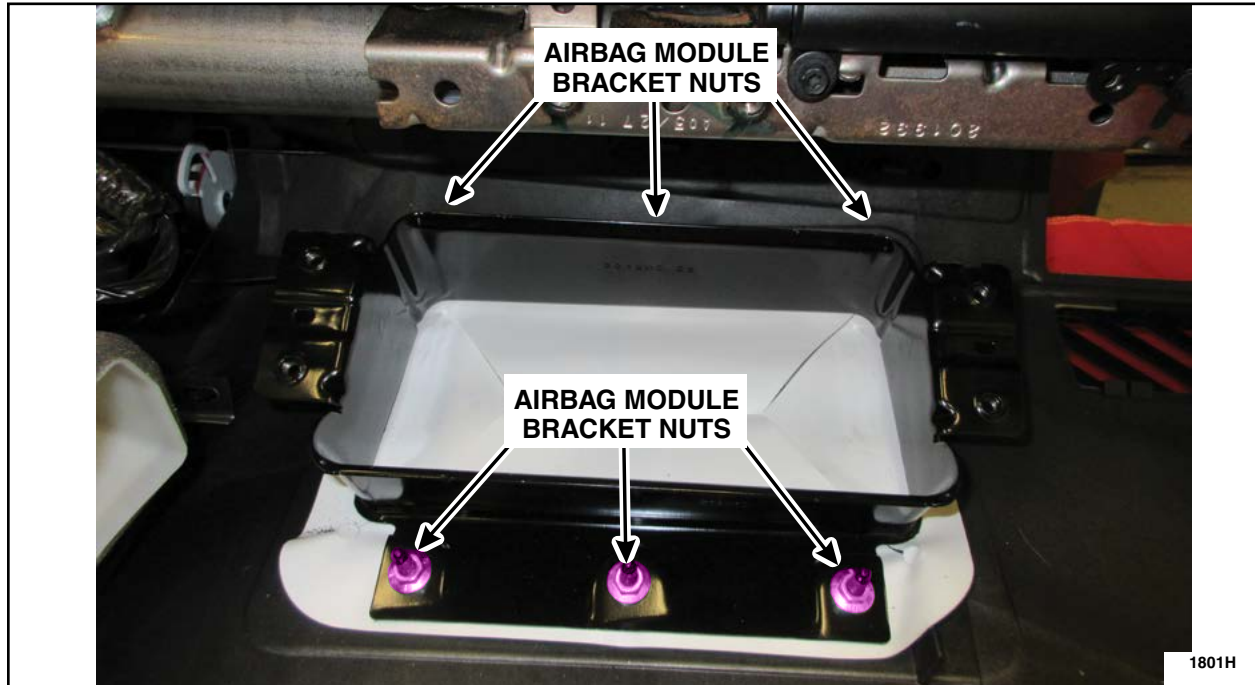
FIGURE 6

5. Remove the six (6) nuts retaining the airbag module bracket to the instrument panel. Remove the bracket from the instrument panel. See Figure 6.

- Torque to: 80 lb.in (9 Nm).

8. Reinstall the airbag module bracket onto the instrument panel. See Figure 6.
9. Install the *new* airbag module and instrument panel. Please follow the WSM procedures in Section 501-20.
 - Install the instrument panel crossmember-to-airbag module bracket. See Figure 5.
