SUBJECT: Safety Recall 21S05

Certain 2005-2014 Mustang, 2005-2006 Ford GT, 2004-2011 Ranger, 2006-2012 Fusion and MKZ/Zephyr, 2006-2011 Milan, and 2007-2010 Edge and MKX Vehicles
 Airbag Module Inspection and Replacement

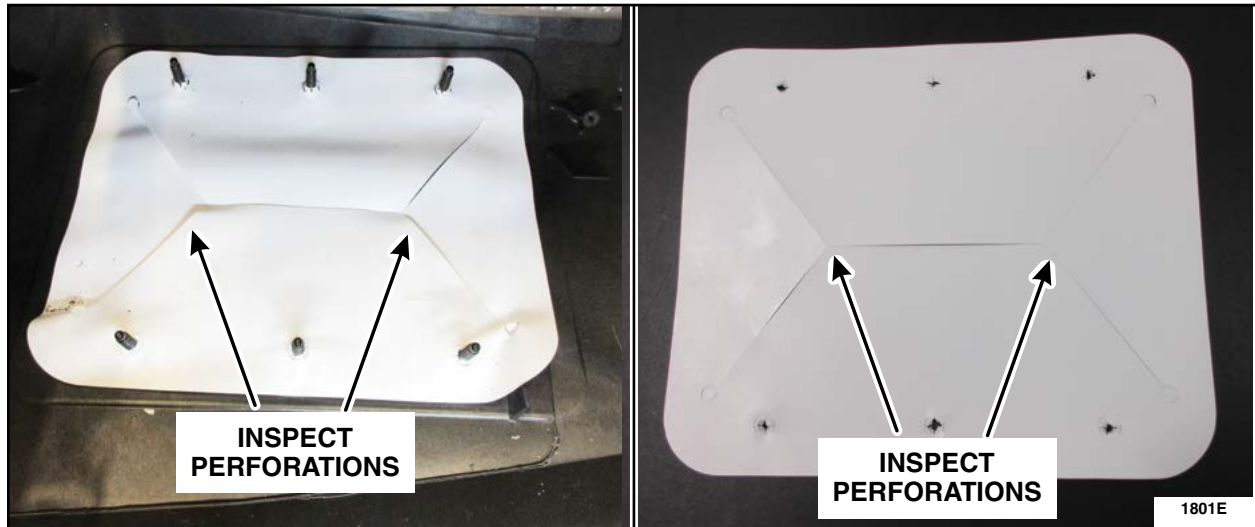
FIGURE 7

6. Inspect the white airbag cushion sheets installed on the instrument panel. See Figure 7.

NOTE: If any damage is present on either of the airbag cushion sheets, the damaged sheet(s) must be replaced. Type of damage includes, but is not limited to, cuts, creases, folds or the perforations being broken.

NOTE: Sheets can be installed in any direction or orientation.

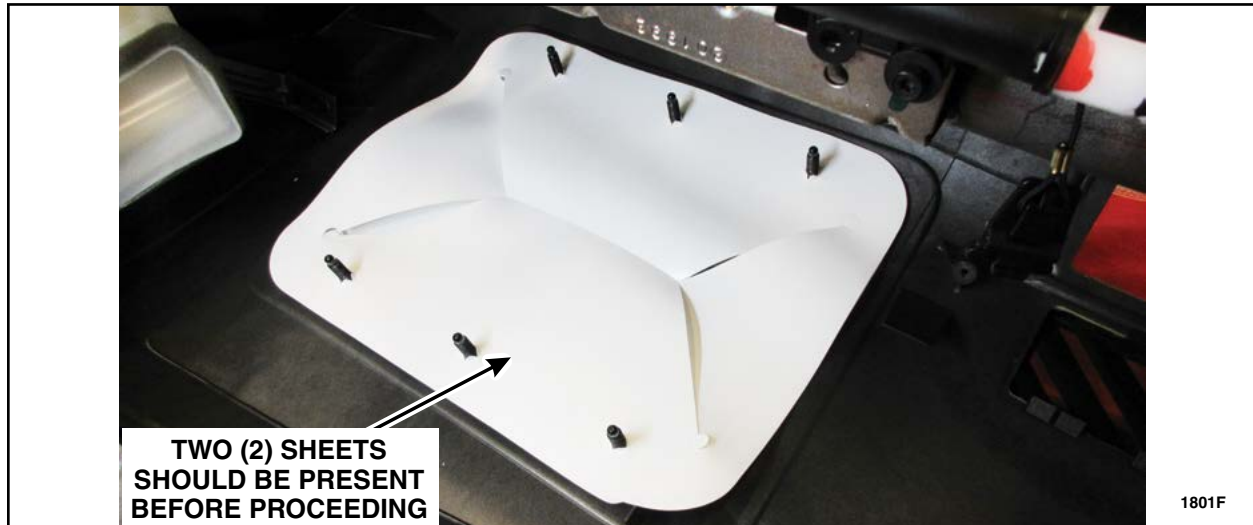
FIGURE 8

7. Replace sheet or sheets if damaged, clear both sheets of any dirt or debris and reinstall both sheets on the airbag mounting bracket studs. See Figure 8.

NOTE: The sheets will not lay perfectly flat when installed on the instrument panel.

IMPORTANT: Two airbag cushion sheets should be present on the instrument panel before proceeding.

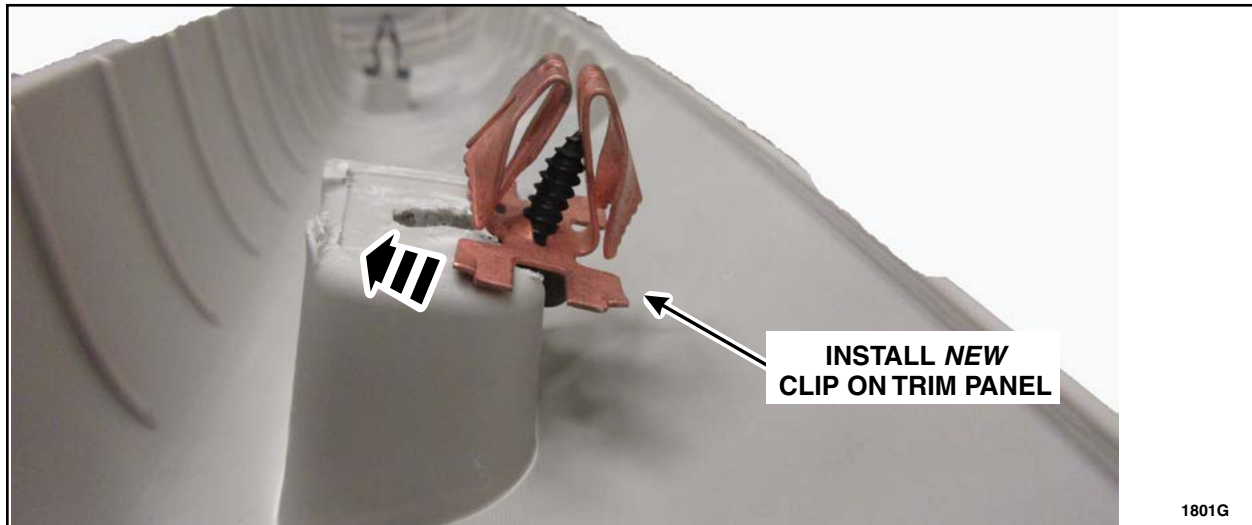
FIGURE 9

10. Install the *new* A-Pillar trim panel clip onto the trim panel. See Figure 9.

NOTE: If the *new* A-Pillar trim panel clips are not equipped with a screw installed, re-use the screw from the original clip from Step 3. Install the screw into the *new* clip by hand.

- Torque to: 9 lb.in (1 Nm).

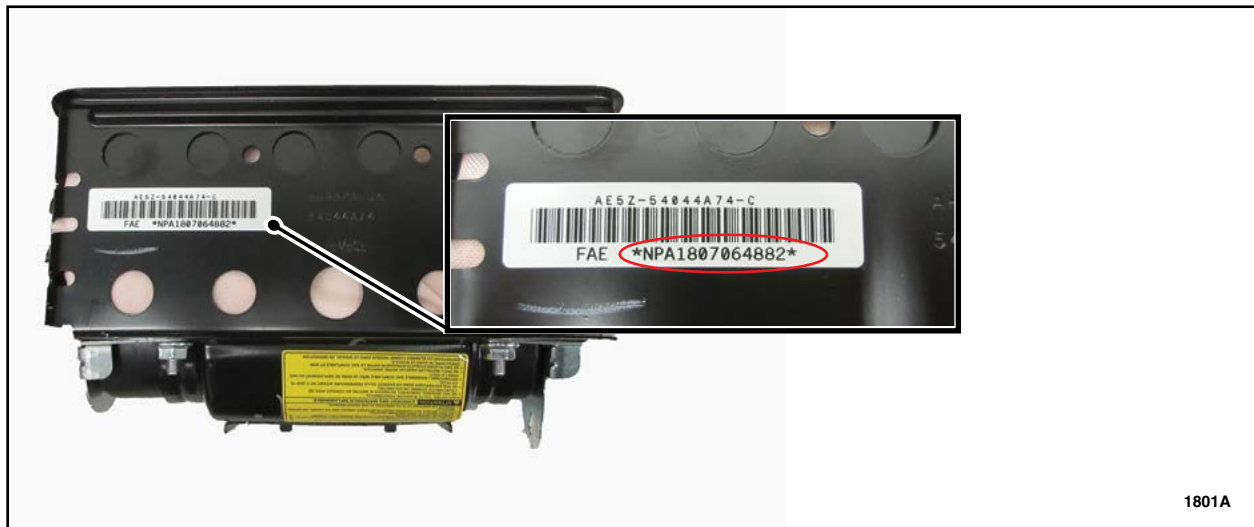
FIGURE 2

1. Record the 13 character serial number of the *new* airbag module on the repair order. See Figure 2.

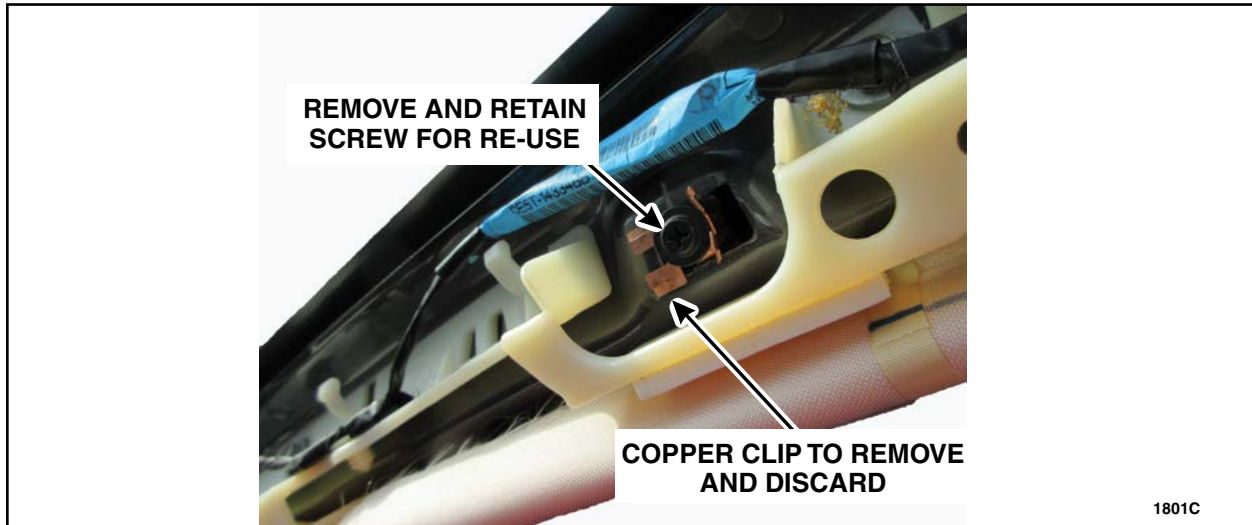
FIGURE 4

3. Remove and discard the top A-Pillar clip from the body. See Figure 4.

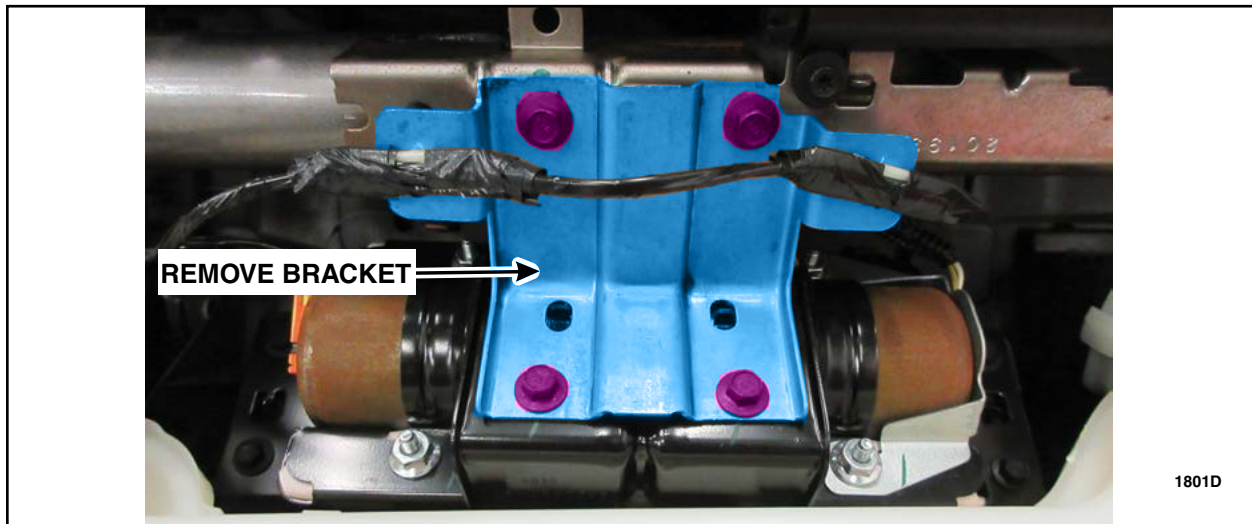
FIGURE 5

- Remove the instrument panel crossmember-to-airbag module bracket. See Figure 5.
- Torque to 80 lb. in (9 Nm).
