Bridgestone Americas Tire Operations, LLC
200 4th Avenue South
Nashville, TN USA 37201

NHTSA ID: 21T012

IMPORTANT SAFETY RECALL

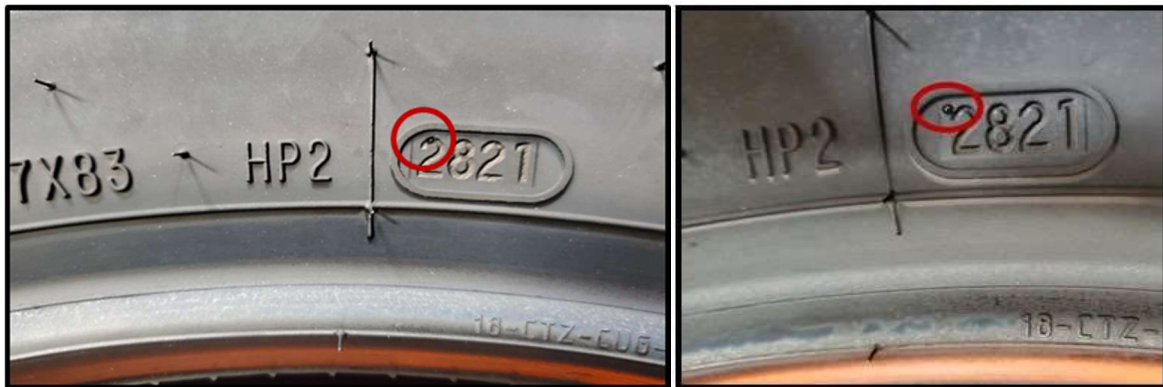
Due to a production error, a small quantity of tires may have sustained a small pinhole in the sidewall of the DOT serial intended outboard side of the tire during the tire marking process. Bridgestone has determined that eight (8) affected tires have been shipped to customers. Affected tires with a pinhole penetrating the tire inner liner may slowly leak air. As such, these tires may not comply with the performance requirements of Federal Motor Vehicle Safety Standard No. 139. If left undetected and/or unaddressed, this slow leak could affect tire performance and increase the risk of a crash.

All affected tires were produced during the 28th week of 2021 and will have “2821” as the last four digits of the Tire Identification Number (“TIN”). **The pinhole is visible on the full serial side tire sidewall of affected tires near or within the first digit of the TIN date code as shown in the photos below.**

If no pinhole is visible, please inform the customer that his or her tires do not contain the recalled condition and no further action is necessary. However, if a pinhole is found near or within the first digit of the TIN date code, any affected tire must be replaced immediately without charge (including mounting and balancing) to the customer. Use the normal Bridgestone/Firestone tire warranty adjustment procedures to replace tires under this voluntary safety recall. The tires will be processed as a no charge tire adjustment. Select “OTHER-RECALL” option on the ENTIRENET/TREADNET warranty adjustment screen as the reason for removal. Retailers who provide services to remove and replace affected tires will be reimbursed at published Standard Service and Labor rates in effect at the time of replacement.

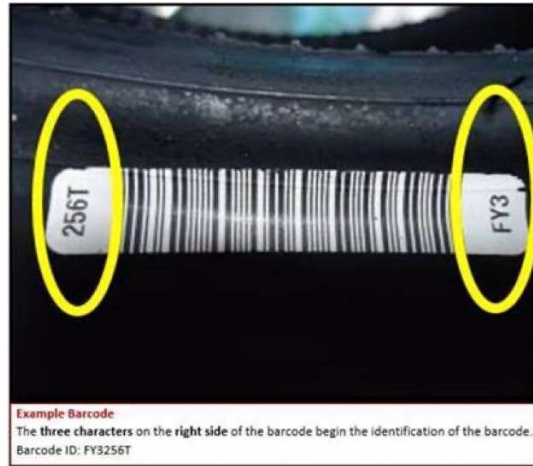
The eight (8) tires with the pinhole condition have unique barcode stickers attached to the bead area of the tire. When reading the barcode, start by reading the three digits on the right side of the sticker followed by the four digits on the left side of the sticker as shown below.
