HMA Recall 200 - Dealer Best Practice

Date: December 20, 2021

Subject: Recall 200 - 19MY-20MY KONA ELECTRIC (OS EV) BATTERY INSPECTION, BMS SOFTWARE UPDATE, AND BATTERY REPLACEMENT (TSB# 21-01-046H-2): Remedy Available

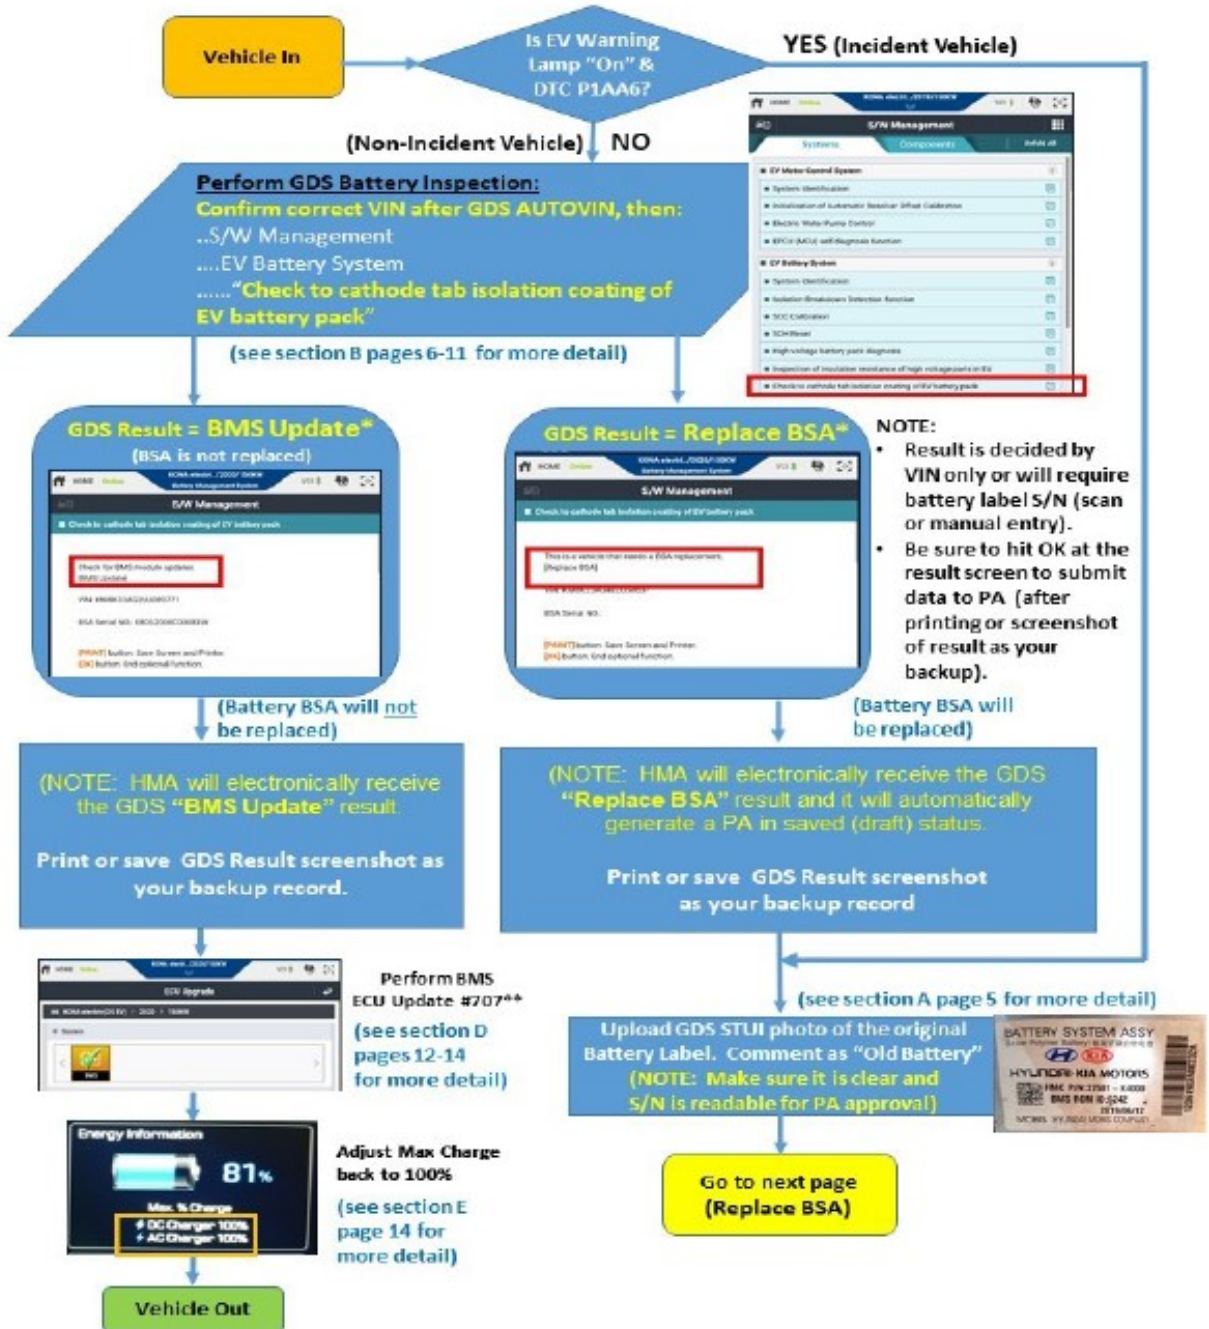
TSB 21-01-046H-1 2019-2020MY KONA EV RECALL 200 PROCEDURE SUMMARY: (2 pages)

For all 2019-2020MY vehicles with an open Recall 200, follow TSB 21-01-046H-2 flow chart below. It can also be found on pages 2-3 of the TSB.

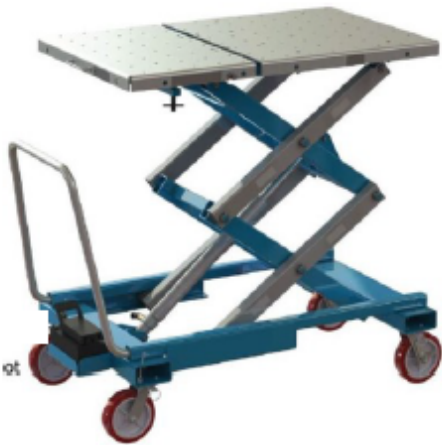
PART NAME / (Part Number)	DIAGRAM	REMARK
PREFERRED TOOL* Propulsion System Lift Table (P/N: HMA52200-A) *For Recall 196/200 alternative tables rated for at least 1100lbs and minimum table size of 20"x 36" are being considered for temporary use. Complete the "Tool Acknowledgment Form" on next page and send for approval by email to: HyundaiTools@hmausa .com

Allows for safe and efficient EV battery replacement. Engine hoist can fit under it to raise an EV battery from the table. Multi-Use air/hydraulic operated lift rated at 1760 lbs. capacity can lift 21.5 to 70 inches high. Multiple uses include EV Battery, Engine/Transaxle, Fuel Tank, Cradles, Suspensions, and Chassis systems.
REQUIRED TOOL High Voltage Battery Lifting Fixture (P/N: 09375-K4100)

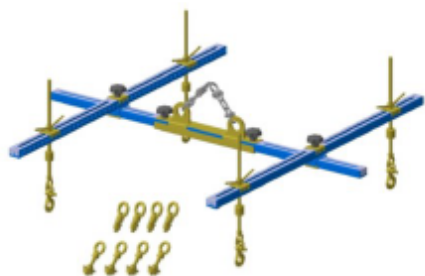
Fits All Hyundai EV Battery.
20MY~ AE EV only High Voltage Battery Pack Transport Hanger (P/N: 09375-G7100)

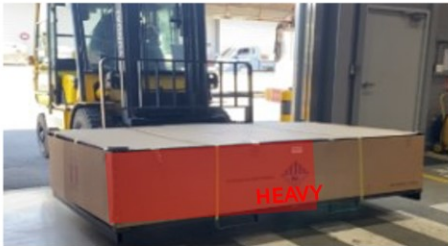
<ul style="list-style-type: none"> ■ Please handle just one battery at a time. - The center of gravity is shifted to one side because of the weight biased shape. - Handling a multi level of parts poses a safety risk due to the danger of weight bias.

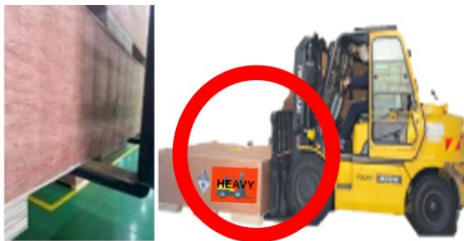
<ul style="list-style-type: none"> ■ Handle the forklift by pushing the fork all the way to the innermost part of the pallet. - Especially, when forking in the longitudinal direction, the heavy side should come toward the machine.
