January 2022  
FL912AB  
NHTSA #21V-921

## Subject: FCCC Motorhome Valve Stem Stabilizers

**Models Affected: Specific model years 2017-2023 FCCC MBC, MC, MT55, S2C, S2G, S2RV, XBR, XBS, XCL, XCM, XCR, and XCS chassis manufactured February 20, 2017, through November 18, 2021, and equipped with a valve stem extension and stabilizer configured with a specific tire valve stem and wheel combination.**

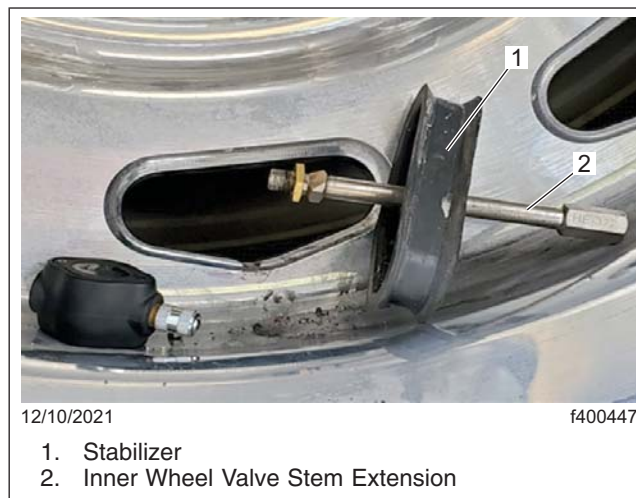
**Fig. 1, Inner Wheel Valve Stem Extension and Stabilizer**

Certain chassis may have been built with the tire valve stem extension for the inner wheel contacting the outer wheel rim opening, potentially damaging the valve stem resulting in a loss of air pressure in the inner tire. A loss of air pressure in the inner tire on a motorhome with a single drive axle may overload the outer tire and increase the risk of a crash.

1. Inspect the base label (Form WAR259) for a campaign completion sticker for FL912 (Form WAR261). If a sticker is present for FL912, no work is needed. If there is no sticker, proceed with the steps below.
2. Remove and discard the rear inner wheel valve stem extensions. See [Fig. 1](#).

3. Remove and discard the rear inner wheel valve stem extension stabilizers. See [Fig. 1](#).
4. Install the valve stem cap MYI 21 534 on the rear inner wheel valve stems. See [Fig. 2](#).
