HYUNDAI Technical Service Bulletin	GROUP RECALL	NUMBER 21-01-032H
	DATE MAY 2021	MODEL(S) Genesis (DH)
SUBJECT: GENESIS (DH) MULTI FUSE REPLACEMENT KIT INSTALLATION (RECALL CAMPAIGN 201)

Description: An electrical short in the hydraulic electronic control unit (HECU) may increase the risk of an engine compartment fire. This bulletin describes the procedure to install replacement fuses.

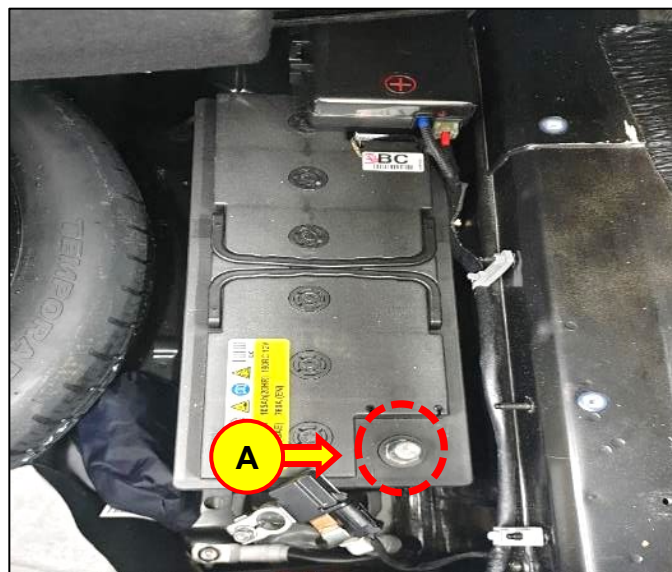
Open the trunk and remove the negative battery terminal (A) by loosening the nut.

Battery Terminal Nut Tightening Torque

lb-ft	• 2.9-4.3
kgf.m	• 0.4-0.6
N.m	• 3.9-5.9

8. Reinstall the negative battery terminal, torque the nut to specification, and reprogram the customer's radio preset stations.

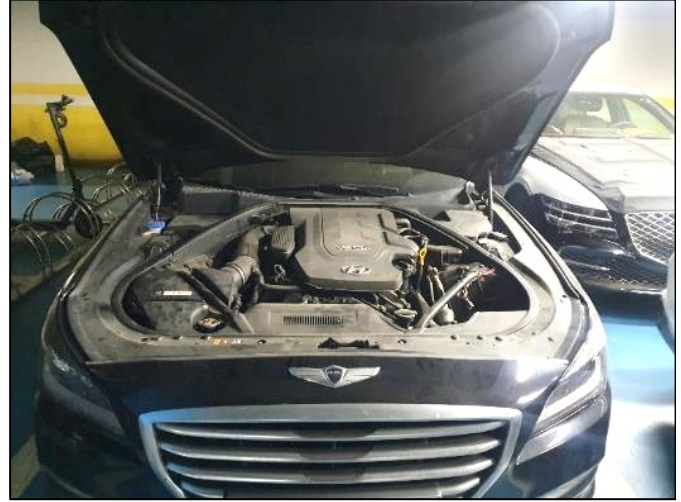
2. Open the hood.

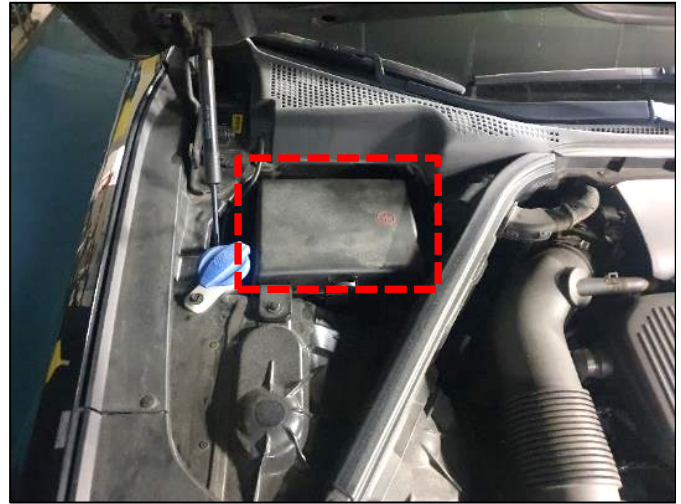
3. Remove the engine room junction box upper cover.

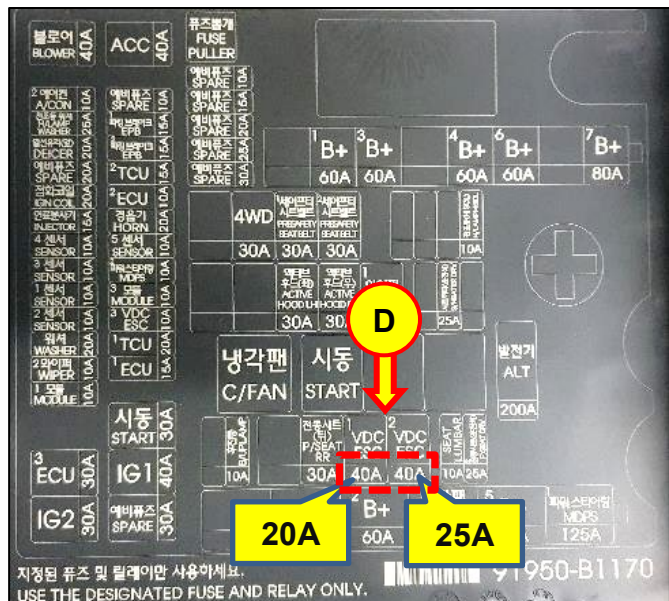
6. Attach the supplied sticker labels (D) to the upper fuse cover in these positions:
- ESC/VDC1: 20A
 - ESC/VDC2: 25A
