Mercedes-Benz

Campaign No.2021070010, August 2021
Revision A 09/03/2021

SUBJECT: **Model C-Class, CLA-Class, GLA-Class, GLC-Class, GLE-Class, S-Class
Model year 2014-2020**

Replace Front Stationary Sunroof Panel

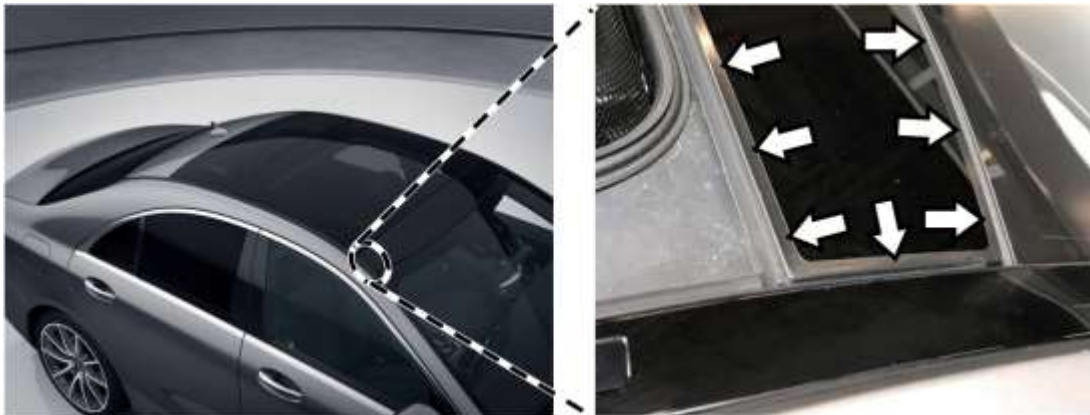
Figure 1

1. Fixed panel (**Figure 1**) made from glass. ⇒ **no repair needed**

The fixed panel made from glass is foam-padded, the padding (**arrows, Figure 1**) is visible at the edge.

- a. The fixed panel is made from **polycarbonate**: Perform **work procedure**.
- b. The fixed panel is made from **glass**: **End measure**.

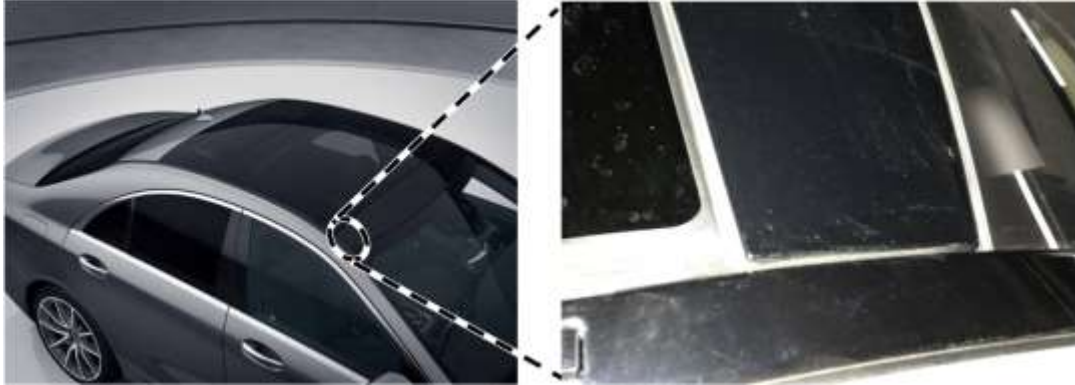
Figure 2

2. Fixed panel (**Figure 2**) made from polycarbonate (PC) ⇒ **repair is needed**

i The fixed panel made from polycarbonate is **not** foam-padded.

1. Replace front fixed panel of panoramic sliding sunroof.
