# Recall Work Instruction

Subject: Remedy Work Instructions for Recall Number 21V-290

Applies To: Certain 2015-2021 Rosenbauer and Commercial Chassis

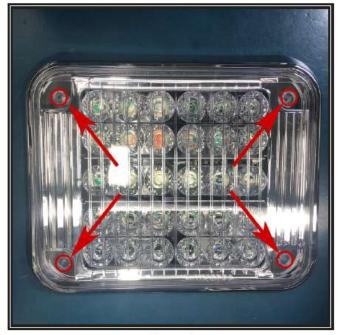
Figure 1

- Step 2. Remove the four screws on the lens as indicated in Figure 1.
- Step 3. Remove the clear lens from the unit.
- Step 4. Remove the backing paper from the provided diffuser as shown in Figure 2 & Figure 3
- Step 5. Place the diffuser in the lens as shown in Figure 4. Ensure the diffuser is placed so that the side that had the paper backing is facing up.
- Step 6. Reinstall the lens to the unit as shown in Figure 5.
- Step 7. Secure the unit using the four screws removed in step 1.
- Step 8. Write the Recall # 21V-290 on the recall decal and stick to the officer side kick plate.
