Service Bulletin

Multiple Model: Rear Reflector #1

May 2021

MULTIPLE MODEL - REAR REFLECTOR

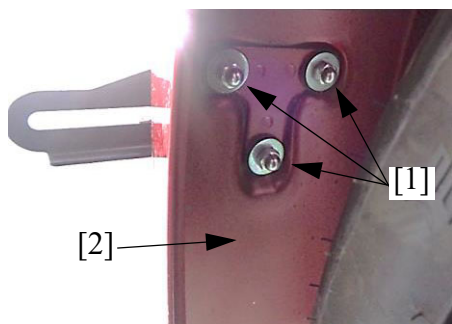
1. Remove the three Cap Nuts [1] from the Rear Fender Comp [2] and remove the License Plate Bracket.

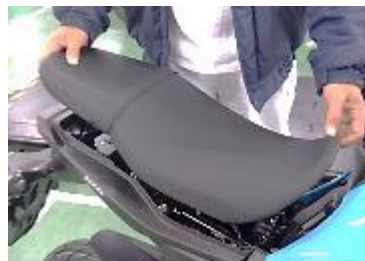
1. Unlock the Seat with the key and remove the Double Seat Assembly.

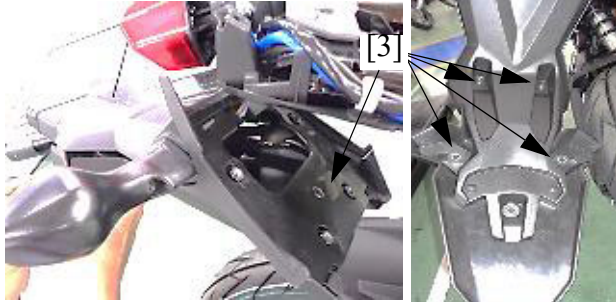
4. Remove the five screws [3] from the Rear Inner Fender.

NOTE: Support the rear Fender Assembly to prevent the Rear Fender Assembly from hanging by the wires.

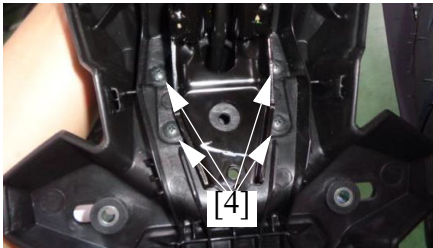
5. Remove the four screws [4] from Rear Fender A.

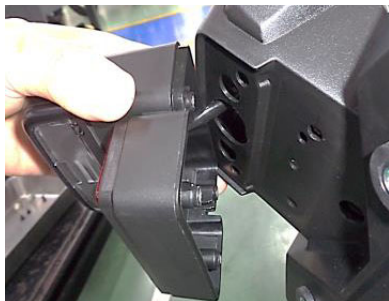
6. Remove the License Light Bracket from the Rear Fender A.

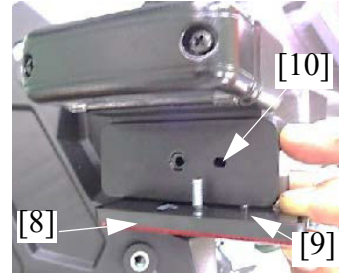
8. Install the new Reflector [8] by aligning the Reflector pin [9] with the fixing hole [10]. Tighten the new U-nut to 15 in-lbs (1.7 N.m). Re-Install the parts in the reverse order of removal.

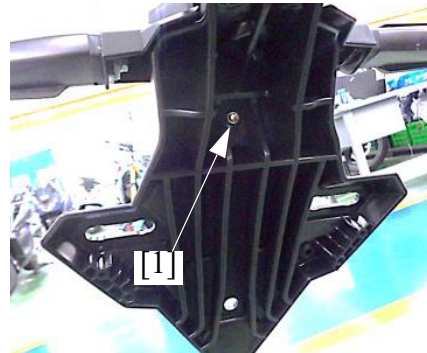
1. Remove the U-nut [1] from the rear fender.

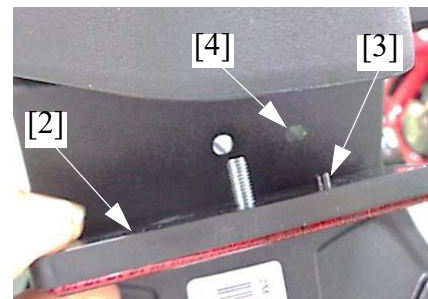
2. Remove the defective Rear Reflector and install the new Reflector [2] by aligning the Reflector pin [3] with the fixing hole [4]. Tighten the new U-nut to 16 in-lbs (1.8 N.m).

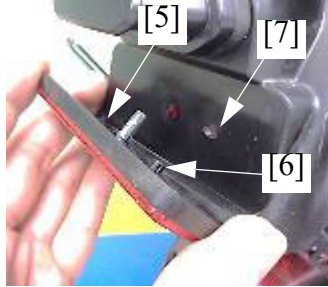
5. Remove the defective Reflector and install the new Reflector [5] by aligning the Reflector pin [6] to the fixing hole [7]. Tighten the new U-nut to 13 in-lbs (1.5 N.m). Re-install the parts in reverse order of removal.

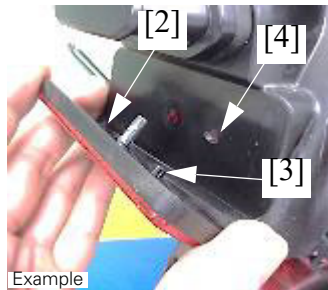
2. Remove the defective Reflector and install the new Reflector [2] by aligning the Reflector pin [3] to the fixing hole [4]. Tighten the new U-nut to 15 in-lbs (1.7 N.m).

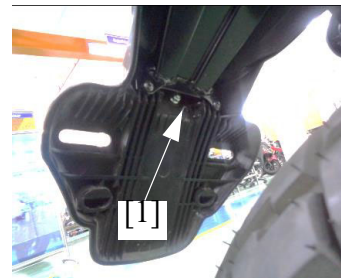
1. Remove the U-nut [1] from the Rear Fender.

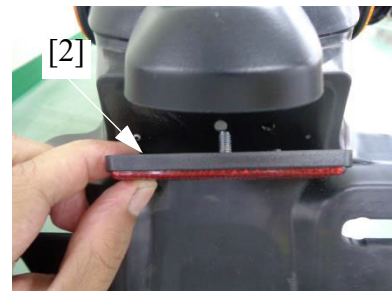
2. Remove the defective Reflector and install the new Reflector [2] by aligning the Reflector pin to the fixing hole. Tighten the new U-nut to 13 in-lbs (1.5 N.m).
