Revision 5 March 2022

Dealer Service Instructions for:

# Safety Recall Y26 / NHTSA 21V-398

## Wheel Studs

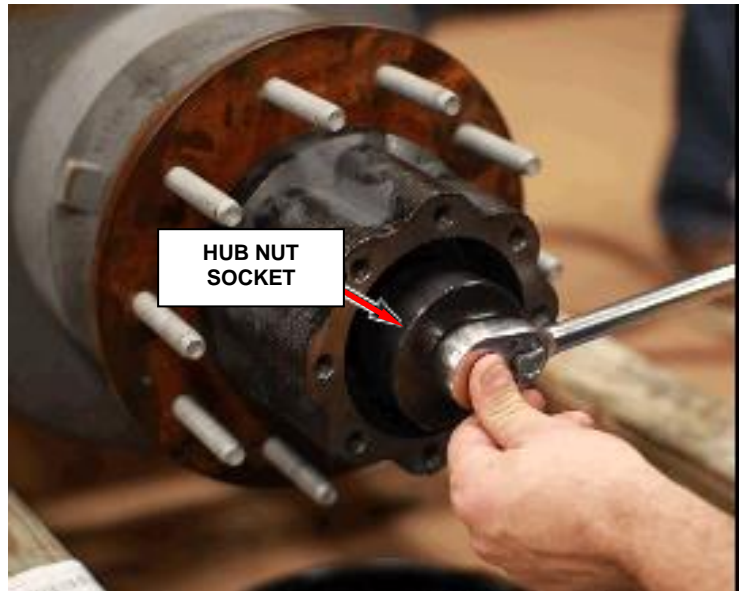
**Figure 12 – Hub Nut**

8. Using **Socket, Hub Nut 6 Pin 8954A, or Socket, Hub Nut 9 Pin 2029500030, or Socket, Hub Nut 12 Pin 2066600030** remove the hub nut (Figure 12).
