NUMBER: WRG-21R

PRODUCT CAMPAIGN BULLETIN

APPLICABILITY: 2018-2019MY Legacy and Outback 2.5L and 3.6L

SUBJECT: Fuel Pump Impeller Failure

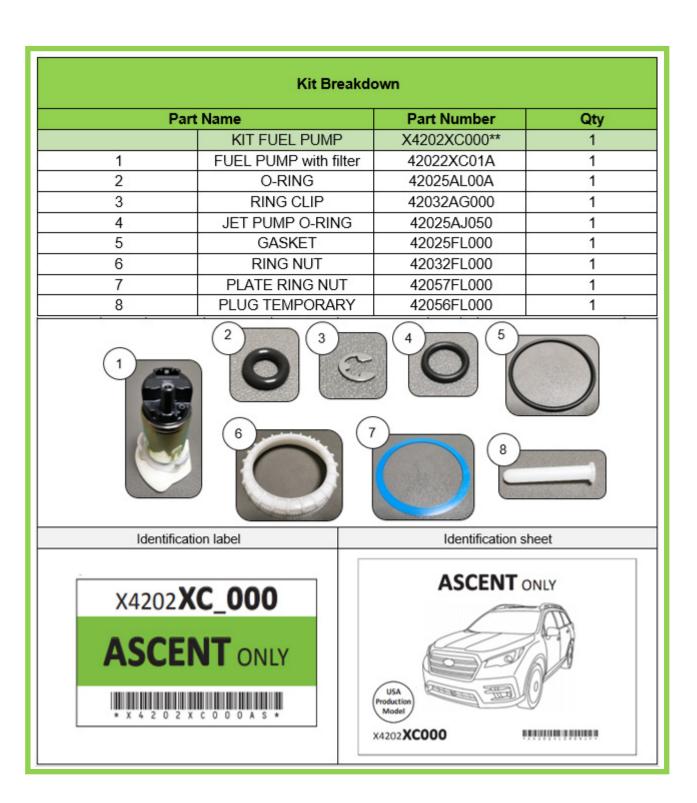
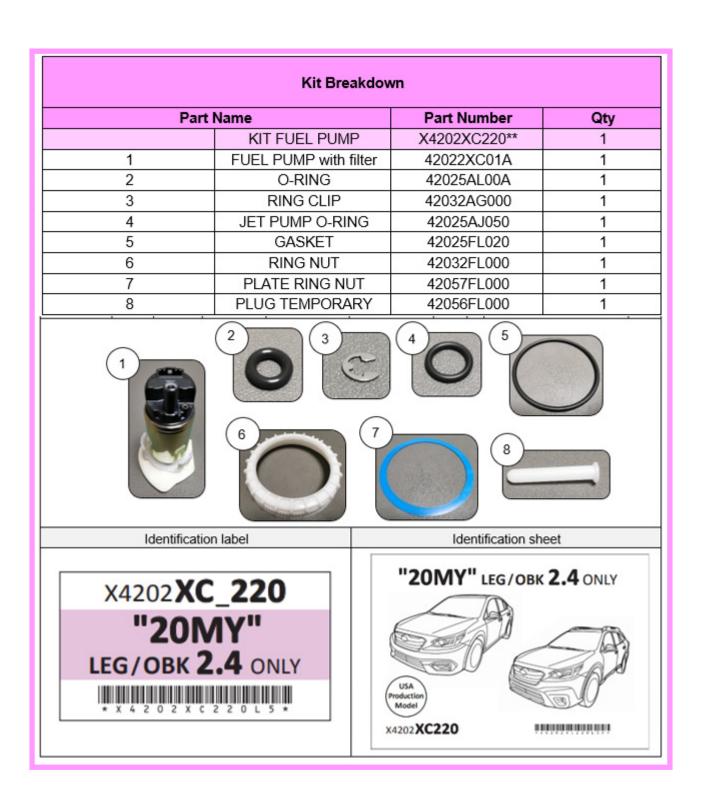
The parts required to perform these repairs have been assembled into Fuel Pump Kits, numbered for each model and labeled accordingly as shown below to help insure installation of the proper kit into the applicable model.

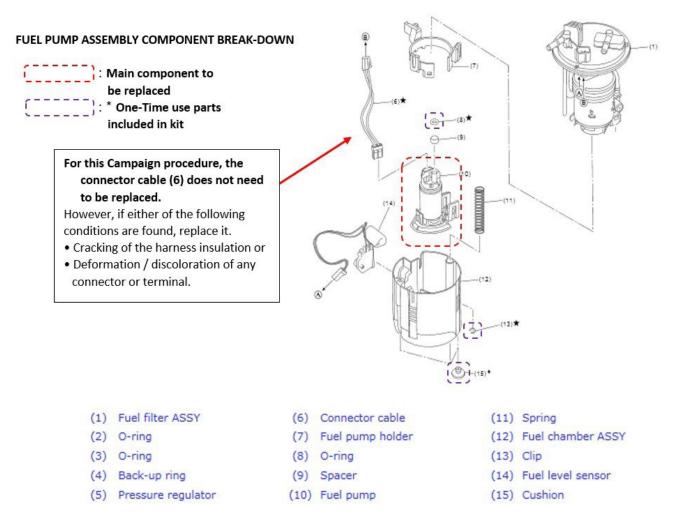
^{*}The 3 rubber cushions (15) on the bottom of the fuel chamber and included in the kit must be replaced as they are 1-time use.

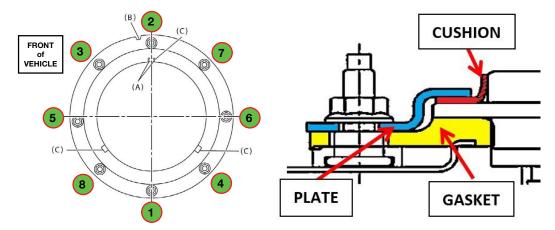
• CRITICAL: Lightly hand tighten all nuts in the sequence shown below. Complete tightening of the 8 retaining nuts to the specified torque: 4.4 Nm, (3.2 ft. lbs. or 38 inch-pounds) following the sequence shown below. NEVER use air or electric powered tools to tighten these nuts as the studs may be damaged.

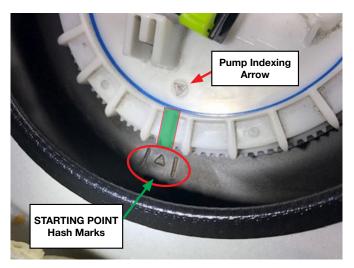
• Inspect the new ring nut and identify the set of 3 "teeth" close together as shown above. **NOTE:** The center or middle line (GREEN tooth) must be aligned with the triangle Δ mark in the middle of the thread starting point hash marks as shown below. Also, there is another Δ mark on the top of the fuel pump (Indexing Arrow) to be used as a reference for making sure the pump is properly indexed inside the tank. See **Appendix B** starting on pg. 60 for more information and a video on this **CRITICAL** step.

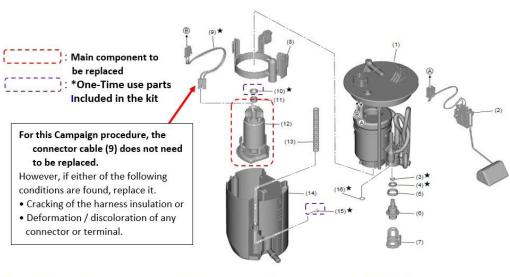
FUEL PUMP ASSEMBLY COMPONENT BREAKDOWN

- (1) Fuel filter ASSY
- (2) Fuel level sensor
- (3) O-ring
- (4) O-ring
- (5) Back-up ring
- (6) Pressure regulator
- (7) Pressure regulator cap
- (8) Fuel pump holder
- (9) Connector cable
- (10) O-ring
- (11) Spacer
- (12) Fuel pump

- (13) Spring
- (14) Fuel chamber ASSY
- (15) Clip
- (16) O-ring

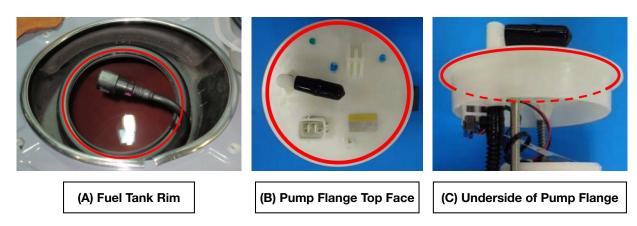
11. CRITICAL: ALL surfaces of the new pump assembly o-ring, top gasket, underside of the ring nut along with the surfaces described and shown below: fuel tank neck rim (A) pump flange top and bottom faces (B) and (C) must be thoroughly wiped clean and completely dried BEFORE re-installation. This will help prevent the pump from turning with the ring nut during final tightening.

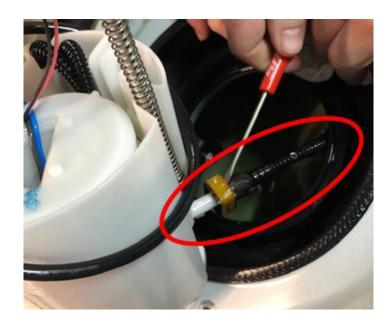
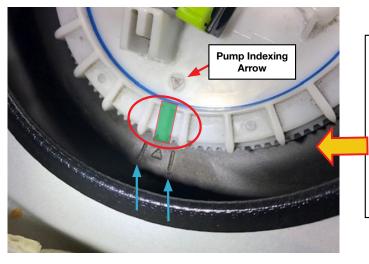
IMPORTANT: This photo shows the NEW ring nut and (Blue) seal plate included in the kit already in place. The ASCENT ring nut thread starting point is identified by the 3 "teeth" close together (RED circled). Align the center (Green) tooth (position mark) with the triangle Δ mark between the molded-in hash marks on the tank (Blue arrows).

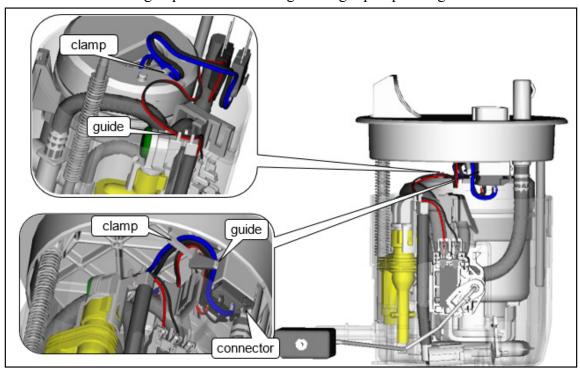
• Confirm the fuel pump harness is routed correctly. Install the thinner fuel lever sensor wires into the two retaining clips before installing the larger pump wiring.

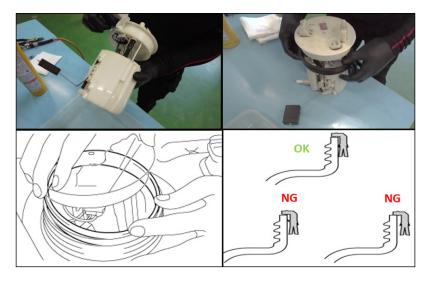
• Clean the gasket contact surfaces. Then install the gasket and fuel pump assembly as shown below.

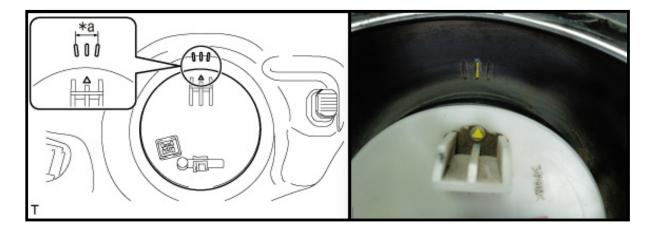
• Match the center index marking of the fuel tank with the fuel pump assembly as shown below.

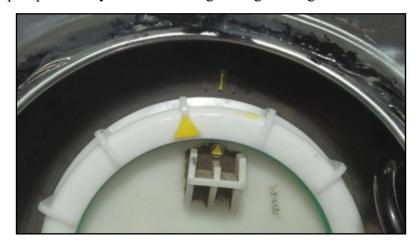
• Align the markings as shown (in yellow) below to ensure the proper thread starting point for the ring nut. Turn the ring nut approximately one full rotation by hand. Take special care to not allow the pump assembly to turn while tightening the ring nut.

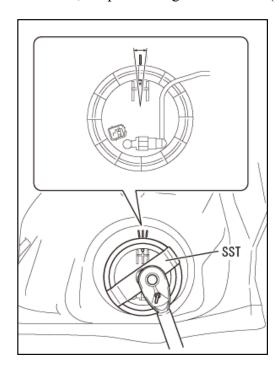
• Using special tool #42099CA000, torque the ring nut to 85Nm (62.7 ft-lbs.).

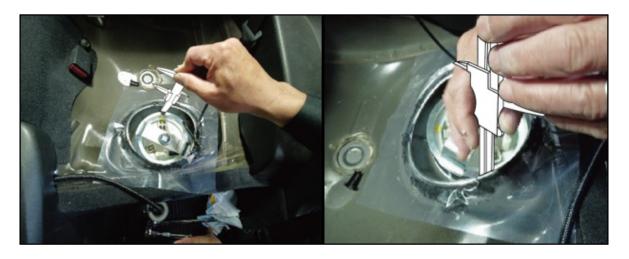
• **CRITICAL:** The height measurement check MUST be performed as a final check to confirm the ring nut is not cross-threaded. The height measurement is similar to other models except, the BRZ requires the ring nut wrench to be installed while performing the measurement. 60mm should be measured in 3 positions around the ring wrench as shown below. Measure from the top of the ring wrench to the top surface of the fuel tank.

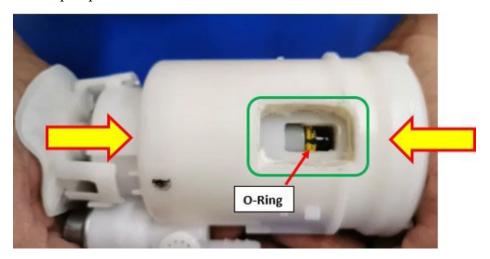
- The original fuel pump o-ring is still in place in the filter housing bore
- The new o-ring was not properly lubricated with gasoline prior to attempting the reassembly
- Repeated attempts to get the pump fully seated have caused the o-ring to come of f the outlet tube of the fuel pump as shown below.

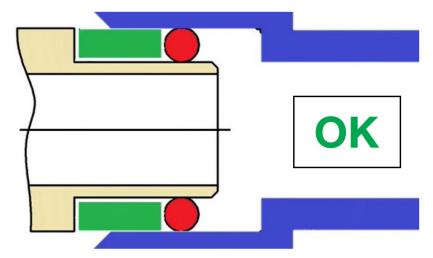
The **RED** circles represent a cross-section of the o-ring.

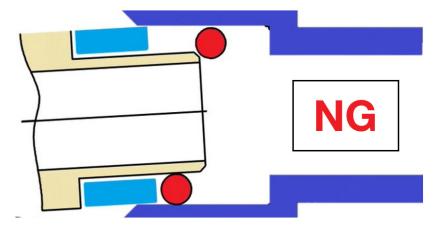
The new fuel pump is being pressed firmly and squarely into the filter housing bore and successfully "clicks" into place.

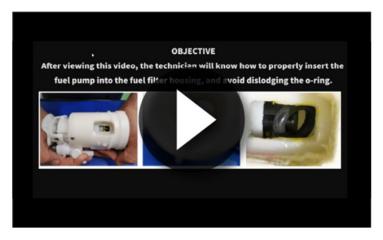
Here, the new fuel pump is being pressed into the filter housing bore at an angle which will likely result in the outlet tube butting against the shoulder of the bore the o-ring seals against followed by repeat attempts which often end up with the o-ring becoming dislodged.

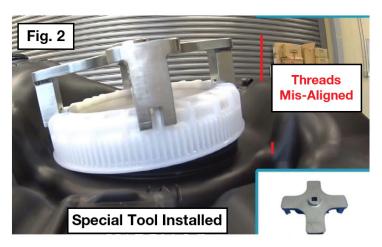
Fig. 2 shows the Special Tool installed onto the Ring Nut making the mis-alignment easier to identify before attempting to tighten it.

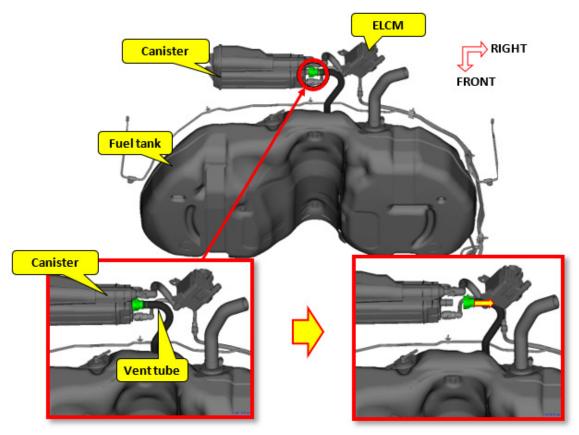
(STEP:1) Using the Redline Detection Smoke Pro (RDL-95-0051), apply 10kpa (1.45 PSI) at the vent tube. NOTE: These pressures for this test are higher than those specified when confirming proper sealing of the fuel pump. Check to ensure the pressure is retained for 10 seconds. Is the pressure retained?
