<b>Tesla, Inc.</b> <b>Service Bulletin</b>		<h2 style="margin: 0;">Inspect Front Lower Lateral Links</h2>	
<b>SB-21-31-003</b> October 26, 2021			
<b>Classification</b>		<b>Section/Group</b>	<b>Mobile Service</b>
Recall Bulletin		31 - Suspension	Cannot Perform
<b>Model Year</b>	<b>Model</b>	<b>Country/Region</b>	<b>Version</b>
2019–2021	Model 3, Model Y	All	All
<small>The model(s) and model year(s) listed are a general approximation of the affected VIN list. Refer to the VIN/Bulletin Tracker or Customer/Vehicle profile to determine applicability of this bulletin for a particular vehicle.</small>

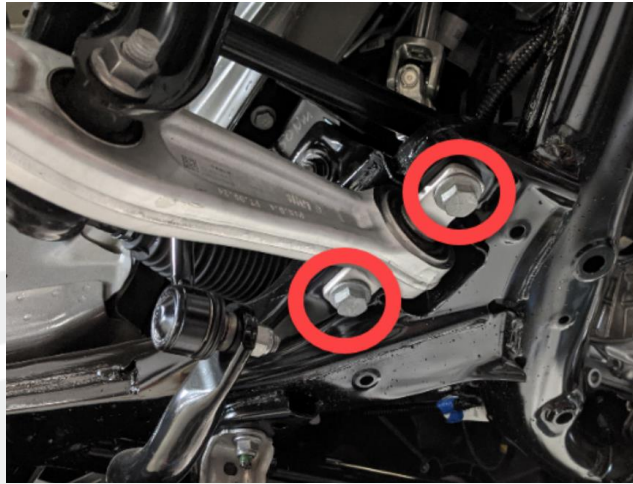
**Figure 1 – LH shown; RH similar**

1. Remove the front aero shield panel (refer to Service Manual procedure 12030102; [Model 3](#), [Model Y](#)).
2. Check for missing bolts where the LH and RH front lower lateral links attach to the front subframe (Figure 1).

- If all bolts are installed (4 total), skip to step 5.
  - If any bolts are missing, go to step 3.
3. Where a front lower lateral link is missing a bolt, check the lateral link(s) for damage that might cause the part to fail, such as cracks or bending at the subframe flanges (Figure 2).

5. Perform a torque check on the bolts that attach the LH and RH front lower lateral links (4 bolts total) to the front subframe (115 Nm) (Figure 1).
  - If all lateral link bolts (4 bolts total) can be torqued to specification, skip to step 7.
  -
