SIB 11 09 21

RECALL 21V-907: EXHAUST GAS RECIRCULATION (EGR) COOLER – N47T HIGH TEMPERATURE

This Service Information Bulletin (Revision 2) replaces SI B11 09 21 **dated February 2022**.

PROCEDURE 1: REPLACE THE EGR COOLER

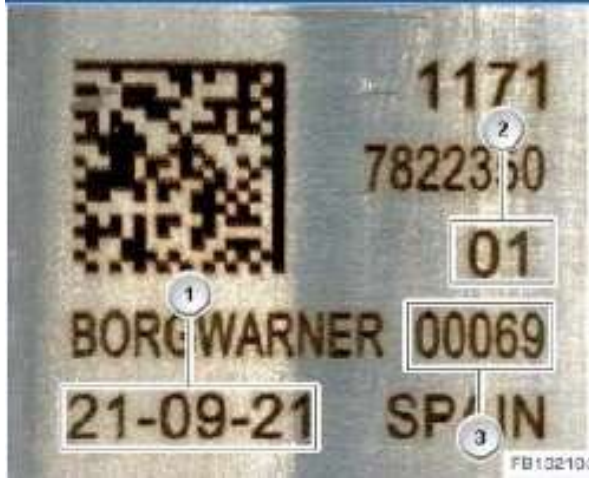
Record or take a photo of the following numbers on the new EGR cooler (1,2 and 3). These numbers will be required later to register the new cooler in ISTA.

1. Production date [YY-MM-DD]
2. Revision index
3. Serial number

Follow the test steps to register the EGR cooler (numbers taken off new cooler)

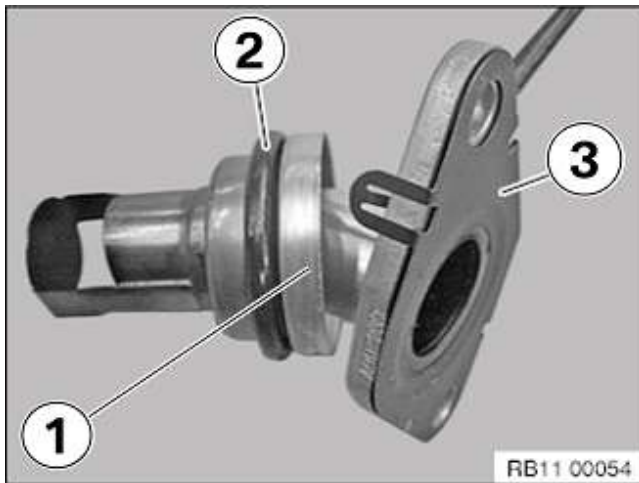
- Remove the EGR pipe from the intake venturi pipe (replace O-ring (2) and gasket (3)).

- Inspect and clean (if needed) the EGR pipe. Wear protective equipment (eyes and hands) and clean out the excessive carbon using a degreasing agent and a brush (suitable brushes can be found in wheel brush kit 83 19 2 298 237).
- Reinstall the EGR pipe with new gasket and O-ring before installing the new EGR cooler.
- Install the new EGR cooler following the repair instructions.
