REPAIR INSTRUCTIONS
KZ RECALL
NHTSA 21V-992
Transport Canada 2021-780
Internal KZ-2021-08

211MKSE Gas Line Relocation

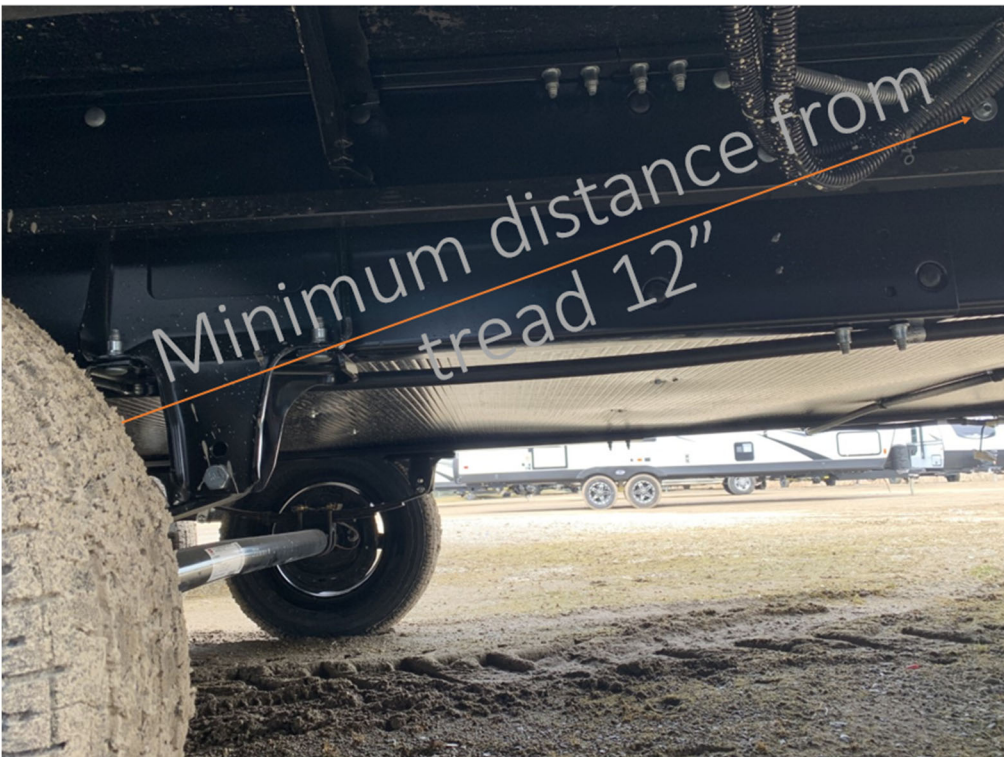
The vehicles subject to this recall were manufactured with the LP gas line routed through the wheel well in too close proximity to the tire tread path. Inspect the LP gas line in the wheel well as shown below. If the gas line is less than 12" from the tire tread it must be relocated as described below.

1. Open slide, remove original screw from existing spring.
2. Re-secure the spring to the frame, making sure to be 12" from tread of tire.

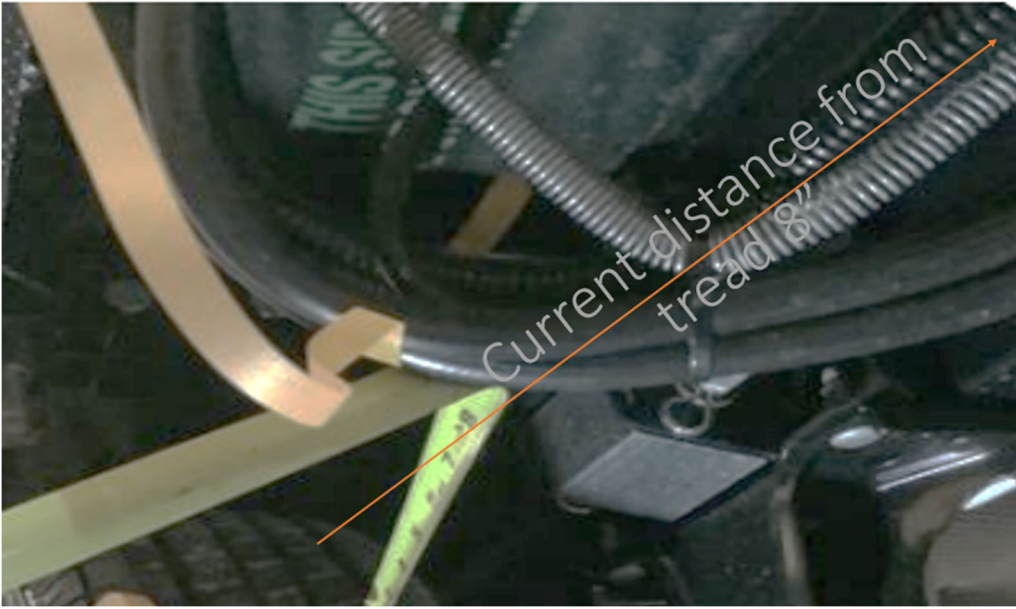
Current distance from tread 8"
