Product Safety Recall

N212329050 Tires Overcured

Condition	General Motors has decided that a defect which relates to motor vehicle safety exists in certain Continental tires installed as original equipment on certain 2018-2021 model year Chevrolet Express and GMC Savana vehicles; certain 2018-2020 model year Chevrolet Blazer and Silverado 1500 and GMC Acadia and Sierra 1500 vehicles; and certain 2020 model year Buick Enclave, Cadillac Escalade, Escalade ESV, XT4, XT5, Chevrolet Suburban, Tahoe, Traverse, and GMC Yukon and Yukon XL vehicles; or sold into the aftermarket by GM dealers. According to the tire manufacturer, Continental Tires the Americas (CTA), the affected tires may have an overcure condition and CTA has initiated a safety recall for these tires. According to CTA, overcured tires may experience a carcass break in the sidewall with sudden air loss or could develop a belt edge separation which could lead to partial or full tread/belt loss. These conditions may increase the risk of a crash.

Correction	Dealers will inspect vehicles and replace tires that have DOT number and production mold number combinations identified by Continental.

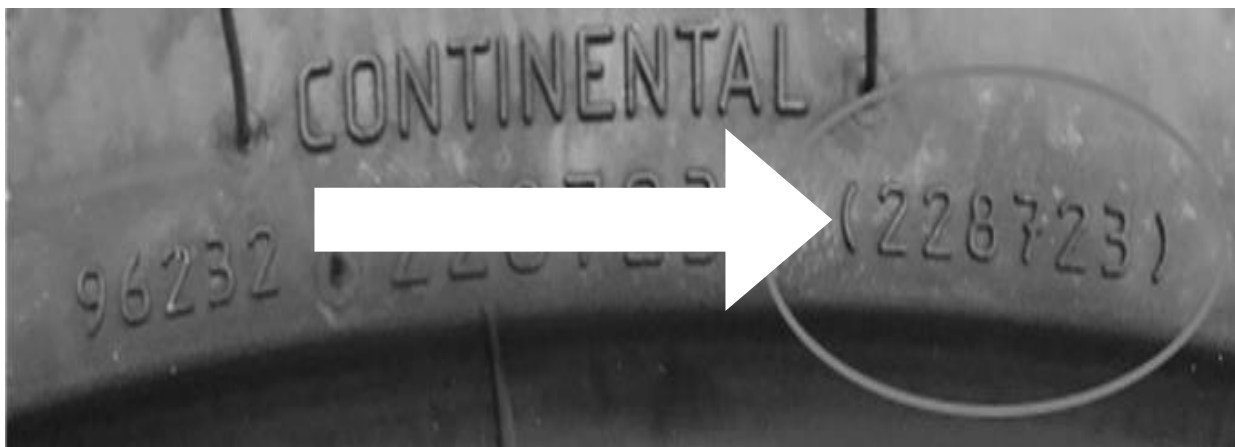
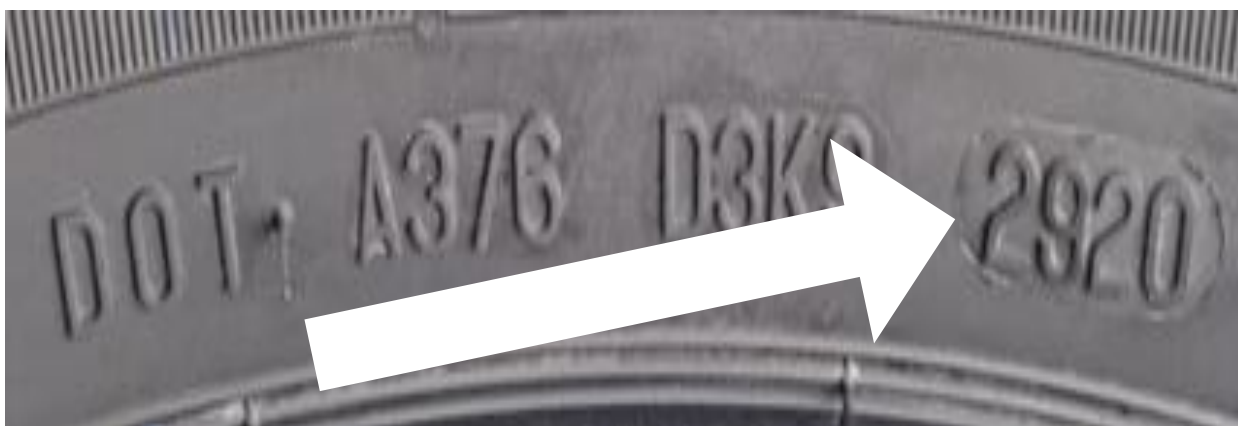
This procedure involves inspecting the tire sidewall for manufacturing information. The mold number, in parenthesis along with the last four numbers in the DOT stamp (Date Code) indicate if the tire is involved in this recall. See the examples in the photographs below.

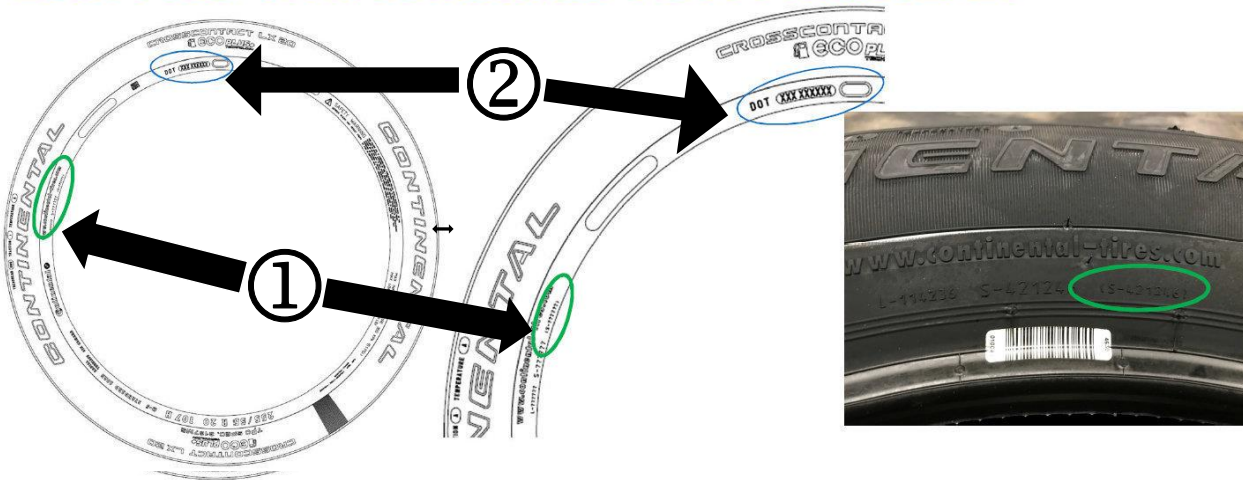
– Traverse / Enclave 255/55 R20 107H Continental CrossContact LX20

1. Inspect the tire sidewall as shown and verify the mold number (1) and DOT week (2).
2. If the mold number and DOT date fall within the **Affected DOT wk(s) – Mold # combination** in the tire information chart, replace the tire.

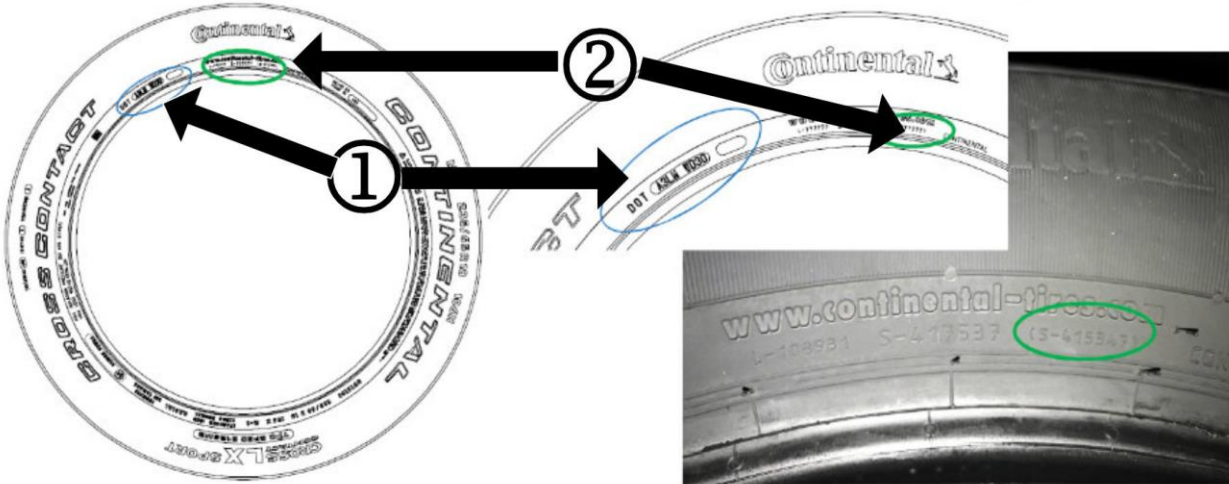
235/65 R18 104 H Continental Cross Contact LX Sport

1. Inspect the tire sidewall as shown and verify the mold number (2) and DOT week (1).
2. If the mold number and DOT date fall within the **Affected DOT wk(s) – Mold # combination** in the tire information chart, replace the tire.

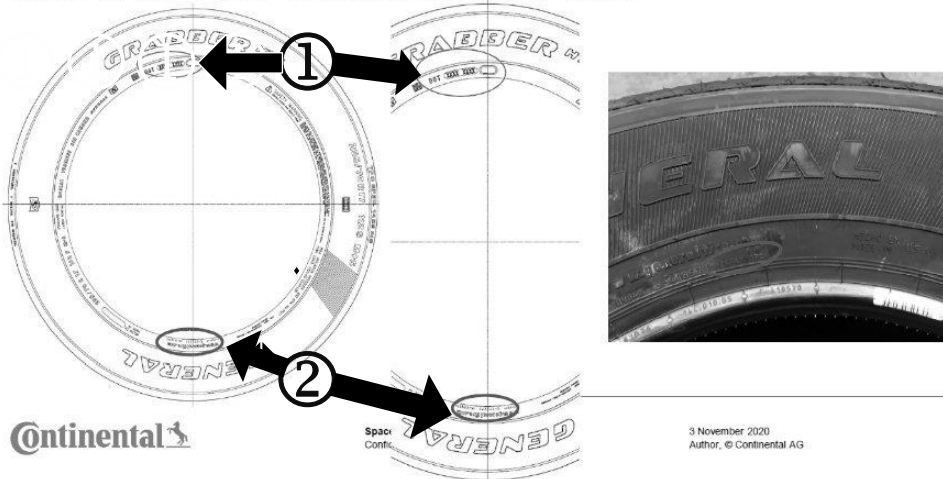
– Silverado / Sierra
255/70R17 112S General Grabber HTS

1. Inspect the tire sidewall as shown and verify the mold number (2) and DOT week (1).
2. If the mold number and DOT date fall within the **Affected DOT wk(s) – Mold # combination** in the tire information chart, replace the tire.

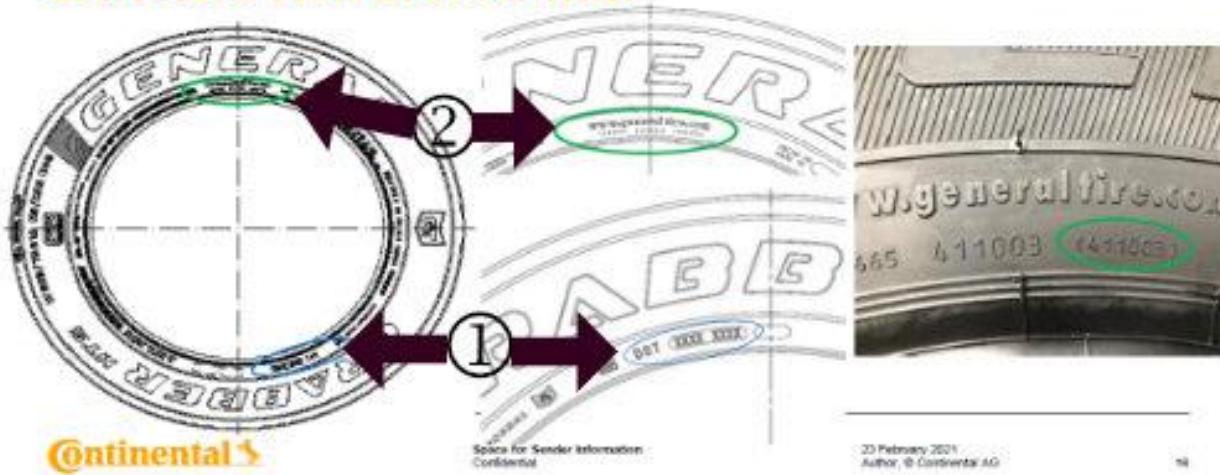
225/75R16 115S Grabber HTS

1. Inspect the tire sidewall as shown and verify the mold number (2) and the DOT week (1).
2. If the mold number and DOT date fall within the **Affected DOT wk(s) – Mold # combination** in the tire information chart, replace the tire.

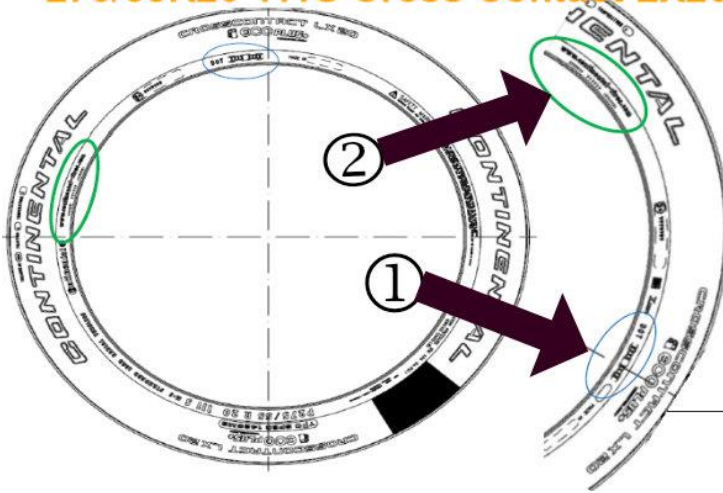
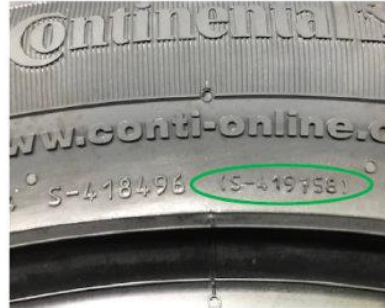
275/55R20 111S Cross Contact LX20

1. Inspect the tire sidewall as shown and verify the mold number (2) and the DOT week (1).
2. If the mold number and DOT date fall within the **Affected DOT wk(s) – Mold # combination** in the tire information chart, replace the tire.
