F/CMVSS Noncompliance Recall

N212340735 Tire Loading Information Incorrect

Release Date: July 2021

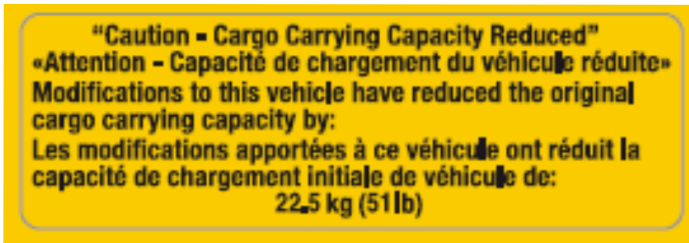
5868279

Note: The graphic below shows both the US and Canadian versions of the Cargo Carrying Capacity Label.

2. Select the appropriate language Cargo Carrying Capacity Reduced Label for your sales market.

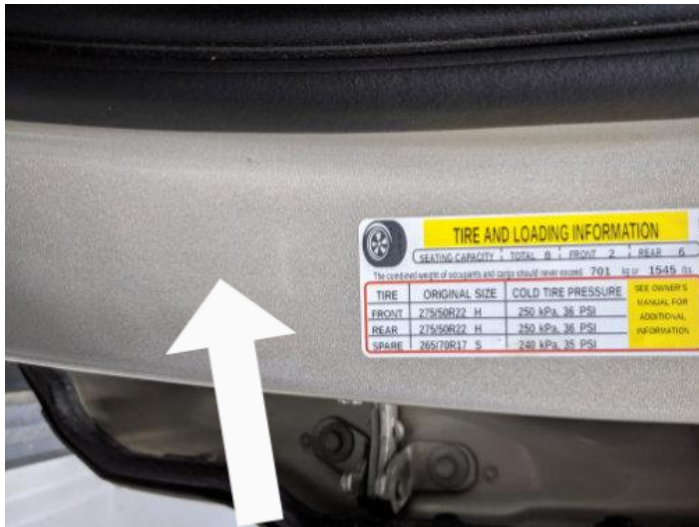
5868280

3. Clean the mounting surface using isopropyl alcohol and dry with clean, lint free cloth. Receiving surface **MUST** be clean, dry and free of any contaminants.
4. Firmly hold the new label and peel protective liner from the back side, being careful not to touch or contaminate the adhesive with dirt or foreign matter.
