**Recall #RT-0001:** Ranger Trail Fender Spacing

**Condition:** Fenders may not have adequate spacing for tire clearance

**Models Affected:** 2022 Ranger single axle deep-v and mod-v trailers

# FENDER ADJUSTMENTS FOR RT & VS SINGLE AXLE MODELS

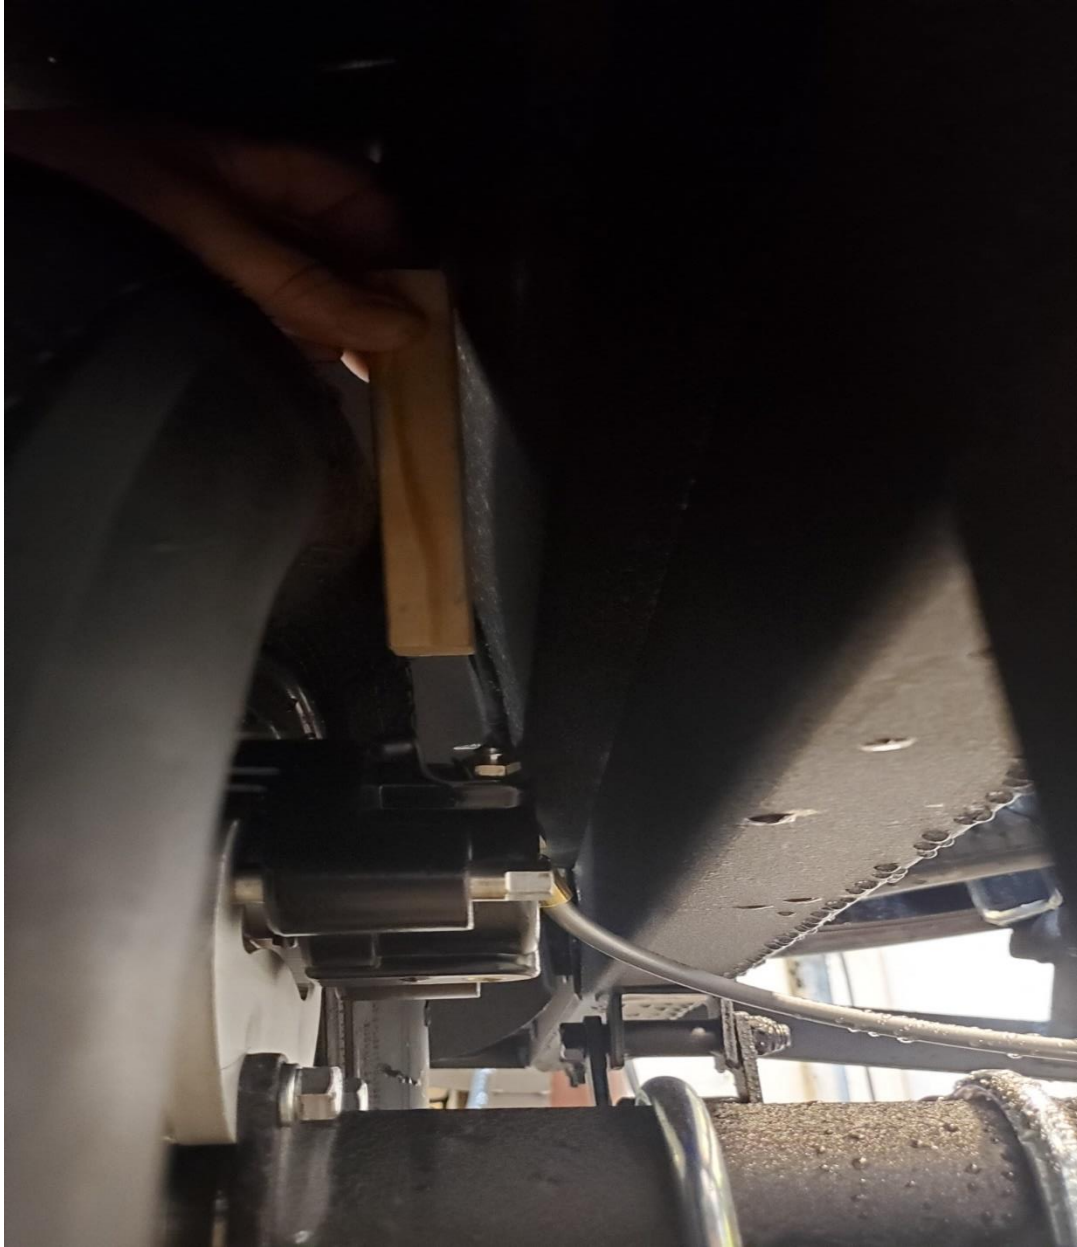
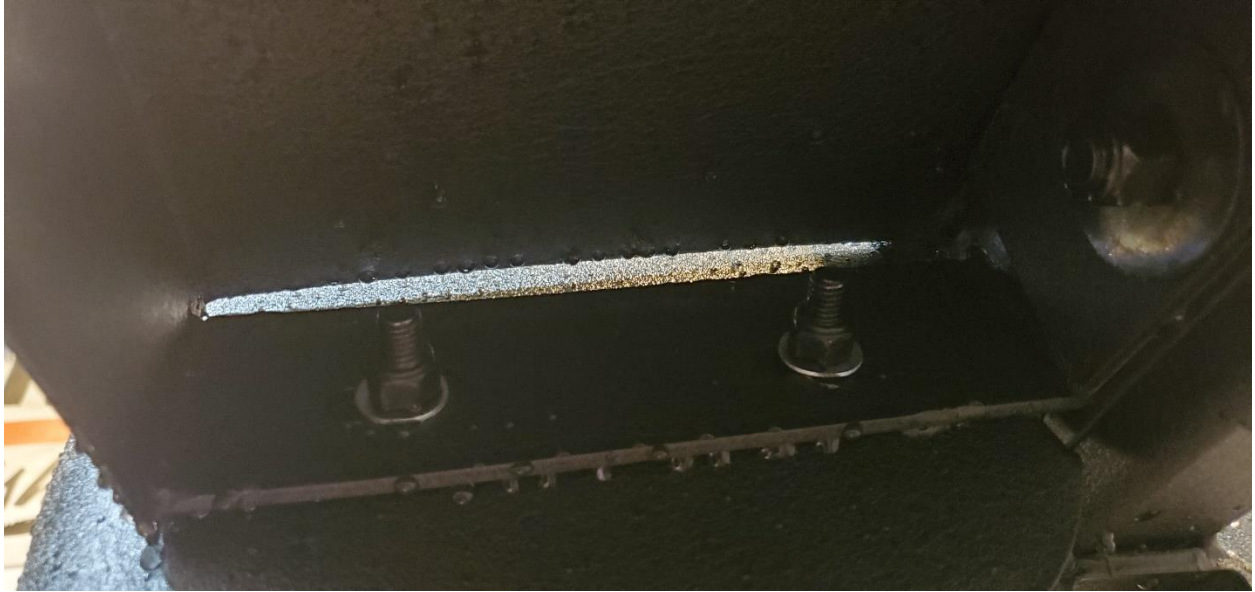
**Loosen the 4 fender bolts attaching the fender to the front and rear box. These will only need slightly loosened as the intent is to slide the fender inward to create more room for the tire. Push the fender inward as far as it will go.**

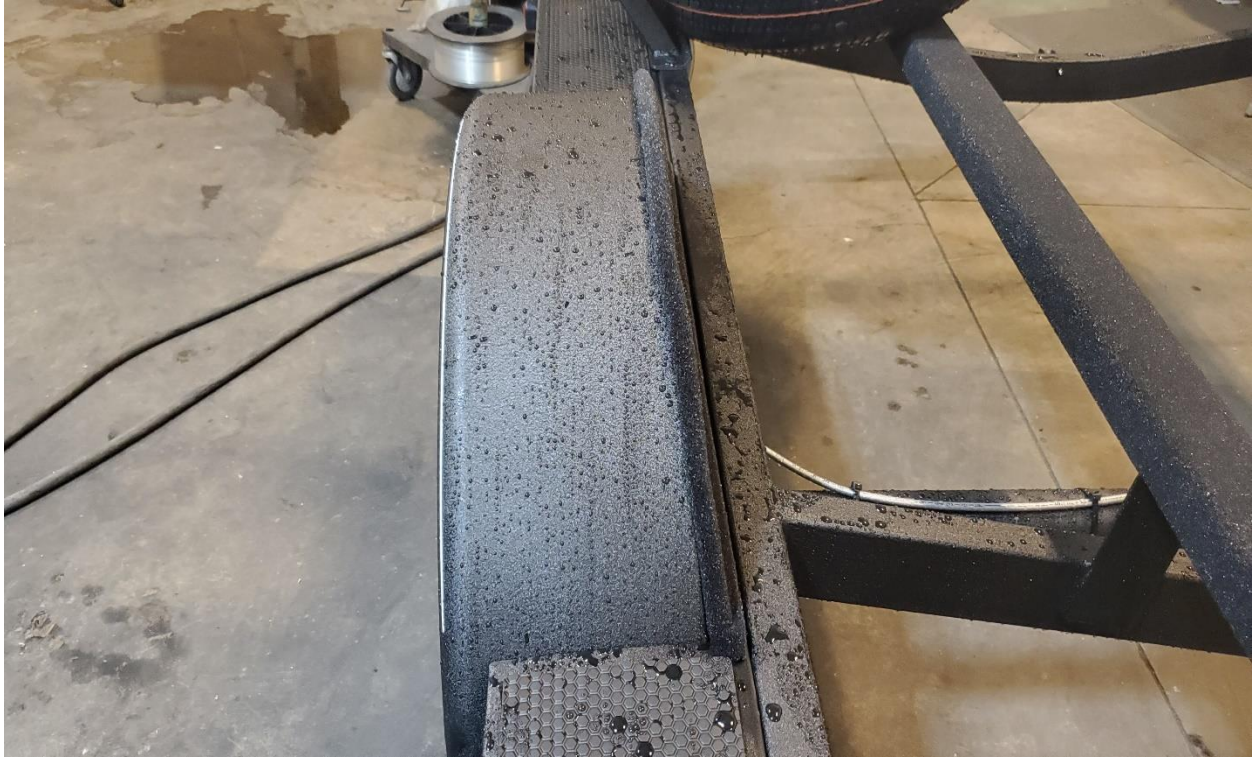
**After making these adjustments, ensure the fender is level and then tighten the 4 fender bolts which were loosened earlier.**
