# IMPORTANT SAFETY RECALL NOTICE

# **Reference to: Continental Product Service Information Bulletin PSIB 01-21**

Continental Tire the Americas, LLC ("CTA") announced a voluntary recall involving **3,232 Volkswagen** passenger tires identified as being fitted OE to Volkswagen Atlas vehicles, after discovering the affected tires may experience a carcass break in the sidewall with sudden air loss or could develop a belt edge separation which could lead to a partial or full tread/belt loss. These conditions could increase the risk of serious injury or death. Tires may experience a sudden air loss without warning while others may exhibit visible **localized** tread wear which may manifest as excessive vibration and/or bulging in the tread area.

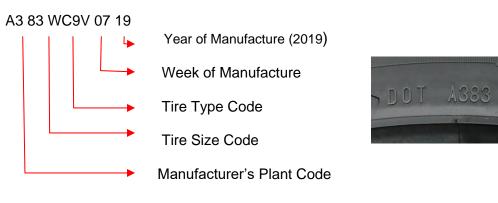
Tires made for use in the United States are required to have the DOT serial number with production week and year on one sidewall of the tire near the rim. The first sample below shows a tire manufactured during the 7<sup>th</sup> week of 2019. The second example shows a tire manufactured in the 16<sup>th</sup> week of 2018.

## A3 N4 WC9X 16 18

WC9V 0719
