**SUBJECT: NEW VEHICLE DEMONSTRATION / DELIVERY HOLD -
Safety Recall 22S25**

Certain 2013-2015 Model Year Escape with 2.0L and 2.5 engine
Transmission Shifter Cable Bushing

CERTAIN 2013-2015 MODEL YEAR ESCAPE VEHICLES EQUIPPED WITH A 2.0L ENGINE AND A 6F35 TRANSMISSION — SHIFTER CABLE BUSHING REPLACEMENT AND PROTECTIVE CAP

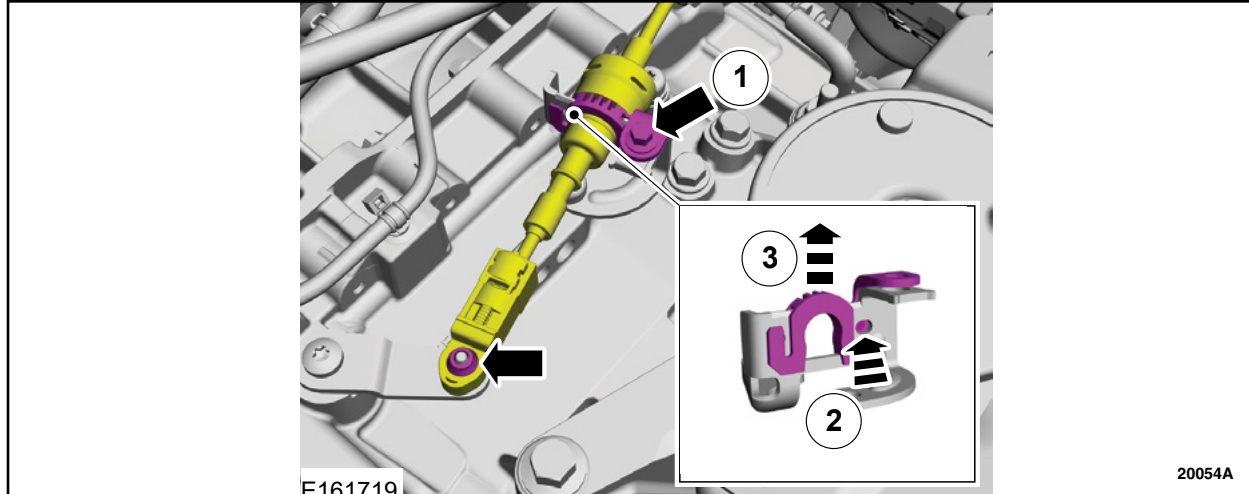
FIGURE 1

1. Apply the parking brake, chock wheels to make sure vehicle does not roll.
2. Position the gear shift lever in Drive (D).
3. Remove the air cleaner assembly. Please follow the Workshop Manual (WSM) procedures in Section 303-12.
4. Remove the air cleaner outlet pipe. Please follow the Workshop Manual (WSM) procedures in Section 303-12.
5. Disconnect the selector lever cable from the transmission manual lever and the bracket. See Figure 1.
 1. Remove the selector lever cable bracket bolt.
 2. Disengage the selector lever cable holding clip.
 - Use caution when removing hold down bracket to avoid damage. Hold down bracket is available separate of shift cable.
 3. Disconnect the selector lever cable.
 - Torque to 62 lb.in (7 Nm).

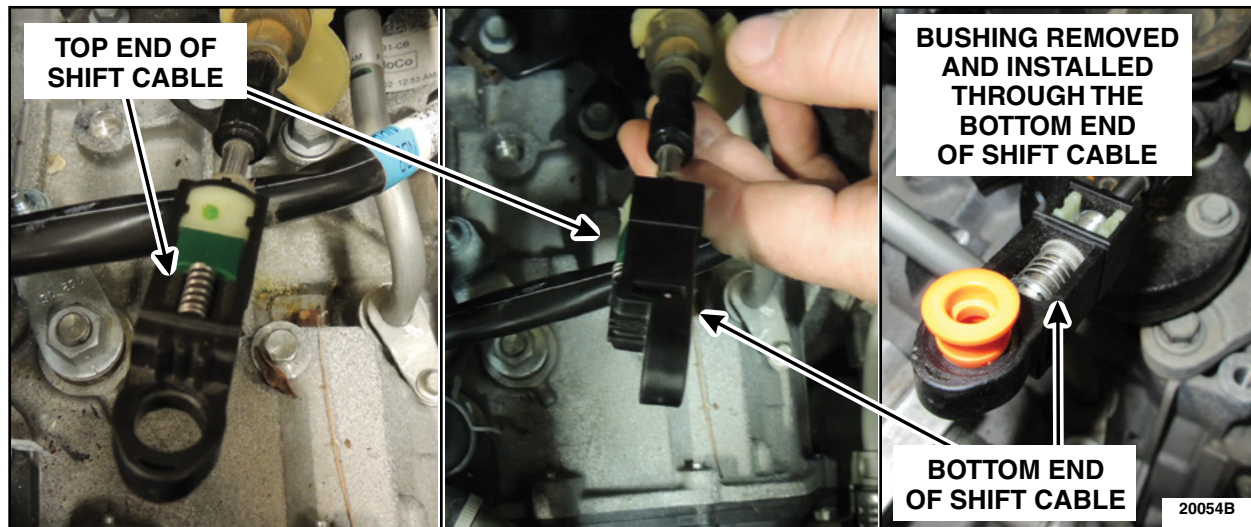
FIGURE 2

NOTE: Selector Lever Cable Bushing Replacement/Orientation. See Figure 2.

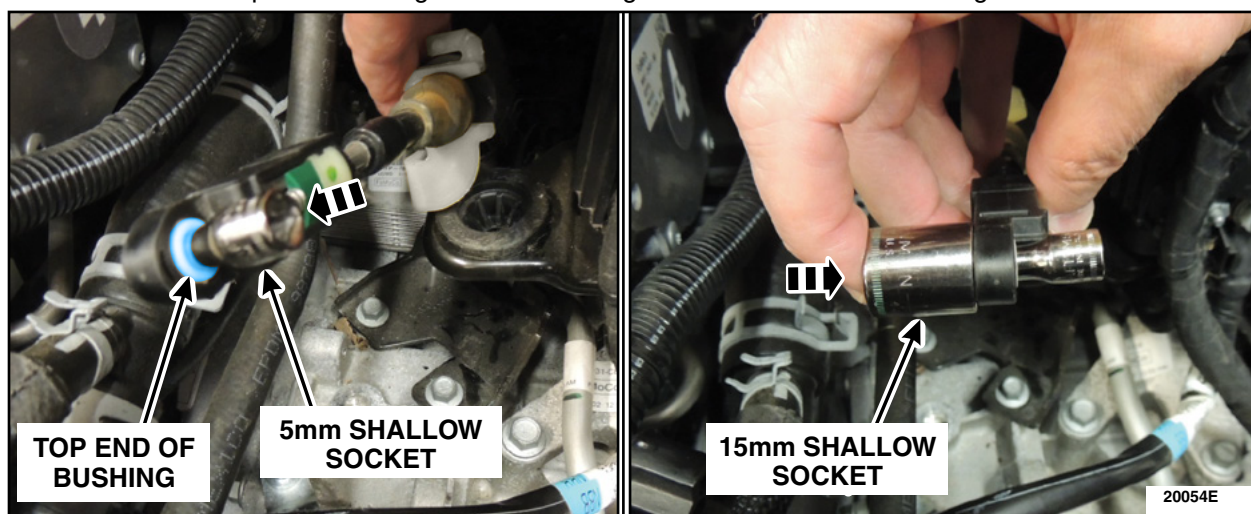
FIGURE 3

6. Press out the shifter cable bushing using one of the two methods below.

- Using a 5mm and a 15mm socket with Straight Jaw Adjustable pliers the bushing can be pressed out of the shifter cable end. The 5mm socket will fit into the small part of the bushing on top, the 15mm will go against the bottom of the shifter cable end, make sure to have socket centered with the bushing to allow clearance of the bushing shoulder as it is being pressed out. See Figures 3 and 4.
- Using a tool such as a Lisle 38350 - Exhaust Hanger Removal plier to press bushing out. By viewing Figure 5 the shoulder of bushing is positioned upward, small end of plier is pressing bushing out. Proceed to Step 7.

- Use caution not to damage the shifter cable during this procedure.
- Inspect for damage before installing the new shifter cable bushing.

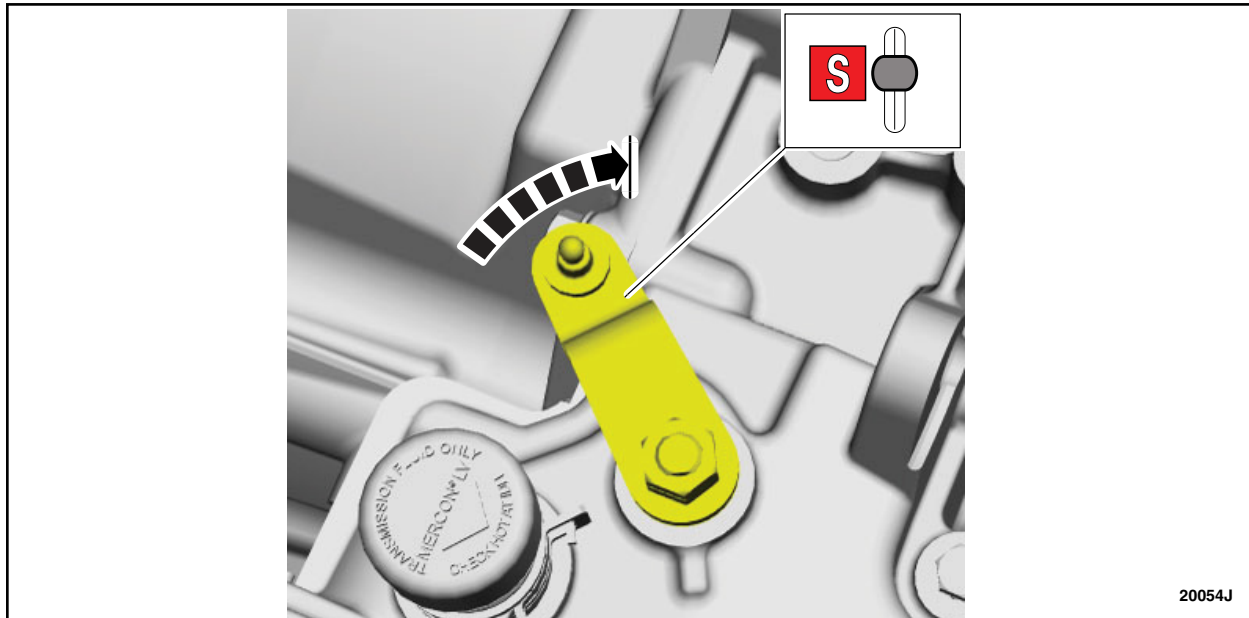
FIGURE 8

9. Rotate the manual control lever clockwise until it stops. See Figure 8.

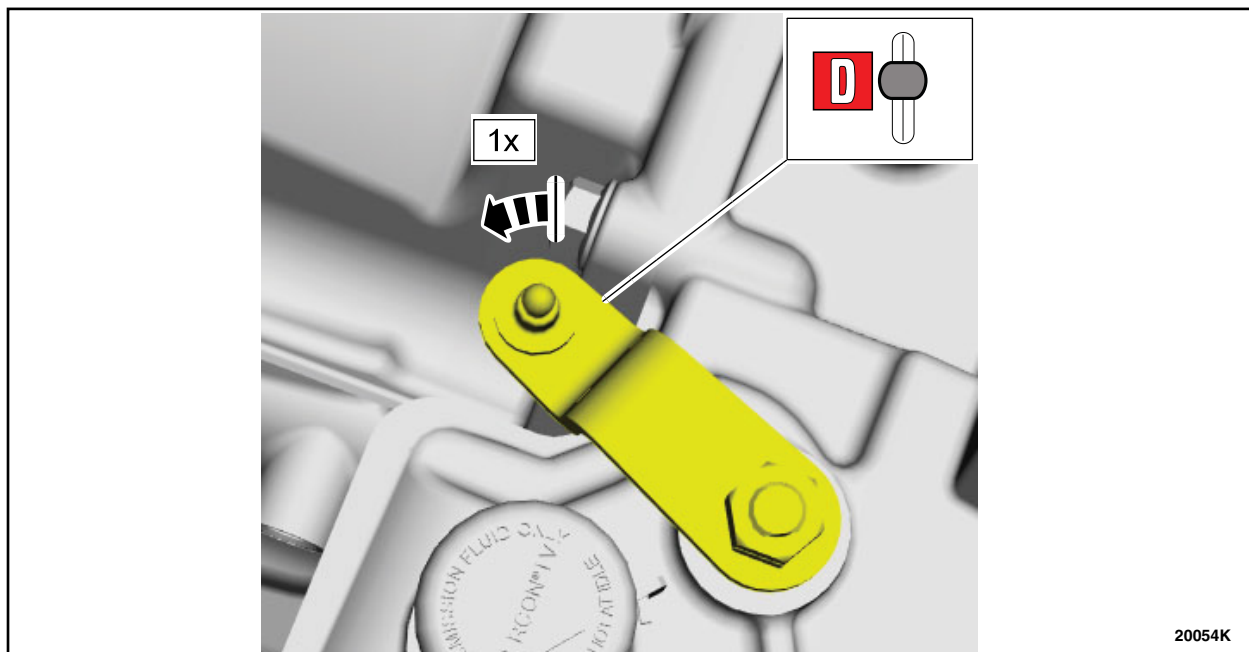
FIGURE 9

10. Rotate the manual control lever counterclockwise 1 detent into Drive (D). See Figure 9.

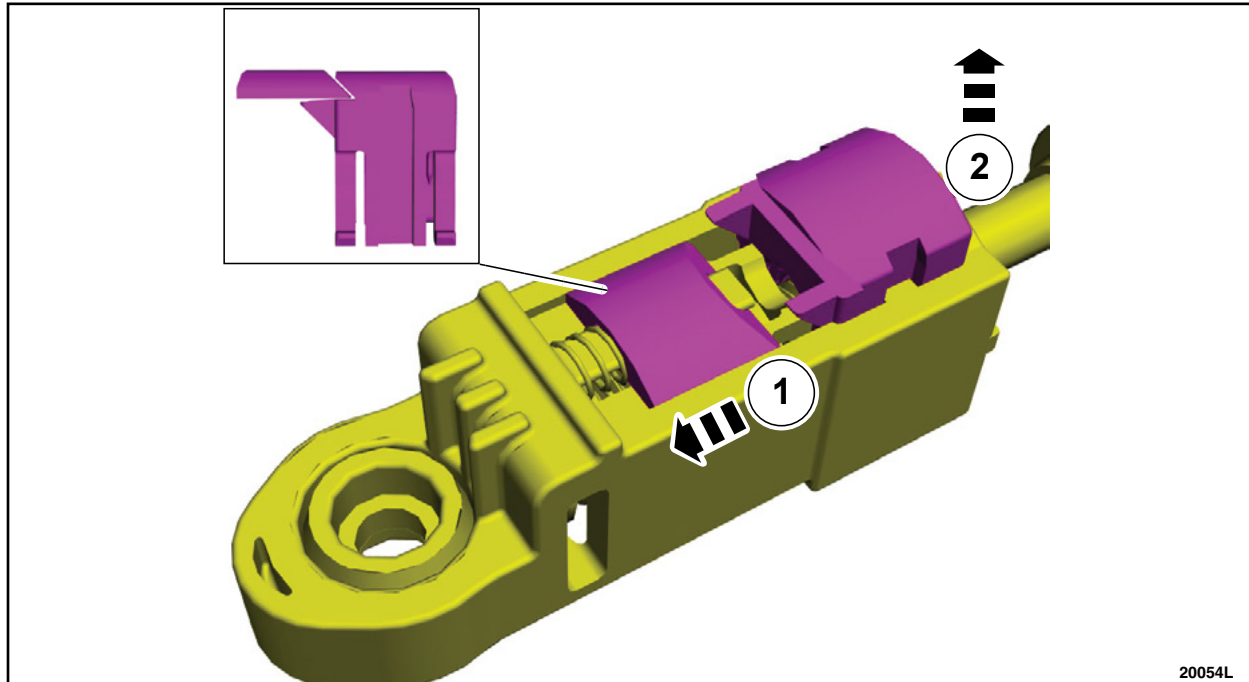
FIGURE 10

11. Release the selector lever cable adjuster lock. See Figure 10.

1. Carefully pry the adjuster lock tabs outward.
2. While holding the adjuster lock tabs outward, slide the lock out to unlock the selector lever cable.

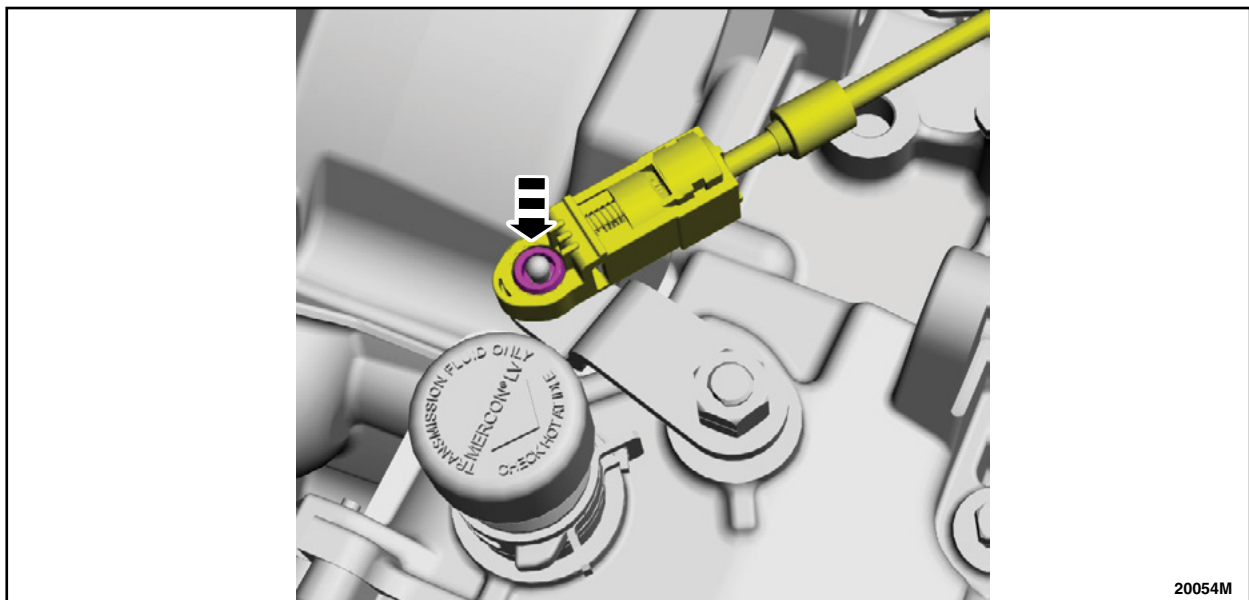
FIGURE 11

12. Connect the selector lever cable to the manual control lever. See Figure 11.

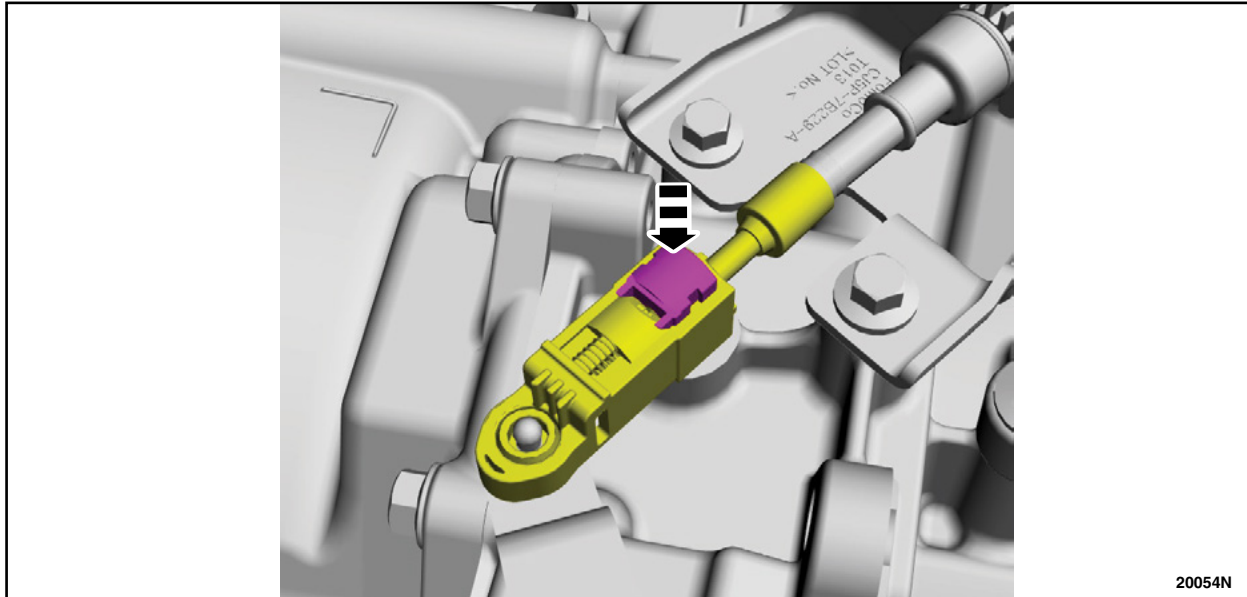
FIGURE 12

13. Slide the adjuster tab in place to lock the selector lever cable. See Figure 12.

NOTE: Visually inspect cable end and give a slight pull up to verify the bushing is fully seated.

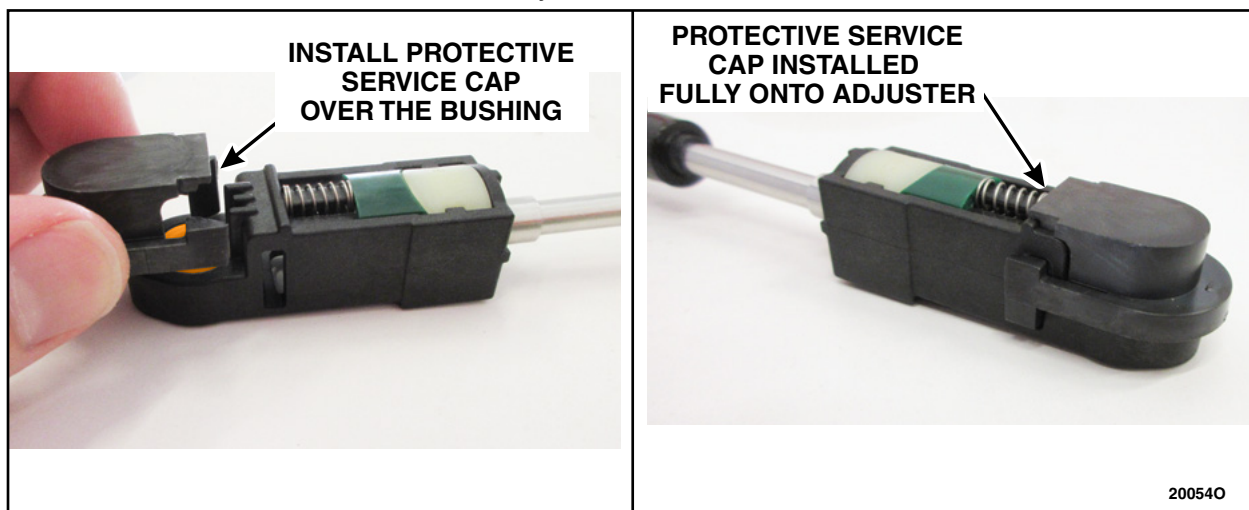
FIGURE 13

14. Install the new cap onto the selector lever cable adjuster. Clip one side into the adjuster body and then slide the other onto the housing until it snaps into place. The protective cap should cover the bushing and the terminal end of the adjuster. See Figure 13.

15. Verify installation by checking the cap is retained by the adjuster body.

NOTE: Selector lever cable removed for clarity.
