SUBJECT: **NEW VEHICLE DEMONSTRATION / DELIVERY HOLD – Safety Recall 22S48 – Supplement #2**
 Certain 2021 Model Year Expedition and Lincoln Navigator Vehicles equipped with a Heavy-Duty Cooling Fan
 Underhood Fire

**NEW VEHICLE DEMONSTRATION / DELIVERY HOLD –
Safety Recall 22S48 – Supplement #2**

Certain 2021 Model Year Expedition and Lincoln Navigator Vehicles equipped with a Heavy Duty Cooling Fan Underhood Fire

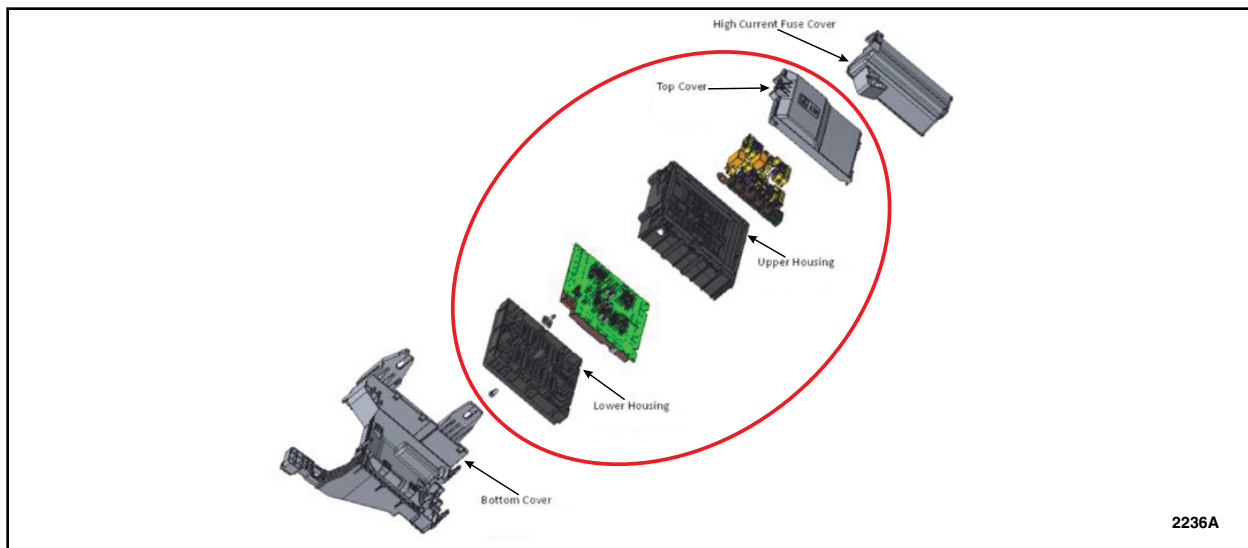
FIGURE 1

Figure 1 is a breakdown of the Battery Junction Box (BJB).

NOTE: Items circled in red are included with a new BJB. Covers can be ordered independently of the BJB.

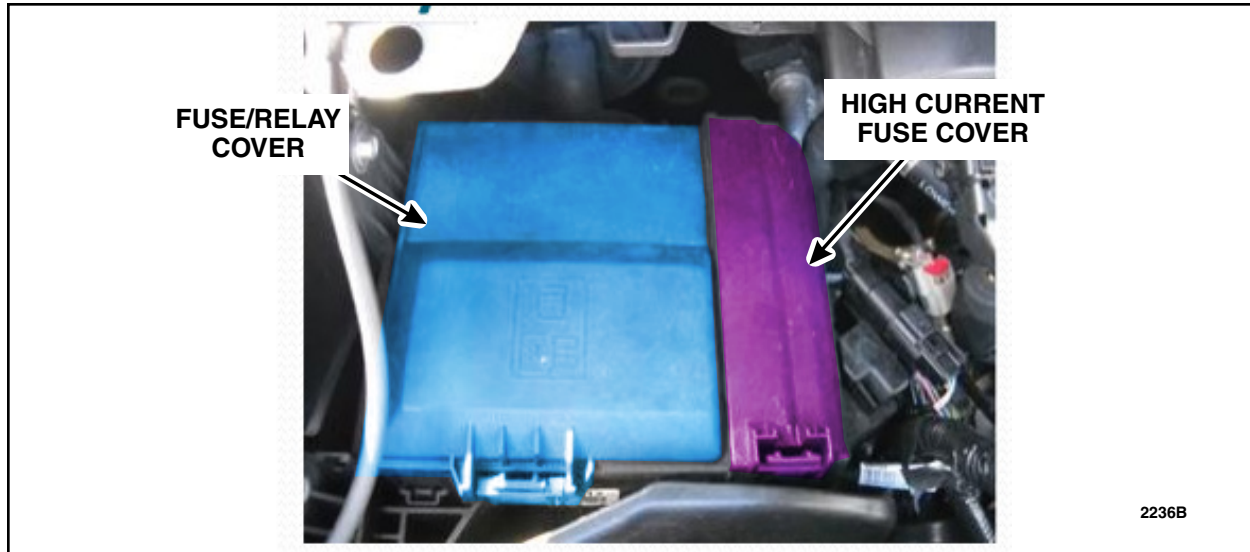
FIGURE 2

IMPORTANT: New cover(s) can be ordered WITHOUT ordering a new BJB.

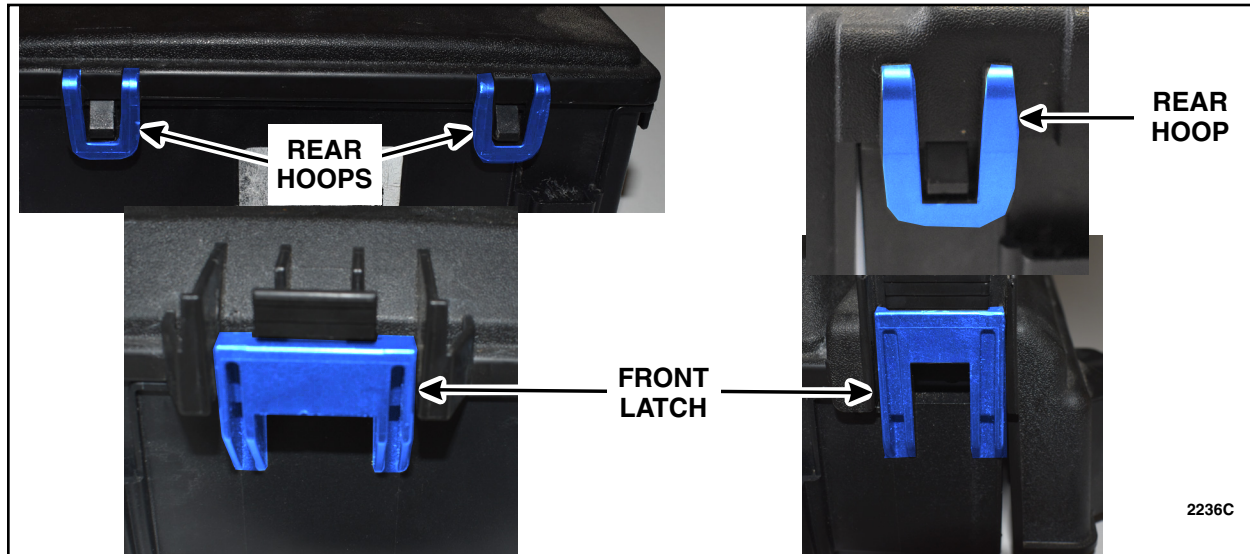
FIGURE 3

Yes - Proceed to Step 3.

No - Ensure that the covers latch and install properly. Proceed to Step 3.

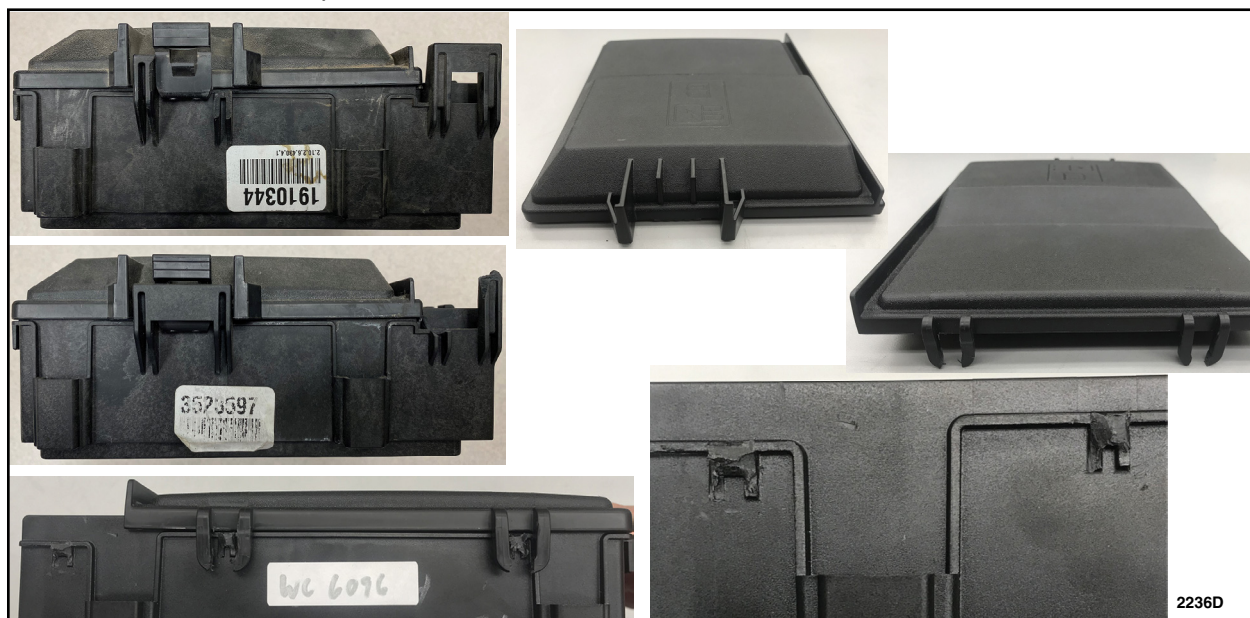
FIGURE 4

3. Check for any damage such as cracks, excessive warping, melting, broken hoop(s), and/or broken latch(es) on both covers. Is there any damage present on either cover? See Figure 4.

Yes - Replace damaged cover(s), proceed to Step 4.

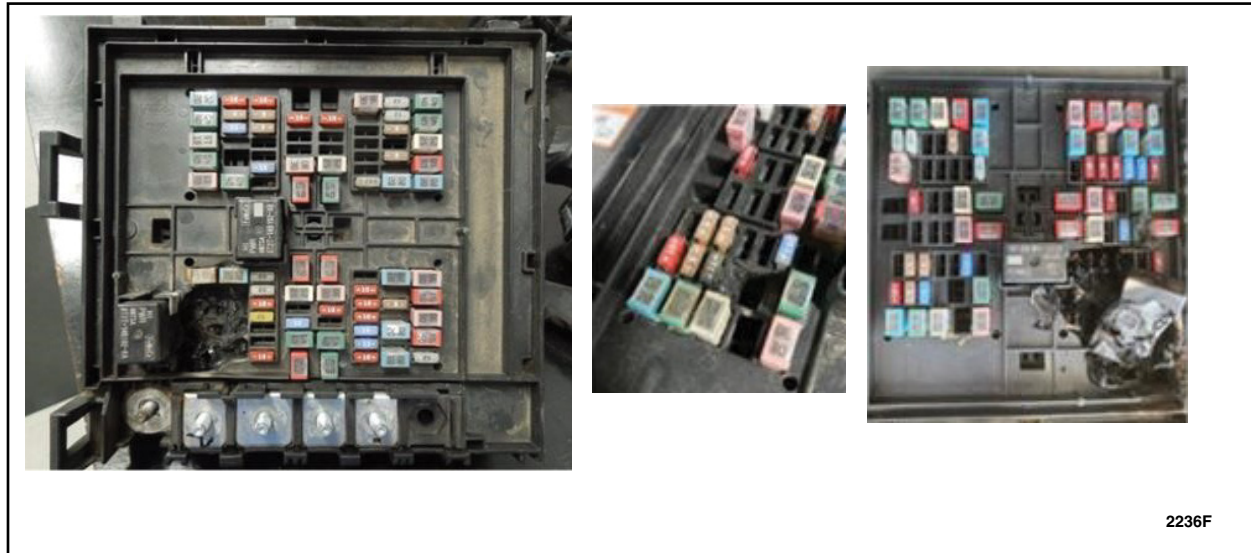
FIGURE 5

4. Remove covers and inspect BJB. Is there any evidence of melted fuse(s), melted relay(s), or melted plastic in the BJB? See Figure 5.
 - Yes - Replace BJB, photos and Special Service Support Center (SSSC) approval required to proceed. Is the part available?
 - Yes - Proceed to Step 5.
 - No - Part is on back-order. Park vehicle outside, disconnect negative battery cable, and contact SSSC for approval for rental vehicle for customer.
 - No - Proceed to Step 6.

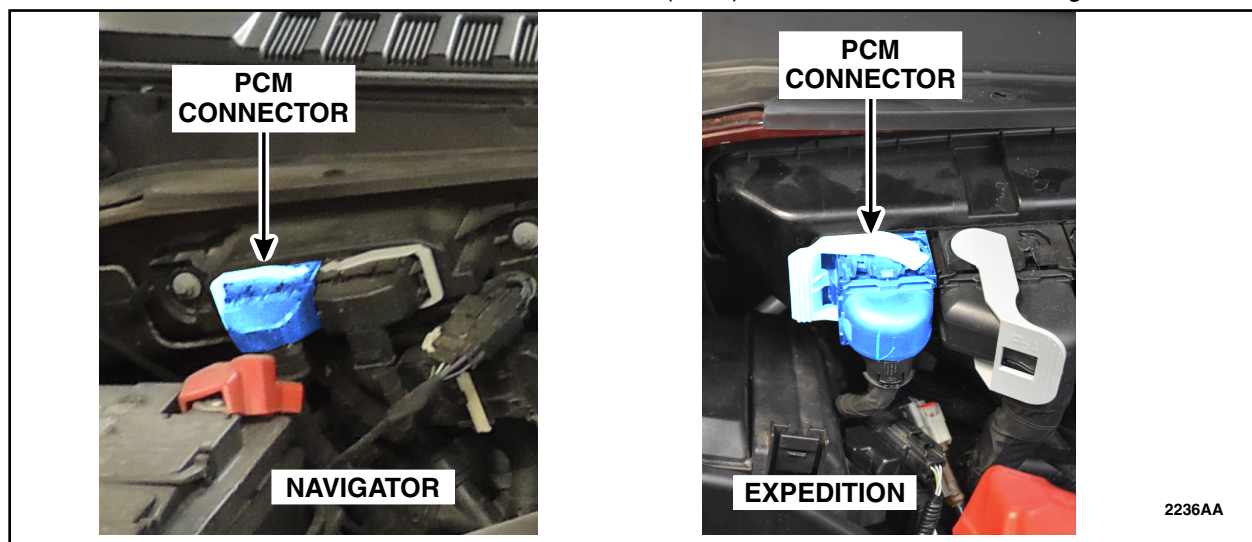
FIGURE 6

5. Remove the battery and battery tray. Please follow Workshop Manual (WSM) procedures in section 414-01.
6. Disconnect the outboard Powertrain Control Module (PCM) electrical connector. See Figure 6.

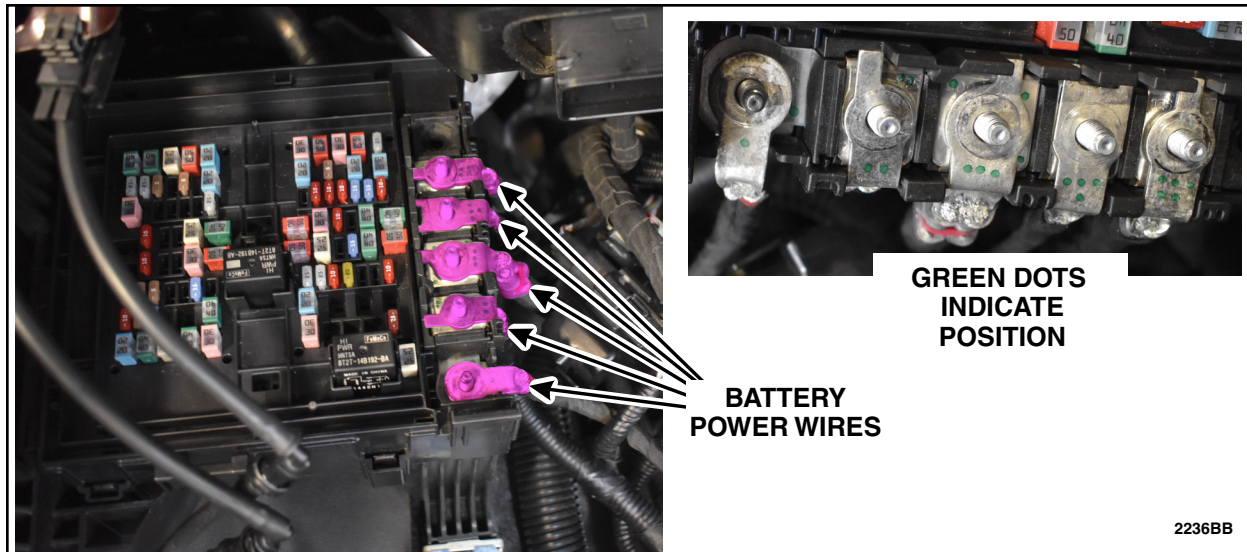
FIGURE 7

7. Remove battery power wires and make sure to document their position. See Figure 7.

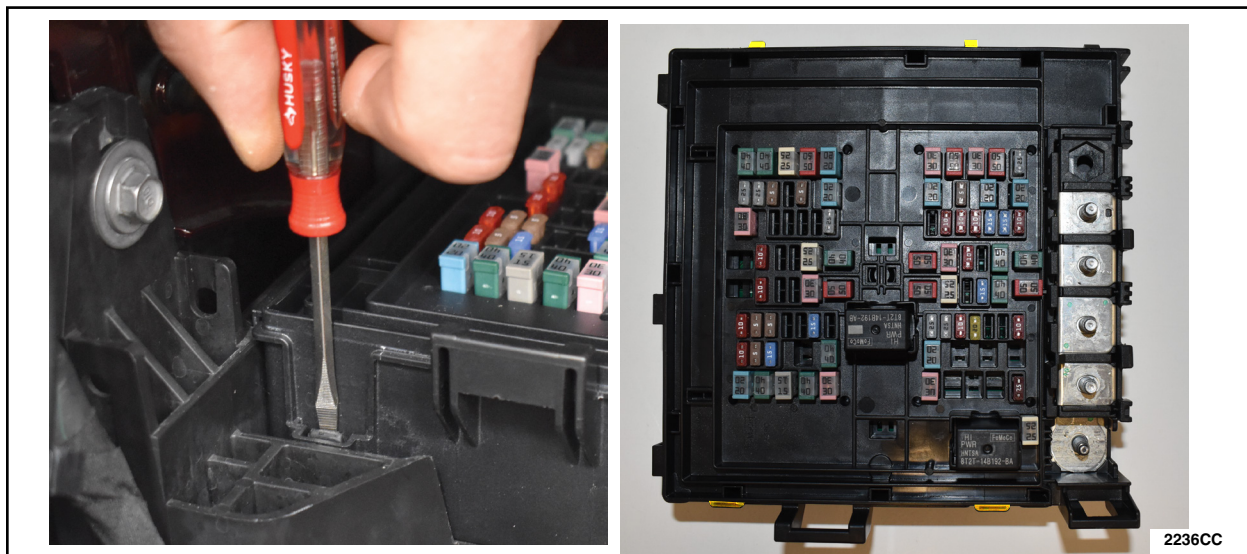
FIGURE 8

8. Separate the upper and lower BJB housings from the bottom cover. There are 4 clips that fasten these two parts together, two in the front and two in the rear. It is easiest to release these tabs with a small screwdriver. See Figure 8.

NOTE: BJB removed for illustrative purposes.

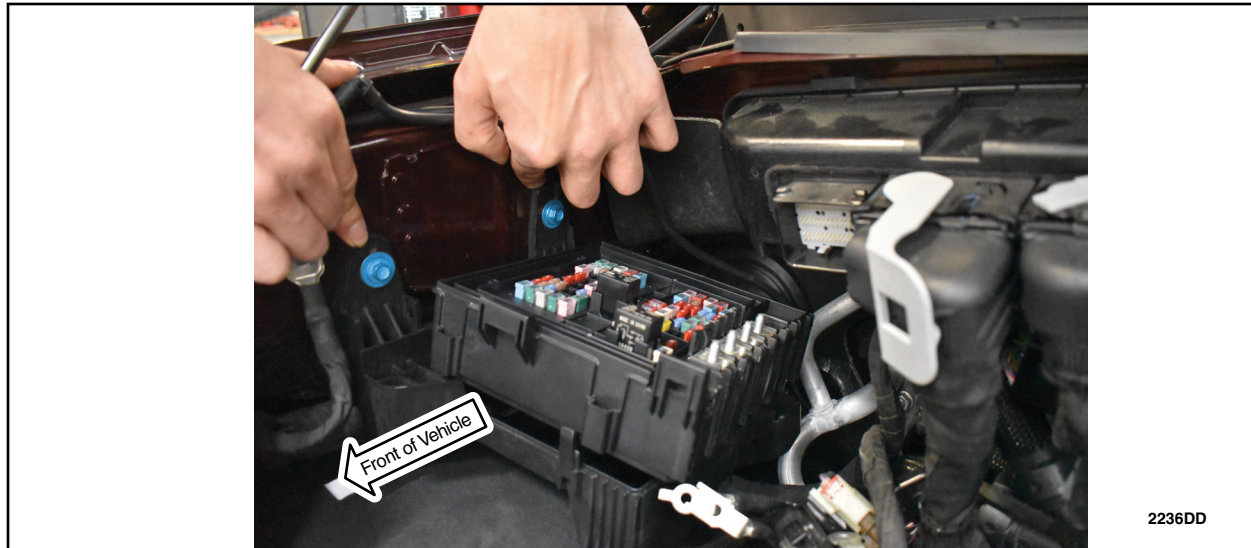
FIGURE 9

9. Remove the fasteners for the bottom cover of the BJB. See Figure 9.

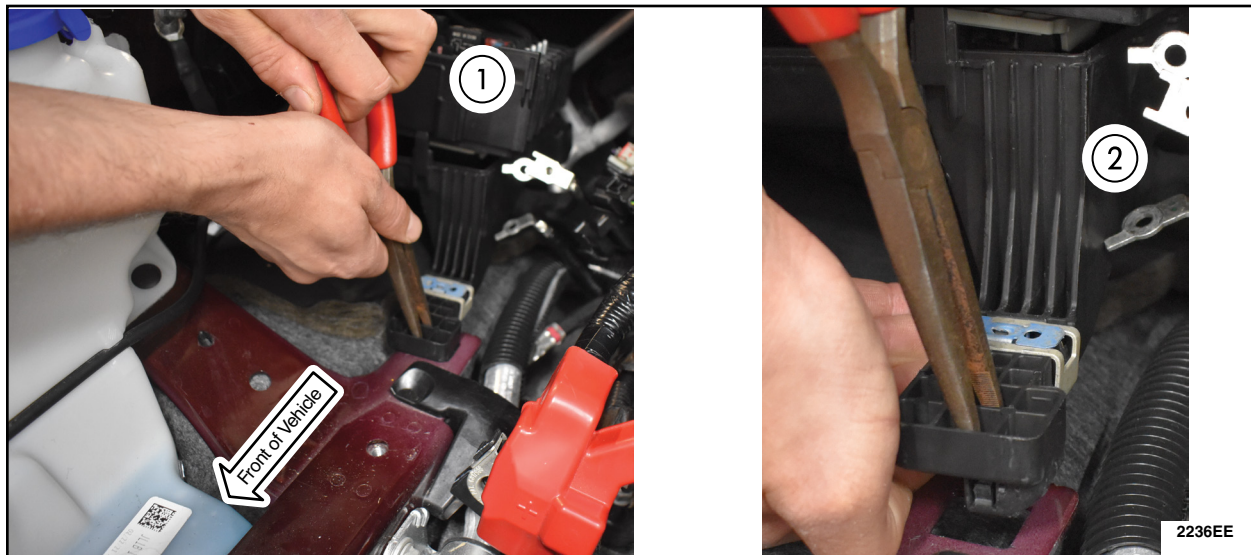
FIGURE 10

10. Release the tab connecting the BJB to the frame. Needle nose pliers will be needed to release the tab. See Figure 10.

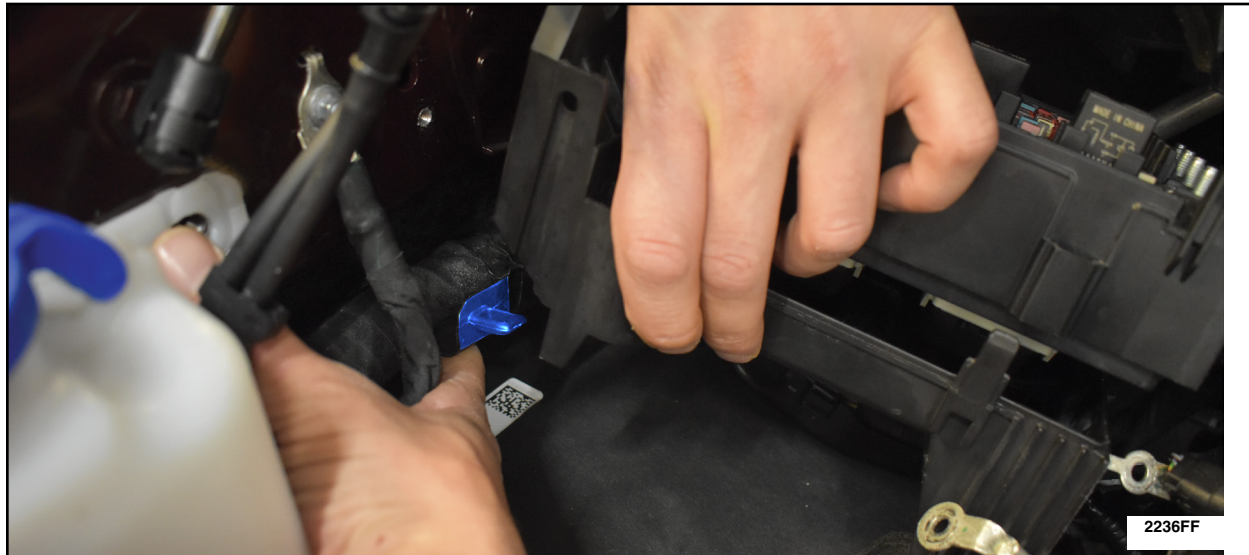
FIGURE 11

11. Release the 2 harness retainers from underneath the lower BJB. See Figure 11.

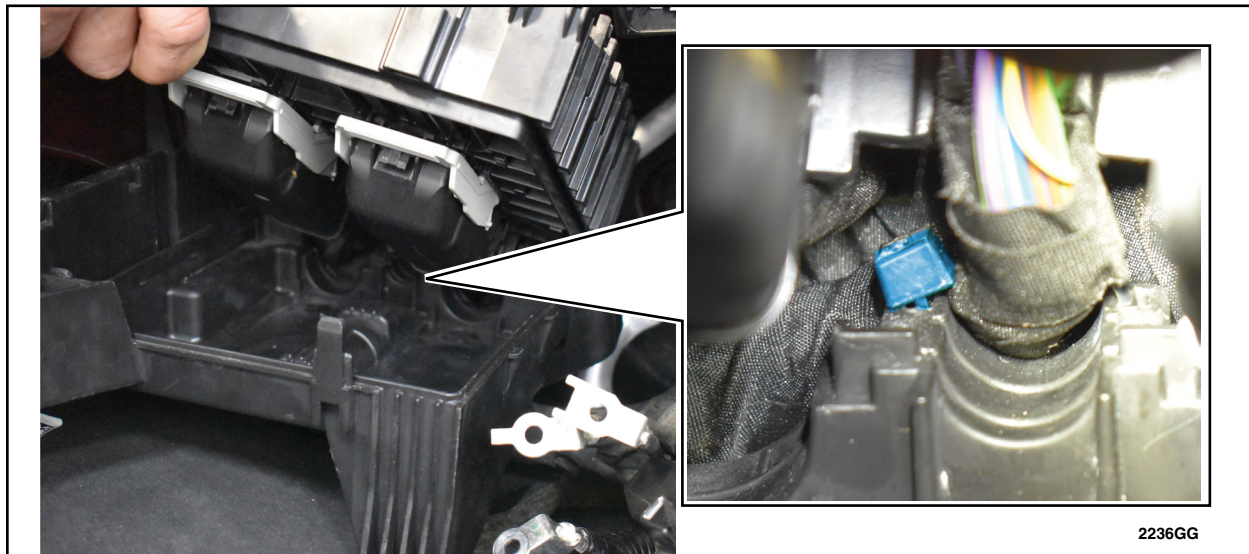
FIGURE 12

12. Position BJB, remove the zip tie connecting the middle wire harness to the lower portion of the BJB. See Figure 12.

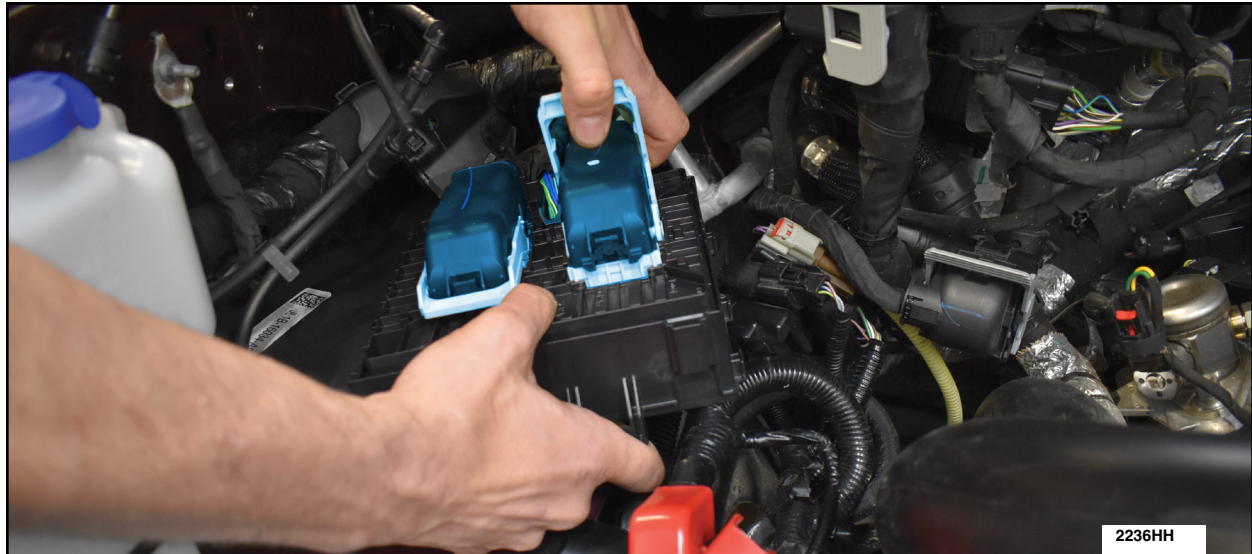
FIGURE 13

14. Disconnect the three wire harness connectors from the BJB. See Figure 13.

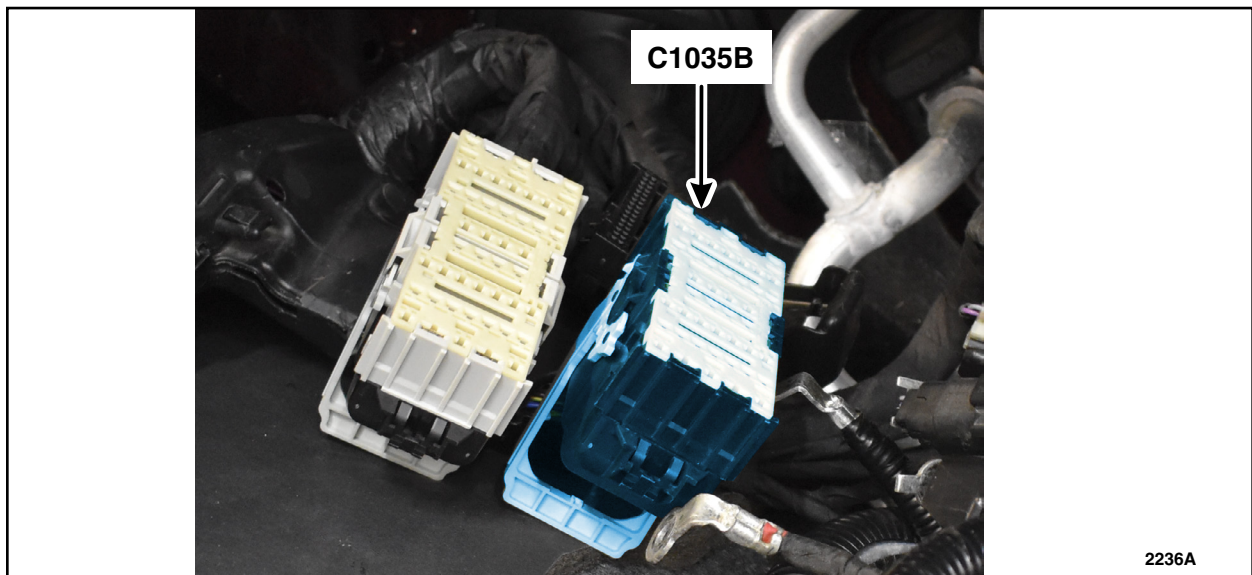
FIGURE 14

16. Locate the black 50-way connector (C1035B). See Figure 14.

NOTE: Connector has been highlighted blue to aid in identification.

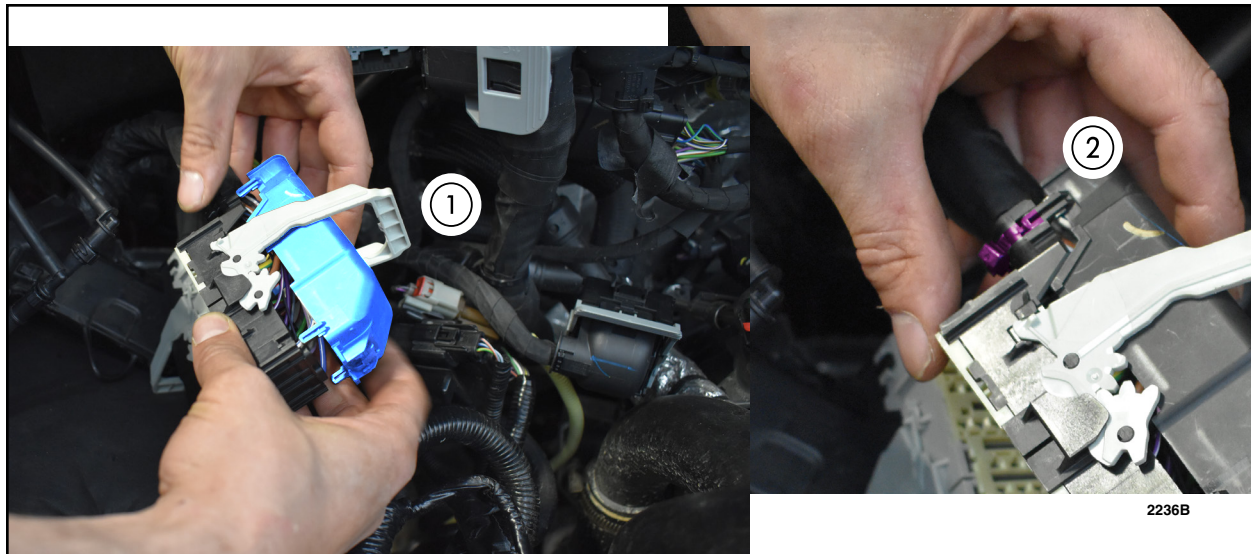
FIGURE 15

17. Remove back shell and zip-tie from 50-way black connector (C1035B). See Figure 15.

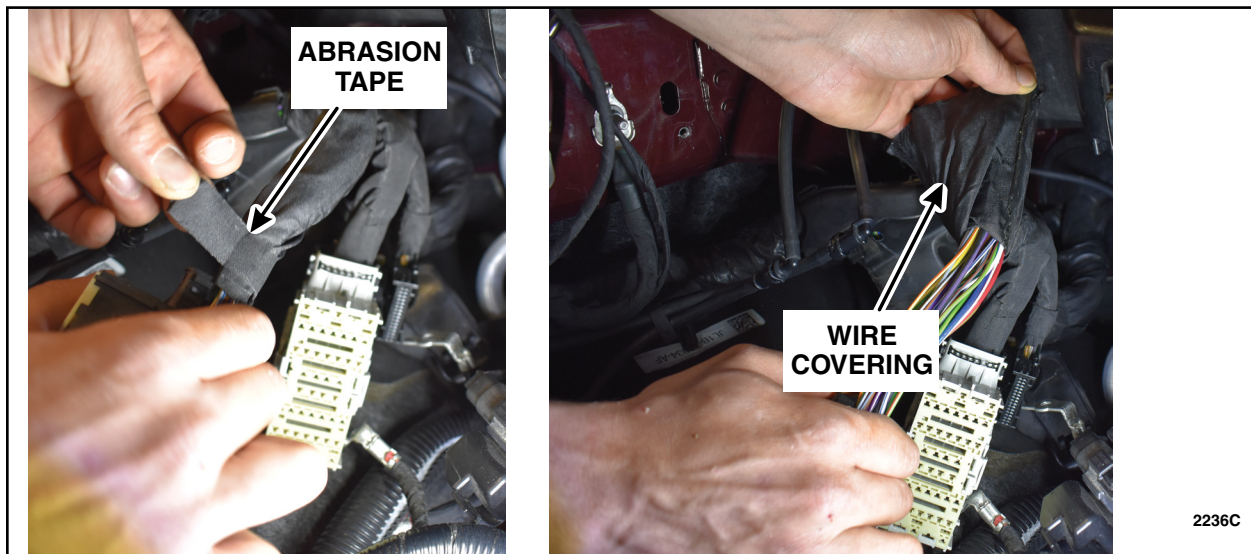
FIGURE 16

18. Remove abrasion tape from the harness and peel back the covering about 300mm. See Figure 16.

NOTE: Do NOT cut wire covering.

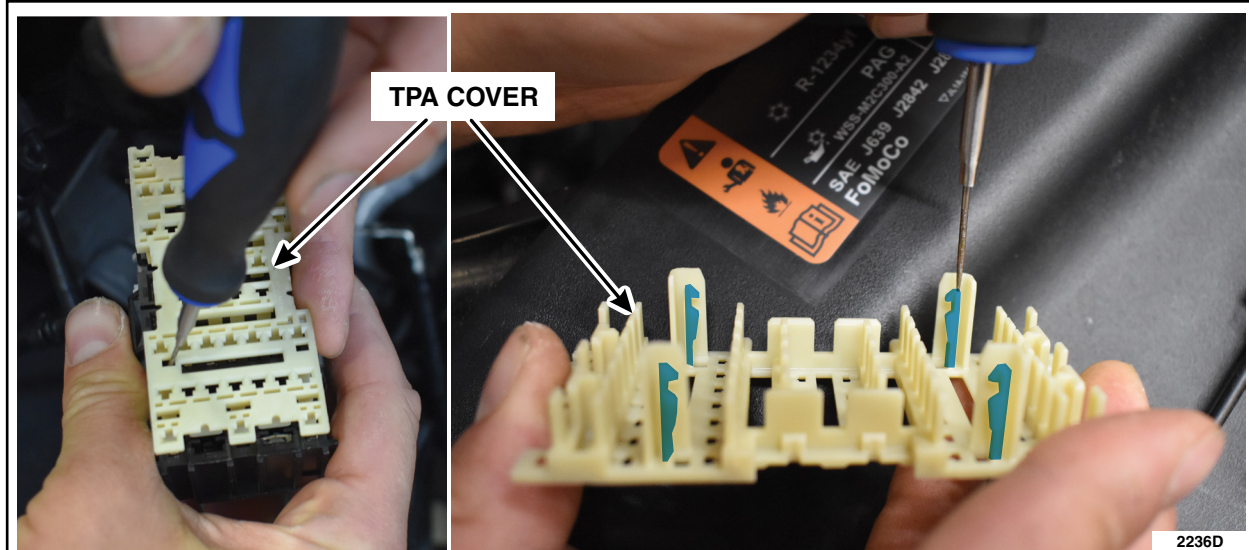
FIGURE 17

19. Using a small flat-head screwdriver, remove the Terminal Position Assurance (TPA) cover. See Figure 17.

NOTE: TPA cover has a hard stop, so it will need to be unclipped twice.

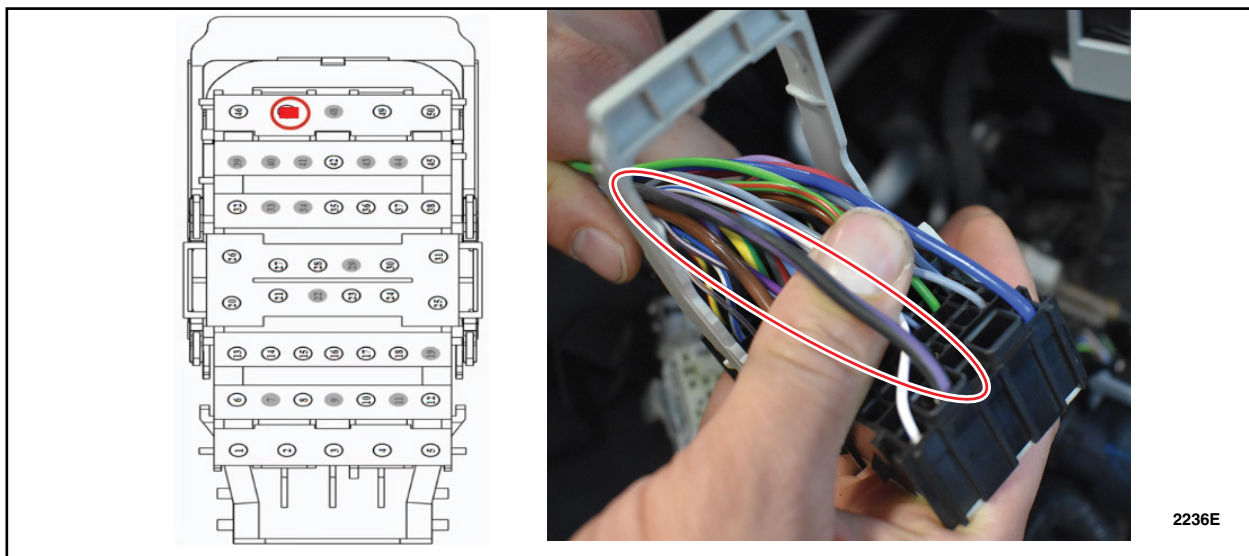
FIGURE 18

20. In connector C1035B identify cavity 47 which contains a black-violet wire. See Figure 18.

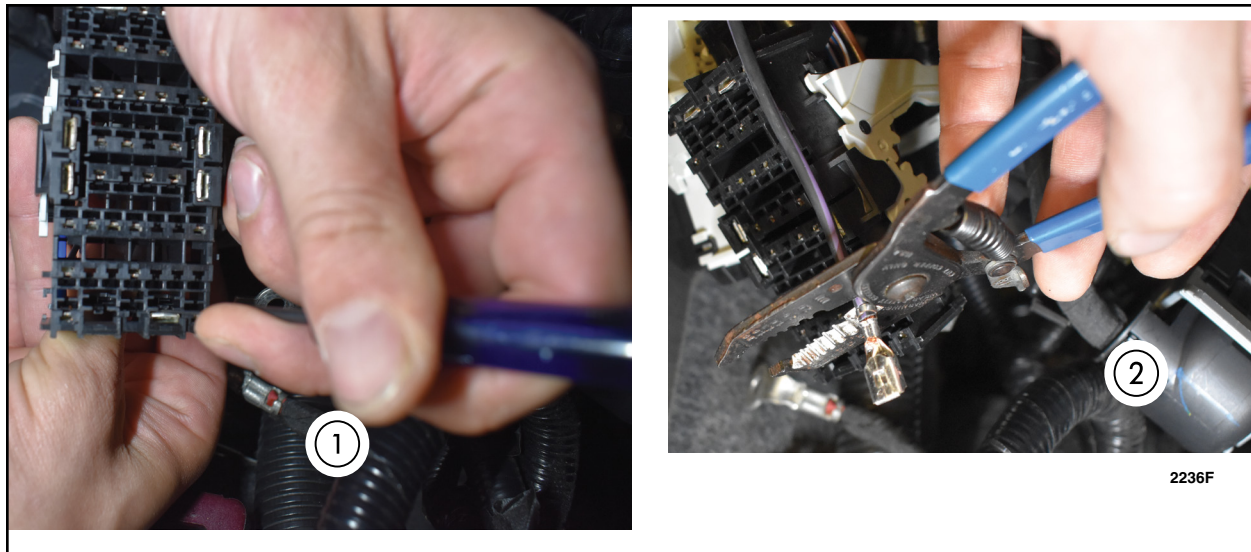
FIGURE 19

21. Remove the black-violet wire located in cavity 47 from the C1035B connector using a terminal tool. Cut terminal end off of wire. See Figure 19.

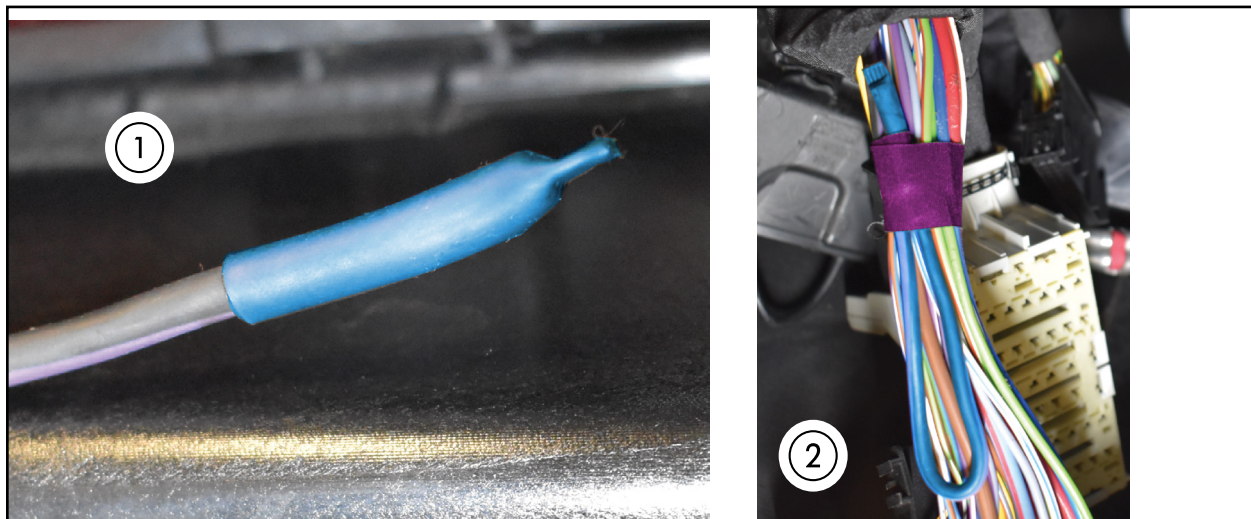
FIGURE 20

22. Add Dual Wall Heat Shrink tubing to cover open end of the black-violet wire. Bend the circuit with heat shrink into the bundle and secure with Coroplast tape. See Figure 20.

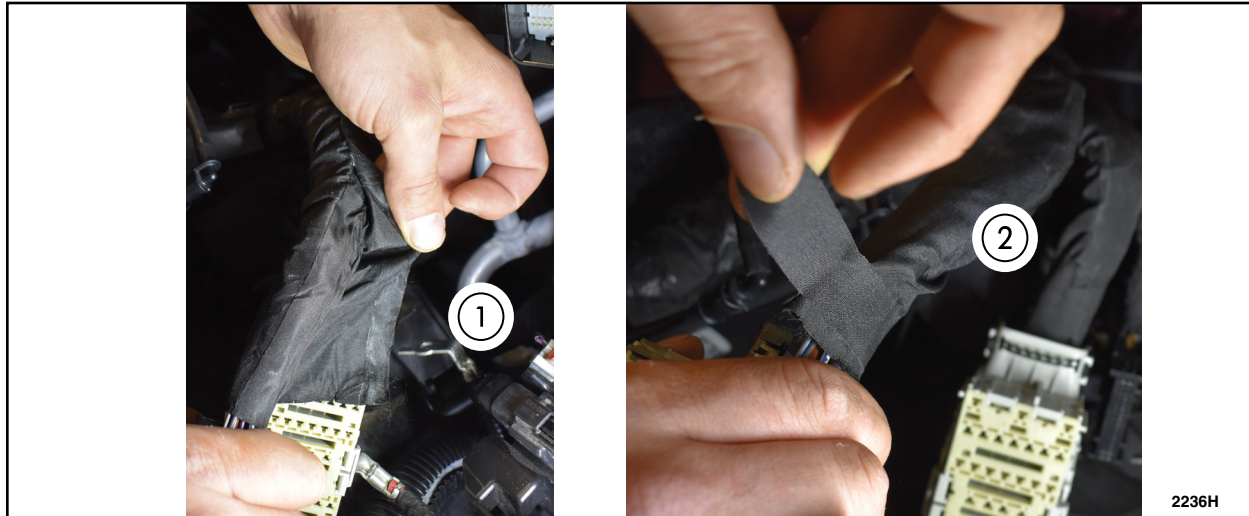
FIGURE 21

24. Put wire covering back into place and secure with new Coroplast tape. See Figure 21.

NOTE: If there are any tears in the wire covering, it will still be reused. Using Coroplast tape, secure any tears in the wire covering.

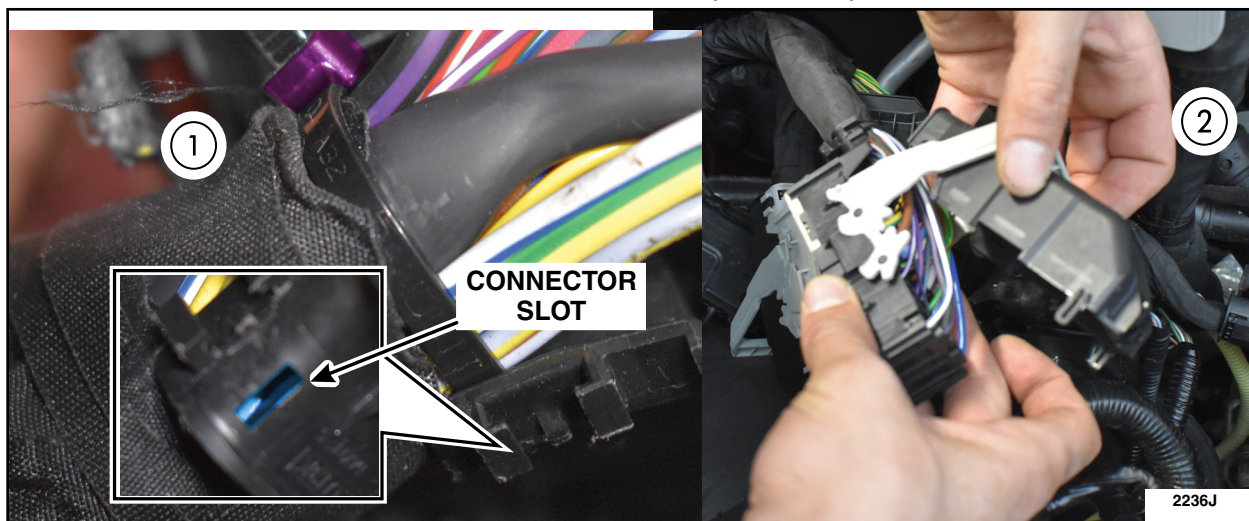
FIGURE 22

25. Secure wire covering and wire bundle with a zip tie. Clip back shell into place on connector C1035B. See Figure 22.

NOTE: Be sure to use identified slots to pull zip-tie through. Also, the head of the zip-tie must be placed so that it will be underneath the shell, or it will not clip back into place.

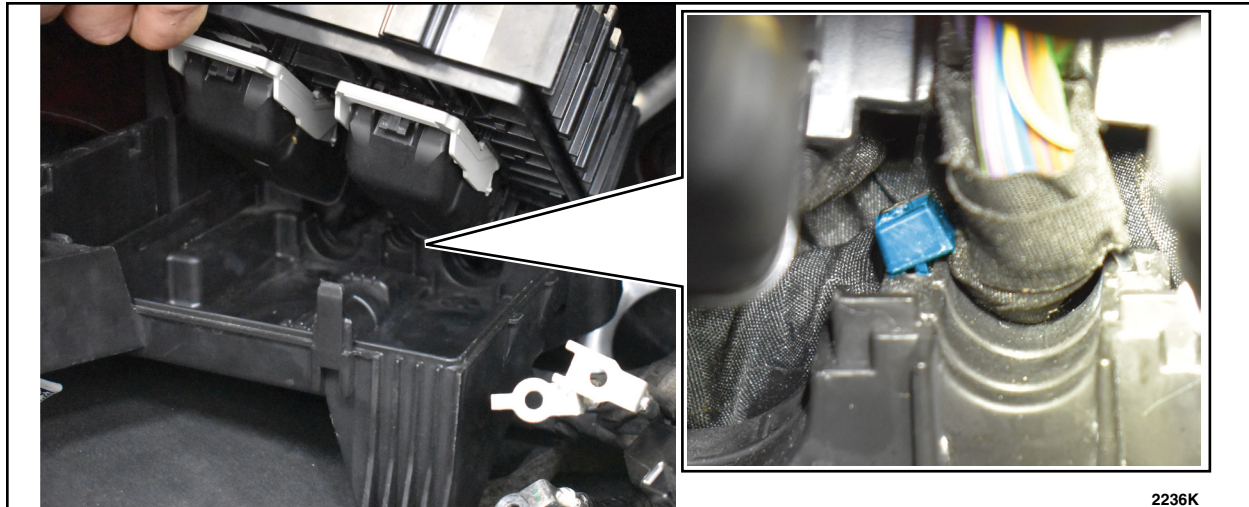
FIGURE 23

A. Ensure that the zip tie connecting the middle wire harness to the lower portion of the BJB is replaced. See Figure 23.
