Recall Campaign Bulletin

Campaign No. 2022100011, November 2022

SUBJECT: Model GLS (167 platform) Model Year 2020-2022

Check Locking Mechanism of Third Seat Row

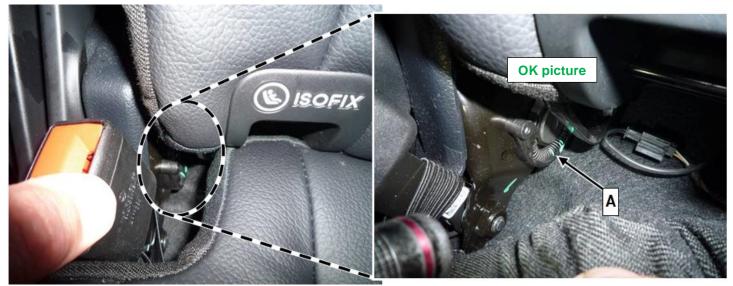
Figure 1

- To perform check, fold 3rd seat row up and down 5 times using buttons in trunk (right and left seats).
 Remove roller blind if necessary.
- 2. Check whether there are 2 springs per seat (*4 pieces*, entire seat row) on right and left seats in 3rd seat row and whether they are installed correctly as shown in (A, Figure 1).

1 The springs must be present and installed correctly as shown in (A, Figure 1).

- a. Springs not present or not installed correctly: Carry out work procedure.
- b. Springs present and installed correctly: End measure.

1. <u>Replace faulty seat backrest.</u>
