**IMPORTANT – RECALL NOTICE - #####**

Kaufman Trailers of NC, Inc. has determined that a defect, which relates to trailer safety, exists in certain 2018 - 2021 Kaufman Trailer 25,000 GVWR Deluxe Tandem Dual Gooseneck Dump Trailers – 20' x 90". These are Model numbers: **FX-10K-20D & FX-10K-20D-SC**. On most of these models, the angle ramp track at the rear of the trailer that holds the lip of the aluminum ramps (once installed) is not properly braced (see pictures below). The improper bracing *could* cause the welds to break on the angle ramp track causing immediate collapse of the ramps while loading/unloading equipment utilizing the aluminum ramps. This could cause injury or death to any person(s) that is behind or near the rear of the trailer or to the operator of the equipment being loaded/unloaded.

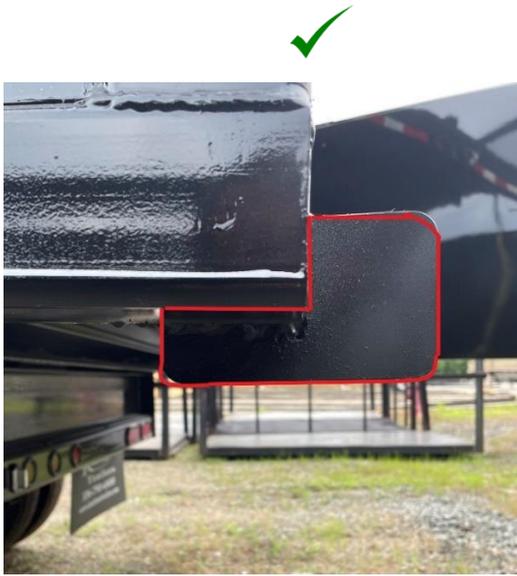
Driver Side Angle Ramp Track Brace Installed

Kaufman Trailers of NC, Inc. will provide two (2) end brace caps to be welded at the ends of the angle ramp track as well as one (1) center support gusset to be welded inside the angle ramp track at the center of the trailer rear. When the braces are installed correctly, this will prevent the angle ramp track welds from breaking. In some cases, additional welding may be needed for further reinforcement as show in the attached picture.

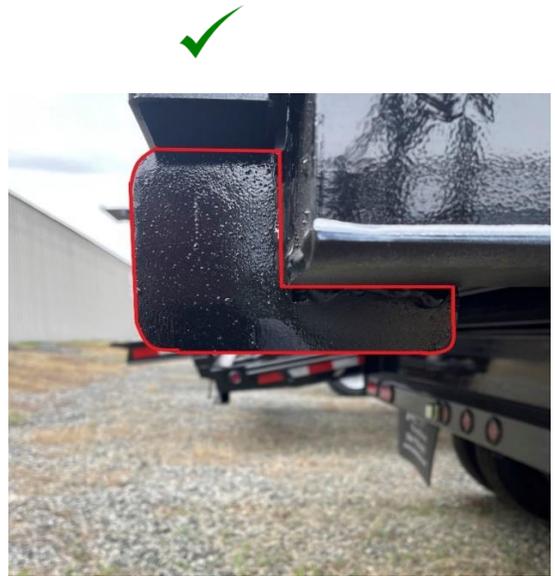
Passenger Side Angle Ramp Track Brace Installed

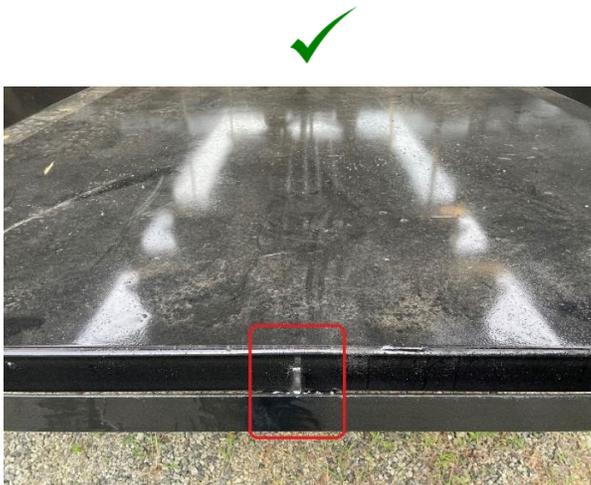
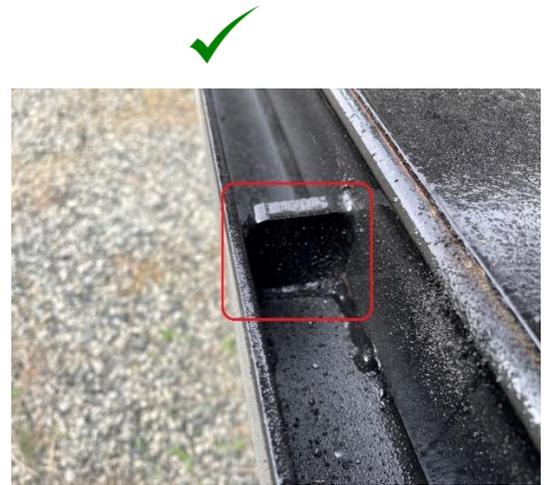
Center Gusset on Angle Ramp Track Installed

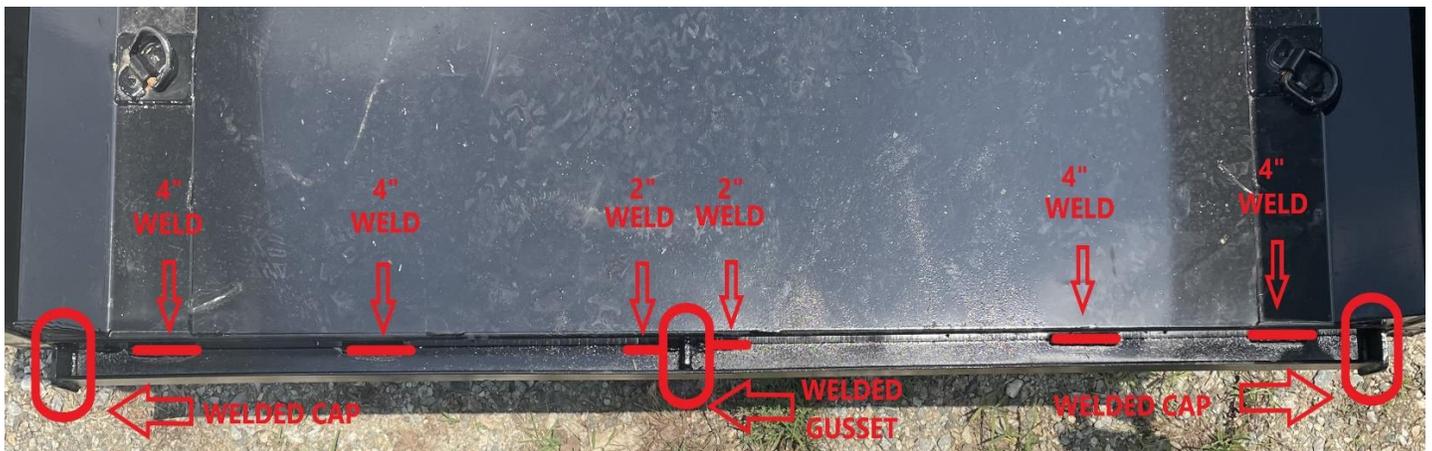
Properly Installed Angle Ramp Track with Caps, Gussets and Welds

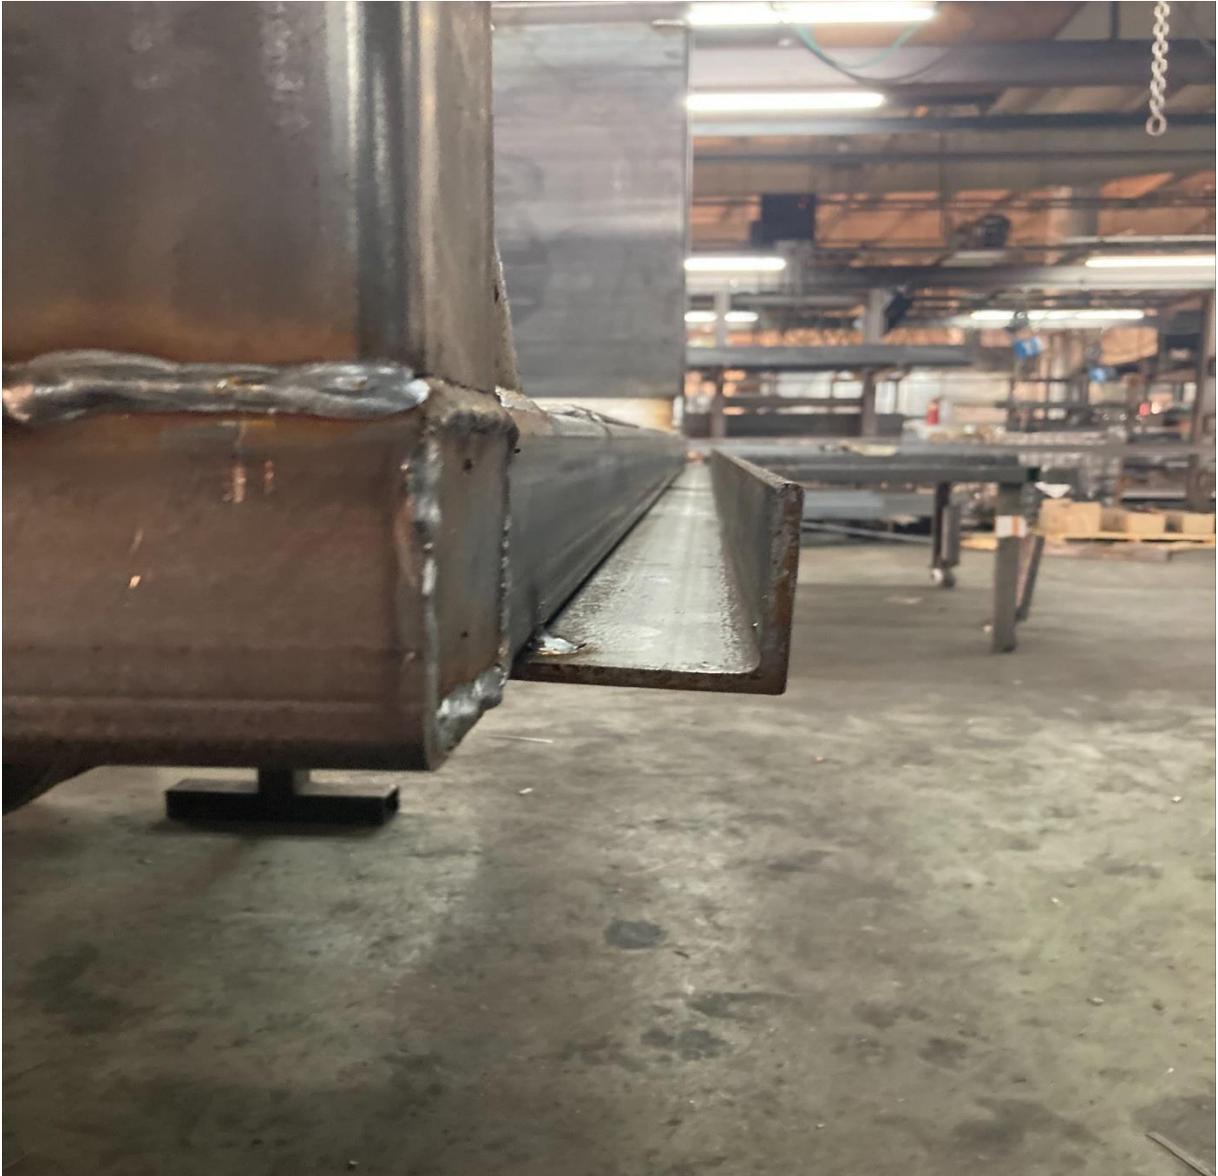
Angle Ramp Track Without Required Bracing / Welds

**DEFECTIVE** - Open Ends of Angle Ramp Track with No End Caps or Center Gusset Installed

**NOTE:** If your trailer does not have caps as the picture displayed above, do NOT use your trailer for any loading/unloading of equipment! Please contact the number listed above to schedule the repair.
