Compliance Recall

Code: 91DF

Subject	Rearview Camera Software															
Release Date	February 22, 2022															
Affected Vehicles

Subject: Compliance Recall 91DF - Rearview Camera Software

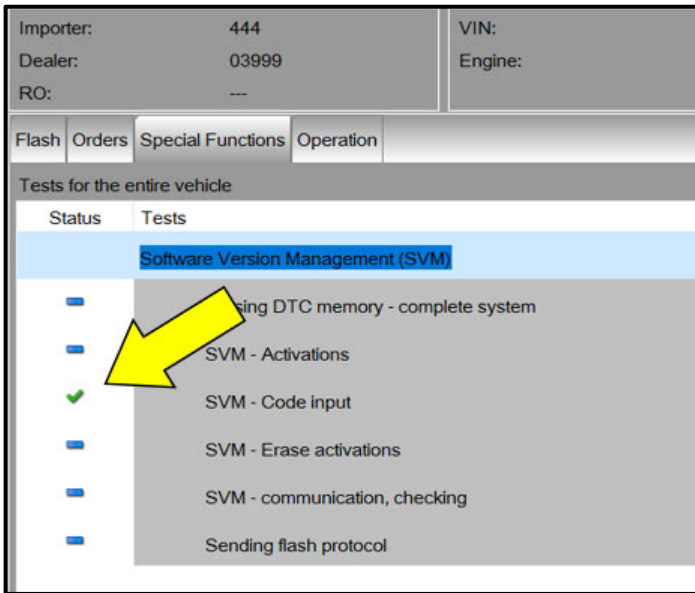
- After receiving confirmation that the update completed successfully (green check mark) <arrow>, the ignition must be turned off for 60 seconds and then turned back on.

This extra ignition cycle step must be followed, otherwise faults stored during the update may not be cleared upon exiting the Flash program.
