Dealer Service Instructions for:

Safety Recall Z11 / NHTSA 22V-077 Plug-in Hybrid Electric Vehicle Fires

2017 - 2018 (RU) Chrysler Pacifica (PHEV)

A. Battery Pack Control Module (BPCM) Software Update and BPCM Integrity Procedure

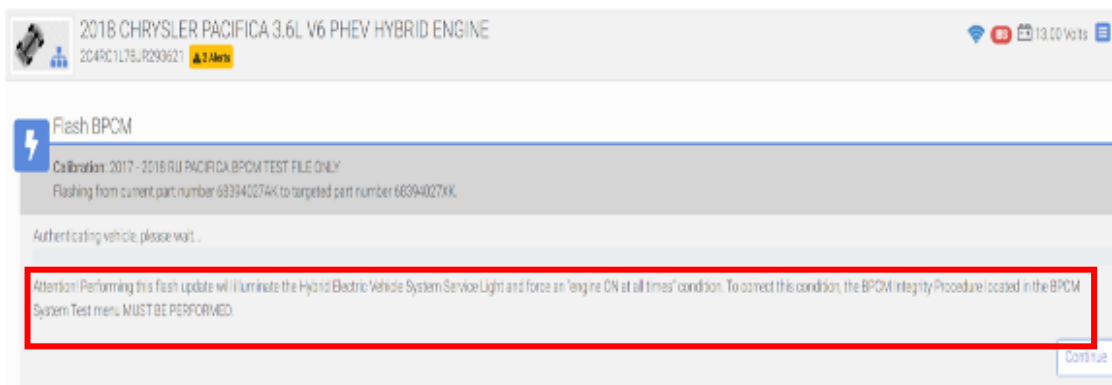
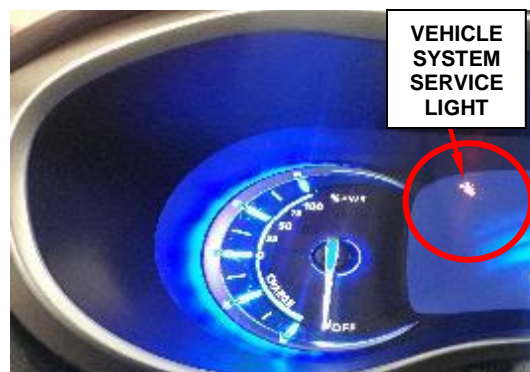
Figure 1 – Service Light

ALERT: Performing the BPCM flash will illuminate and continuously flash the Hybrid Electric Vehicle System Service lamp located in the instrument panel cluster. Every step in the Z11 BPCM Integrity Procedure MUST be completed in order to turn the flashing service lamp off.

Do not return the vehicle to the customer if the service lamp is flashing. (Figure 1).

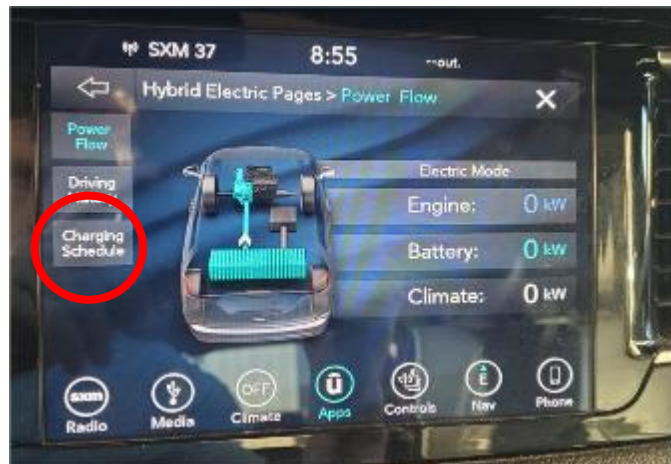
Figure 2 – Charging Schedule Display

- 23. Select “Charging Schedule” (Figure 2).

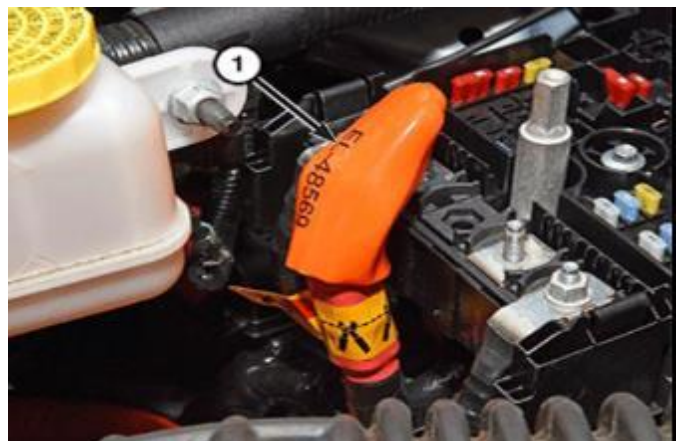
Figure 6 – Battery Cable

6. Disconnect the B+ battery cable (1) from the 12-volt Power Distribution Center (PDC) (Figure 6).

7. Isolate the battery cable terminal with Cover, Protective 10084

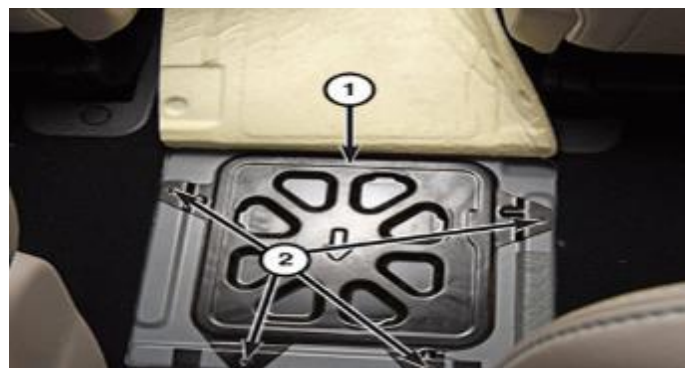
Figure 7 – MSD Access Cover

8. Lift the carpet away from the high-voltage MSD floor access cover.
9. Remove the four screws (2) and remove the high-voltage MSD access cover (1) (Figure 7).
10. Depress the lever release latch (2) firmly. With the latch fully depressed, rotate the lever (1) upward. The lever will stop at the 45° position (Figure 7).

NOTE: At this stage, the High Voltage Inter-Lock (HVIL) connection has been broken and the circuit is de-energized.

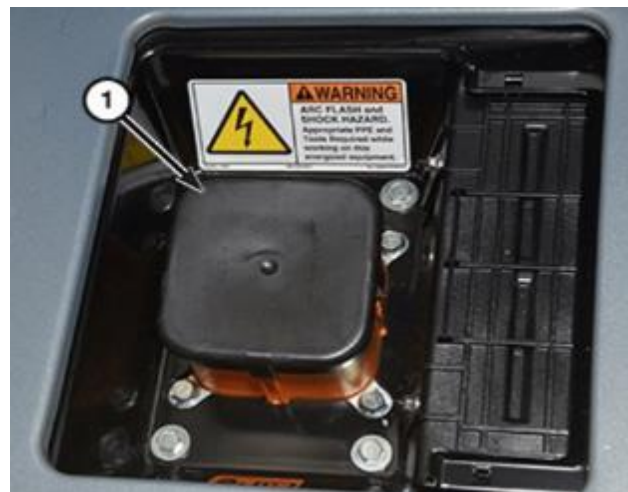
Figure 10 – MSD Cover

NOTE: Make sure the location of the high-voltage MSD is always known; after removal, it is best practice to place the high-voltage MSD in a highly visible location.

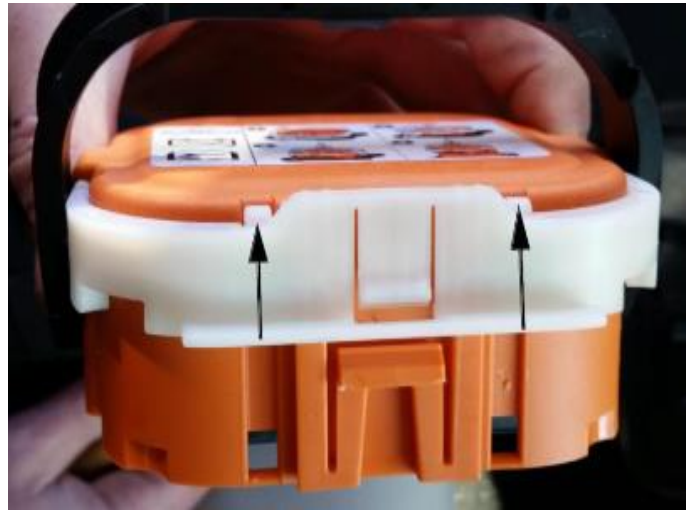
Figure 21 – MSD Position

16. Position the white sleeve in the full upright position for installation of the MSD to verify proper engagement as shown (Figure 21).

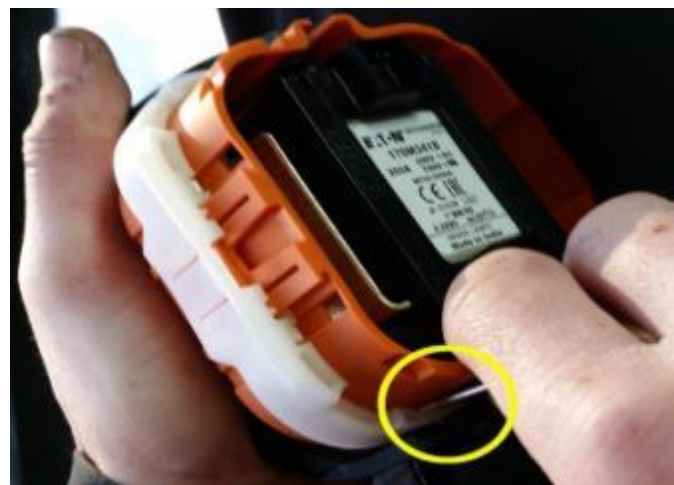
Figure 22 – White Sleeve

NOTE: If necessary, use a small screwdriver to loosen and guide the white sleeve to the full upward position as shown (Figure 22).
