SERVICE PROCEDURE

22508
JUNE, 2022

**SUBJECT: SAFETY RECALL
BENDIX WINGMAN PREWIRE on certain
International® HV™, MV™ Series trucks and IC Bus®
RE commercial buses built 26 August 2021 thru 18
March 2022 with feature code 0008TXK or 0008TXM
(Bendix Wingman Prewire option)**

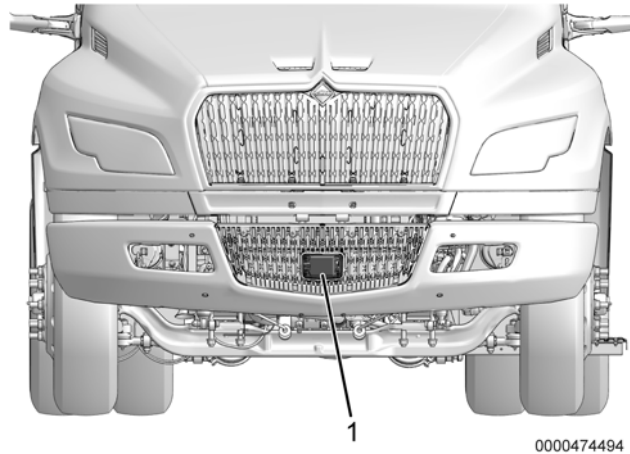
Figure 1. Radar Unit

1. Radar installed
5. Determine if forward radar is installed. Radar unit located at center of front bumper.
 - a. If radar unit is installed (Figure 1, Item 1), no additional action is required. Proceed to Step 11.
 - b. If radar unit is not installed, continue with Step 6.

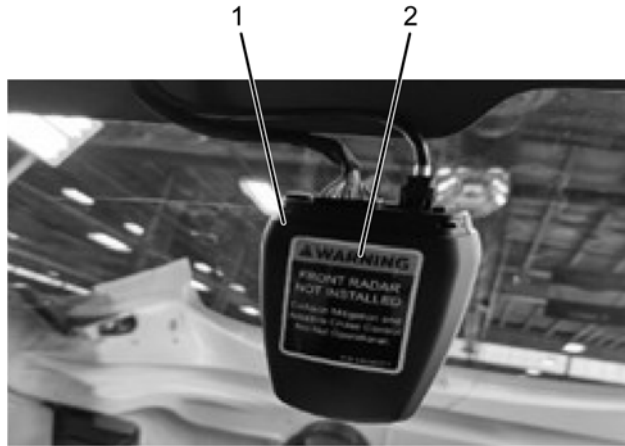
Figure 2. Camera Location

1. Camera
 2. Label
-
6. Determine if camera is installed, located at center top section of front windshield (Figure 2, Item 1).
 - a. If camera is installed, and no label is present, clean back of camera and install label (Figure 2, Item 2). Proceed to Step 11.
 - b. If camera is not installed, proceed to Step 7 (HV / MV Series Trucks) or Step 9 (RE Series Bus).

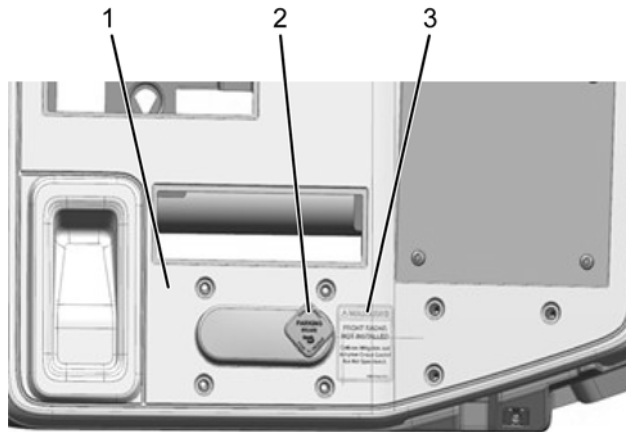
Figure 3. HV / MV Series Trucks

1. Dash panel
 2. Park brake knob
 3. Warning label
7. For HV / MV Series trucks, determine if warning label (Figure 3, Item 3) is installed adjacent to park brake knob (Figure 3, Item 2).
 - a. If label is installed, proceed to Step 11.
 - b. If label is not installed, proceed to Step 8.
 8. Clean dash panel (Figure 3, Item 1) located adjacent to park brake knob (Figure 3, Item 2) and install label (Figure 3, Item 3). Proceed to Step 11.

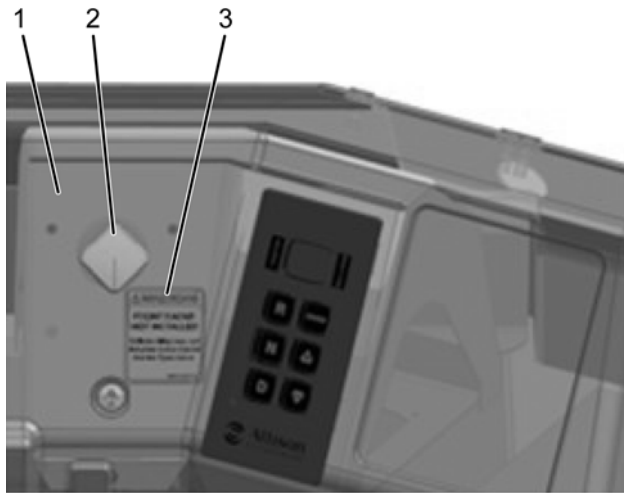
Figure 4. RE Series Bus

1. Dash panel
2. Park brake knob
3. Label

9. For RE Series buses, determine if warning label (Figure 4, Item 3) is installed adjacent to park brake knob (Figure 4, Item 2).
 - a. If label is installed, proceed to Step 11.
 - b. If label is not installed, proceed to Step 10.
10. Clean dash panel (Figure 4, Item 1) located adjacent to park brake knob (Figure 4, Item 2) and install label (Figure 4, Item 3). Proceed to Step 11.
11. Remove wheel chocks.
