Recall Campaign Bulletin

Campaign No. 2022090006, October 2022

SUBJECT: **Model GL-Class, ML-Class, and R-Class (X164, W164 and 251 platform)**
Model Year 2006-2012

Replace Brake Booster

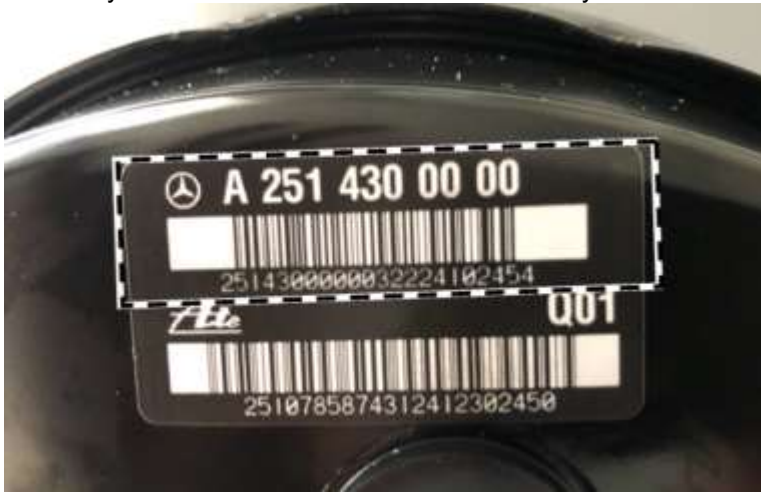
Figure 2

4. Read out serial number (figure 2) using the **Mercedes-Benz PartScan** app.

i The serial number is automatically entered in VeDoc.
 Verify the VIN reads from the vehicle correctly.

i If the PartScan app cannot be used, a **VeDoc XSF ticket** must be opened to document the new Brake Booster Serial Number. Include a **picture of the Serial Number** in the VeDoc XSF ticket and note the XSF ticket number on the workshop order.
