**ANB4 - Retrofitting Locking Caps on the Front Left and Right Headlights (Stop Delivery / Recall Campaign)**

Model Line: **Cayenne (9PA)**

Model Year: **As of 2008 up to 2010**

Concerns: **Caps on headlight**

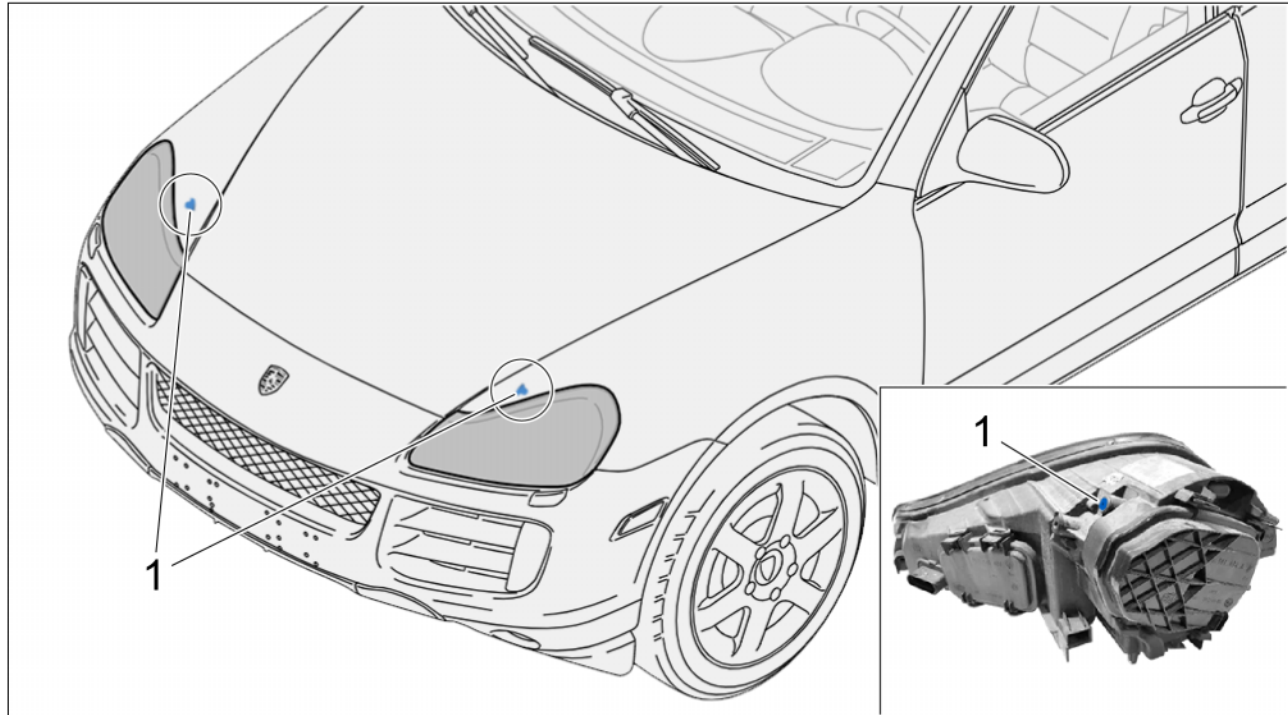
Installation position of caps

1 – Cap (retrofit)

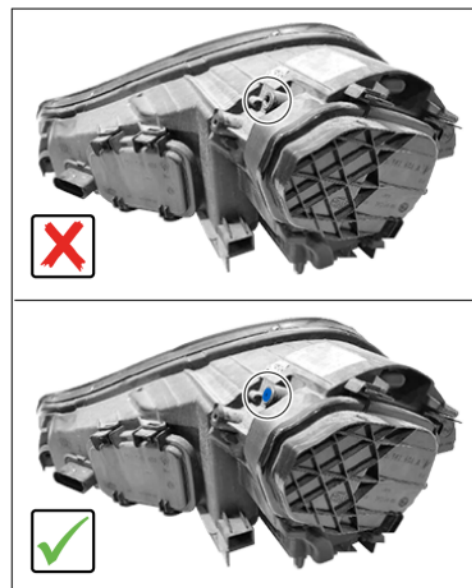
- 2 Check that a cap is installed on the adjusting screw for the horizontal adjustment on the left and right headlight. ⇒ *Checking sealing caps*

*Checking sealing caps*

Assessment		Action
(✓)	A <b>cap is installed on the left and right headlight.</b>	End of remedial action. Continue with Step 4.
(✗)	There is <b>no cap</b> or only one <b>cap installed on one headlight.</b>	Retrofit cap. Continue with Step 3.

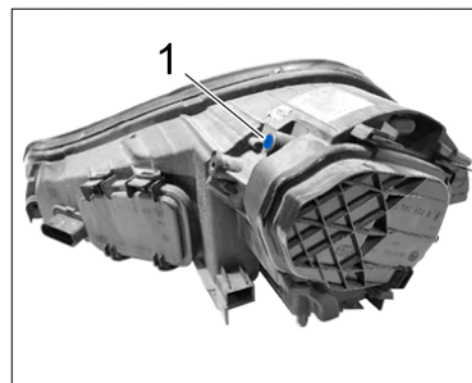
*Installing cap (e.g. right headlight)*

- 3 Press the cap on the left and right headlight into the adjusting screw for horizontal adjustment ⇒ *Installing cap (e.g. right headlight) -1-*.
- 4 Install headlights on the left and right.  
⇒ *Workshop Manual '94151900 Removing and installing main headlights'*
- 5 Enter the campaign in the Warranty and Maintenance booklet.
