SERVICE PROCEDURE

22524 / 22534
JANUARY, 2023

SUBJECT: SAFETY RECALL 22524 Variation 22534
Hex Flange Lock Nut on certain International® HV™
and MV™ Series trucks built 02/24/2022 thru
08/16/2022 and certain IC Bus® CE commercial
buses built on 02/28/2022.

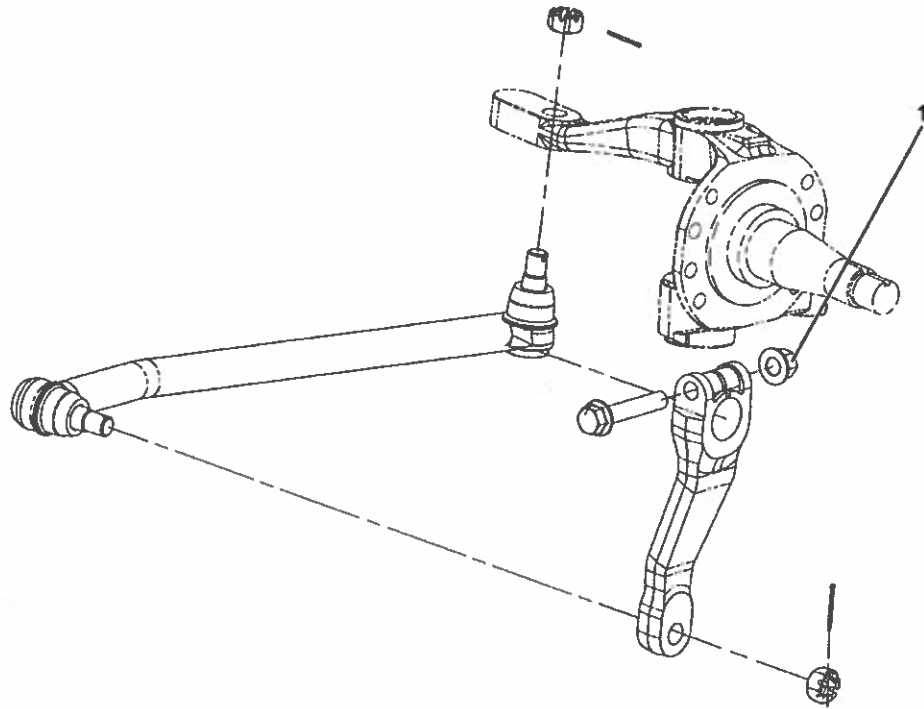
Figure 1. TRW Pitman Arm Nut

1. Nut

6. Access Pitman arm nut (Figure 1, Item 1).

NOTE: After installation of each nut, ensure at least one thread is protruding past the top edge of the nut.

7. Remove and replace nut. Using a torque wrench and backup wrench positioned on bolt, tighten nut to 330-370 lb-ft (450-500 N·m).
8. Close and latch hood.
9. Remove wheel chocks.
