# SERVICE PROCEDURE

22524 / 22531  
JANUARY, 2023

**SUBJECT:** SAFETY RECALL 22524 Variation 22531  
Hex Flange Lock Nut on certain IC Bus® 1300 FBC,  
CE, FE Chassis, SFC, and TC commercial buses  
and certain International® WorkStar® model trucks  
and certain International® CV™, HV™, and MV™  
model trucks built 01/18/2022 thru 08/16/2022.

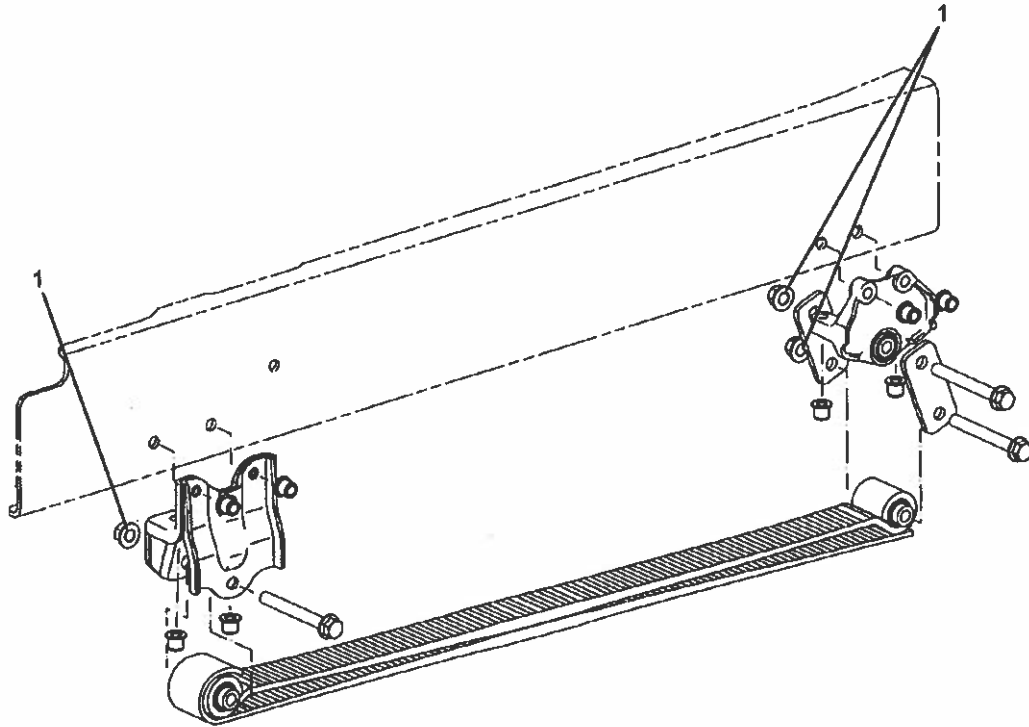
**Figure 1. Typical Steer Axle Shackle**

A specific hex flange lock nut used in several, but not all, steering and / or suspension locations may have not been properly formed and heat treated to Navistar's specifications and can result in a loss of joint tension as the vehicle ages. A loss of joint tension in these joints may affect vehicle handling and could contribute to a vehicle crash.

1. Nut (3)

7. Access nuts (Figure 1, Item 1) securing the front steer axle shackle.

**NOTE:** After installation of each nut, ensure at least one thread is protruding past the top edge of the nut.

8. Remove and replace nuts (Figure 1, Item 1). Using a torque wrench, tighten nuts to 330-370 lb-ft (450-500 N·m).

9. Repeat Steps 7 and 8 for opposite side.

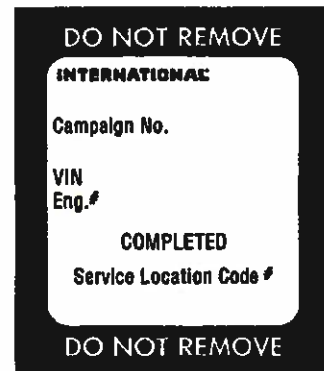
Each vehicle corrected in accordance with this campaign must be marked with a CTS-1075 Campaign Identification Label.

Complete the label and attach on a clean surface next to the vehicle identification number (VIN) plate.
