# SERVICE PROCEDURE

22524 / 22532  
JANUARY, 2023

**SUBJECT:** SAFETY RECALL 22524 Variation 22532  
Hex Flange Lock Nut on certain International® LT®,  
RH™, and Lonestar® Series trucks built 02/13/2022  
thru 08/16/2022.

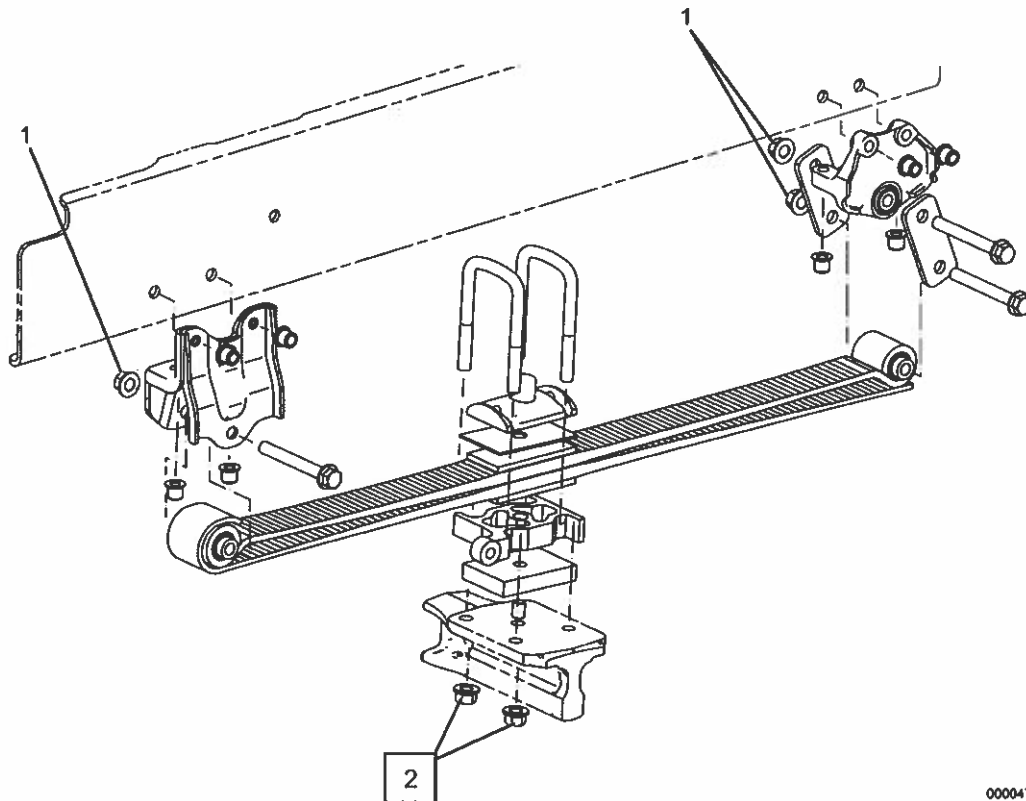
**Figure 1. Steer Axle Shackle and U-Bolt**

- 1. Shackle nut (3)
- 2. U-bolt nut (4, 2 not shown)

- 7. Access nuts (Figure 1, Item 1) securing the front steer axle shackle.

- 8. Remove and replace nuts (Figure 1, Item 1). Using a torque wrench, tighten nuts to 330-370 lb-ft (450-500 N·m).
- 9. Repeat Steps 7-8 for opposite side.
- 10. Access nuts securing U-bolt to axle (Figure 1, Item 2).

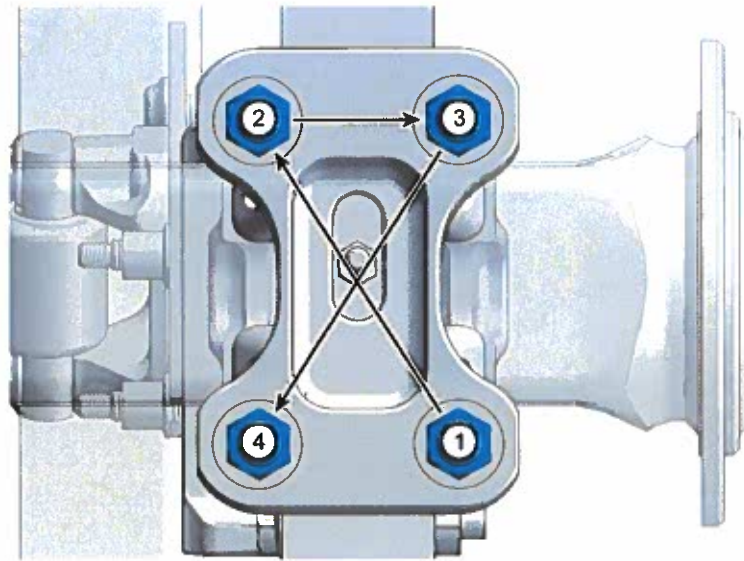
## Figure 2. U-Bolt Torque Sequence

**NOTE: U-bolt nuts require multiple stages of tightening to ensure proper installation.**

12. Vehicles equipped with Hendrickson STEERTEK™ Axle, remove and replace U-bolt nuts one at a time. Using a torque wrench, tighten U-bolt nuts using torque sequence (Figure 2):
  - a) Tighten nuts to 15 lb-ft (20 N·m)
  - b) Tighten nuts to 100 lb-ft (135 N·m)
  - c) Tighten nuts to 200 lb-ft (270 N·m)
  - d) Tighten nuts to 300 lb-ft (405 N·m)
  - e) Tighten nuts to 400 lb-ft (540 N·m)

13. Vehicles not equipped with Hendrickson STEERTEK™ Axle, remove and replace U-bolt nuts one at a time. Using a torque wrench, tighten U-bolt nuts using torque sequence (Figure 2):
  - a) Tighten nuts to 15 lb-ft (20 N·m)
  - b) Tighten nuts to 100 lb-ft (135 N·m)
  - c) Tighten nuts to 200 lb-ft (270 N·m)
  - d) Tighten nuts to 300 lb-ft (405 N·m)
14. Repeat Steps 11-13 for opposite side.
15. Raise vehicle, remove jack stands, and lower vehicle.

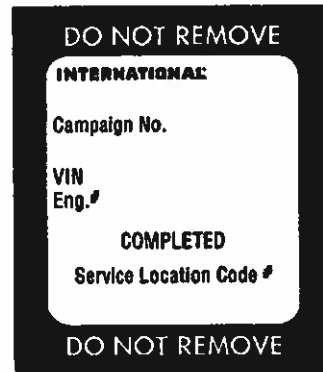
**CAMPAIGN IDENTIFICATION LABEL**

Each vehicle corrected in accordance with this campaign must be marked with a CTS-1075 Campaign Identification Label.

Complete the label and attach on a clean surface next to the vehicle identification number (VIN) plate.
