Recall Campaign Bulletin

Campaign No. 2023010005, January 2023

SUBJECT: **Model C-Class (203 platform)**
Model Year 2002-2005

Check Sliding Roof Bonding

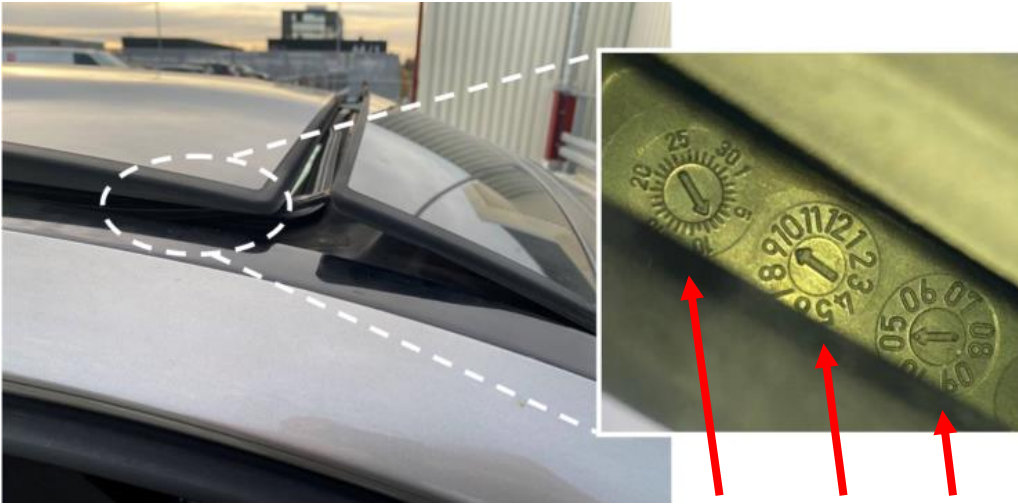
Figure 1 (The manufacturing date in the sample picture is 08 day / 10 month / 5 year) (10/08/2005)

1. **Open** panoramic sliding sunroof **approx. 3 cm** and check manufacturing date (Figure 1).

i Vehicles with a registration date that does **not** match with the manufacturing date of the panoramic sliding sunroof can also be affected.

- a. Manufacturing date is **on or after 06/30/2005**: Carry out **check/test procedure B**.
- b. Manufacturing date is **on or before 06/29/2005**: **End measure**.

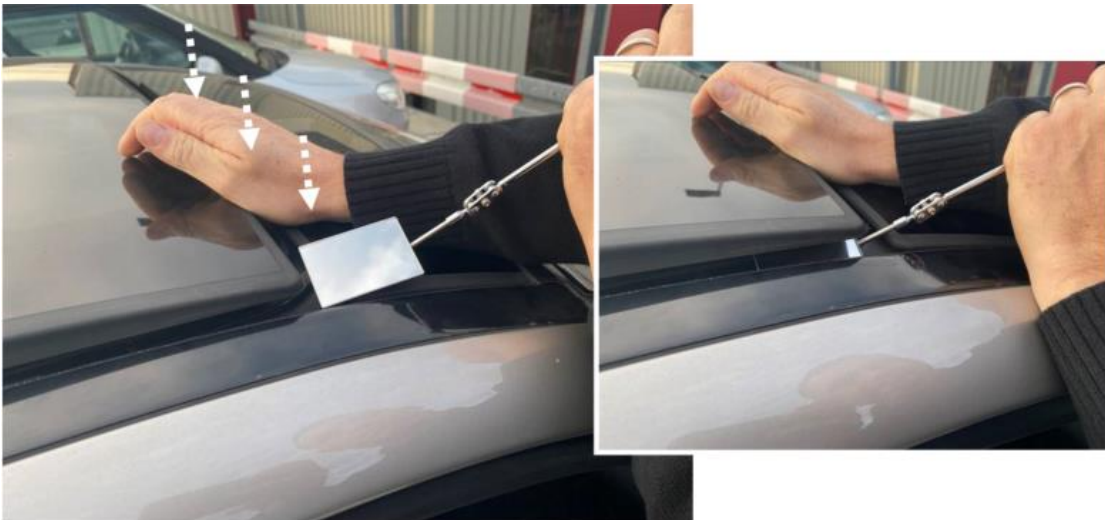
Figure 2

i Carry out check with a mirror as shown in Figure 2.

i To position the mirror, the wind deflector must be pushed downward by hand.

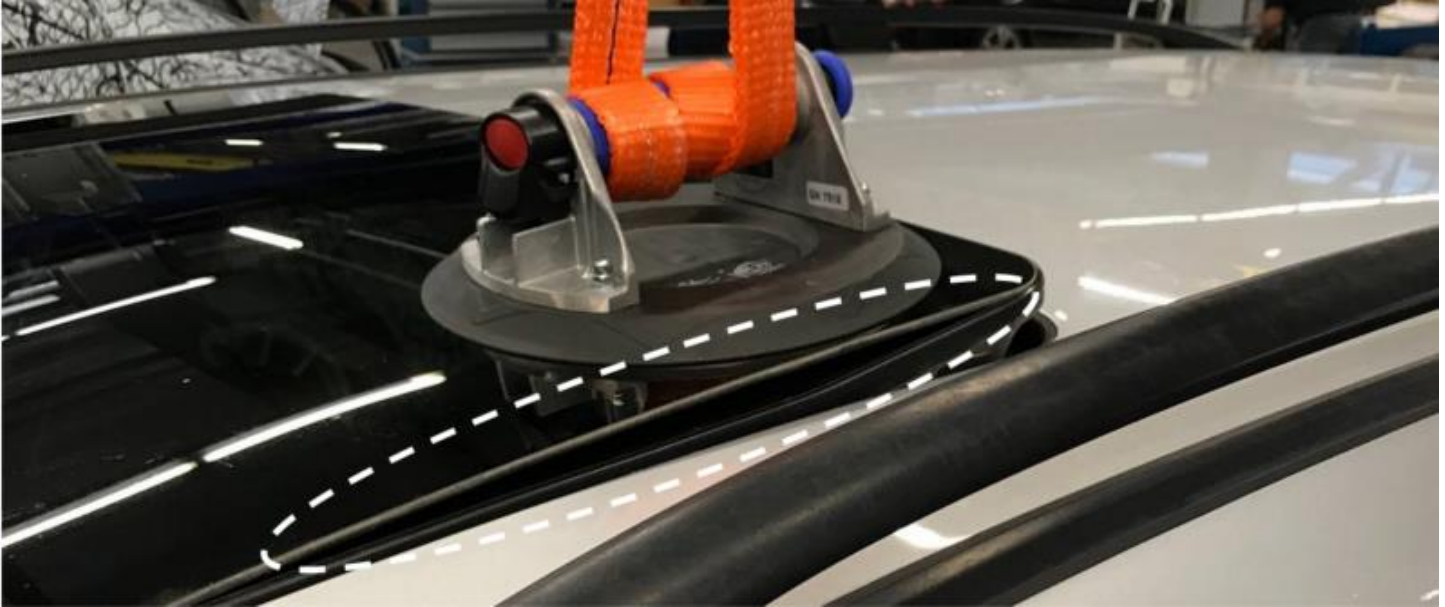
i If the panoramic sliding sunroof panel detaches from the padding of the tilting/sliding sunroof frame at one of the test positions (see Figure 5), the glass cover must be replaced.

Figure 5, not OK (shown on an SHD)

- c. If the panoramic sliding roof panel detaches from the padding: Carry out **work procedure**.
- d. If the panoramic sliding roof panel **does not** detach from the padding: Carry out operation step 4 and **end measure**.

1. Replace panoramic sliding sunroof cover (AR77.21-P-0500PB).
-
