PREVOST SAFETY RECALL SR22-05  
 NHTSA SAFETY RECALL #22E-030  
 December 2023

SR22-05 THIRD NOTICE

## IMPORTANT SAFETY RECALL – THIRD NOTIFICATION

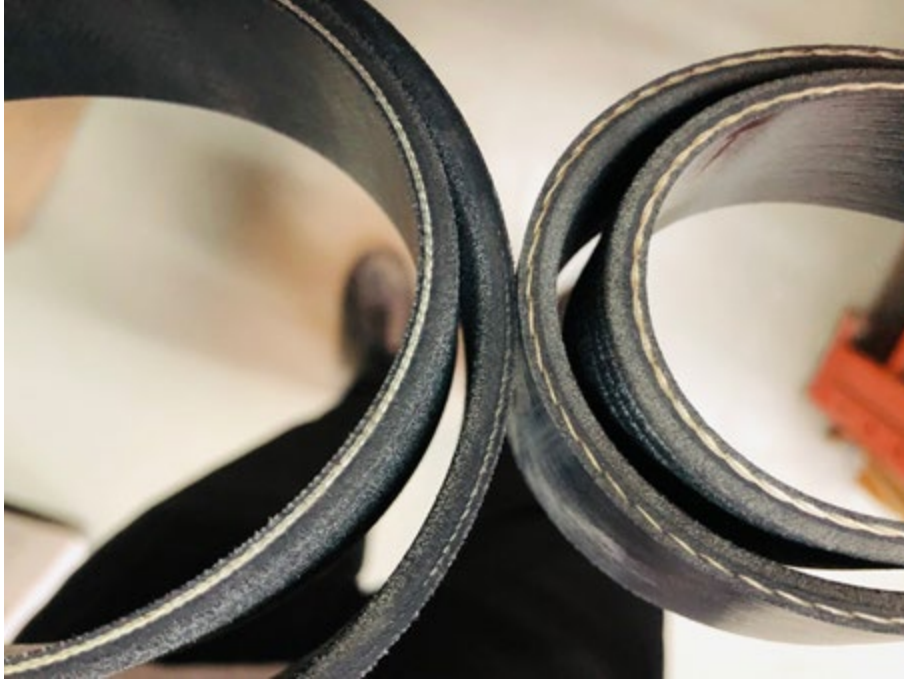
### DEFECTIVE BELT IDENTIFICATION:

**Defective Aramid cord reinforced belt (left) vs New polyester cord belt (right)  
– Note the different cord arrangement between the two belt types.**

Upon the failure of an alternator front bearing, these robust alternator belts may continue to turn the alternator bearing even after the failure.

If an alternator belt continues to turn a front damaged bearing, it could overheat causing a local fire

If belts are installed, Prevost will change the defective belts for polyester belts free of charge (parts and labor) under safety recall SR22-05 and safety recall SR22-83 and send a distinct notification letter to the owners of the affected vehicles. If one of your current vehicle is equipped with a belt listed above, these recall will instruct you how to proceed to get the proper remedy program.
