R22CD

Subject: R22CD: Parts 1192 ADA Noncompliance Minimum Handrail Diameter

IMPORTANT SAFETY RECALL NOTICE

INCORRECT HANDRAIL DIAMETER

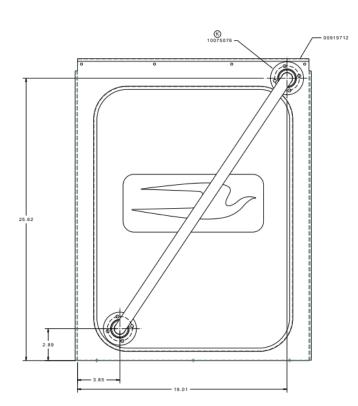
Issue: The stepwell grab rail is 1" and needs to be 1.25".

Corrective Action: Remove and replace grabrail.

Step 1: Remove grab rail Step 2: Install grab rail
