FMVSS Noncompliance Recall

N222359830 Taillamp Malfunction

Release Date: March 2022

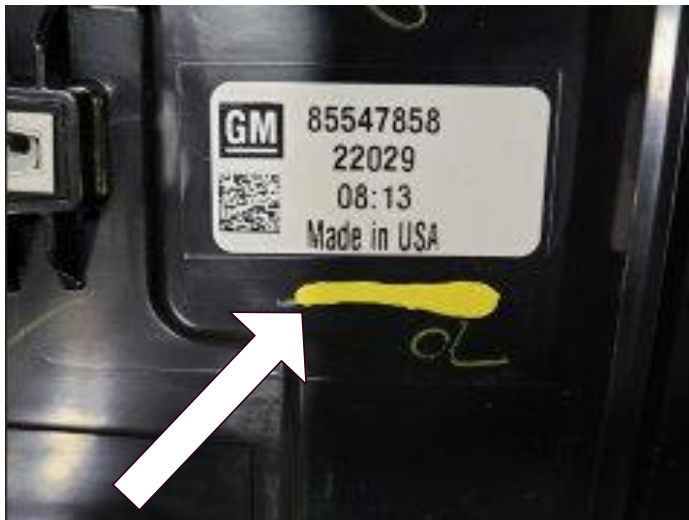
6001474

NOTE: There may be other yellow paint or crayon markings on the lamp housing in this area. These other markings do not affect this inspection.

- If the lamp housing **has a yellow paint stripe** below the part number label, no further action is required. Reinstall the assembly.
 - If the lamp housing **does not have a yellow paint stripe** below the part number, replace the lamp assembly.
2. Reinstall the left and right rear body structure stop lamp (taillamp assembly). Refer to *Rear Body Structure Stop Lamp Replacement* in SI.

1. Remove the left and right rear body structure stop lamps (taillamp assembly). Refer to *Rear Body Structure Stop Lamp Replacement* in SI.
