SERVICE BULLETIN

Vermeer Corporation

FIELD CAMPAIGN SERVICE BULLETIN #: SVC2022-136

Tongue Replacement
Kit
(IK004226)

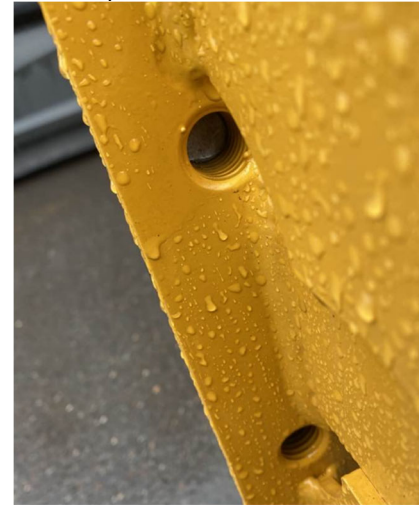
During manufacturing, improper length mounting bolts were installed causing damage to the tapped threads. Inadequate thread engagement of the mounting bolts may result in bolt failure leading to pintle hitch separation from the tongue/towbar. See **photos below**.

IMPROPER LENGTH BOLT
(Bolt engaged in approximately 1/3 of tapped hole)

If **improper length bolts** are installed (see photo to the right), contact your local Vermeer dealer to make arrangements for the dealer to **replace the tongue and pintle hitch bolts**.

IK004266 has been created to provide the necessary parts and instructions to replace the tongue and pintle bolts of proper length. **The kit must be installed as soon as possible.**

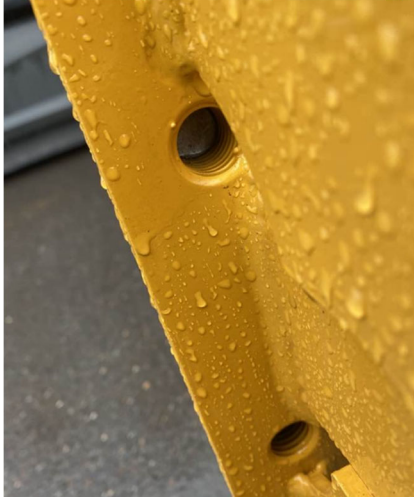
During manufacturing, improper length mounting bolts were installed causing damage to the tapped threads. Inadequate thread engagement of the mounting bolts may result in bolt failure leading to pintle hitch separation from the tongue/towbar. See **photos below**.

| <p>If improper length bolts are installed (see photo to the right), contact your local Vermeer dealer to make arrangements for the dealer to replace the tongue and pintle hitch bolts.</p> <p>DO NOT:</p> <ul style="list-style-type: none"> tow the brush chipper on public roadways, or operate the brush chipper as operation applies forces to the pintle hitch which may cause the improper length bolts to break resulting in injury and/or brush chipper damage. | <p style="text-align: center;">IMPROPER LENGTH BOLT (Bolt engaged in approximately 1/3 of tapped hole)</p> |

IK004266 has been created to provide the necessary parts and instructions to replace the tongue and pintle bolts of proper length. **The kit must be installed as soon as possible.**
