SAFETY RECALL N720 H412 – Autoliv Seat belt Retractor Functionality

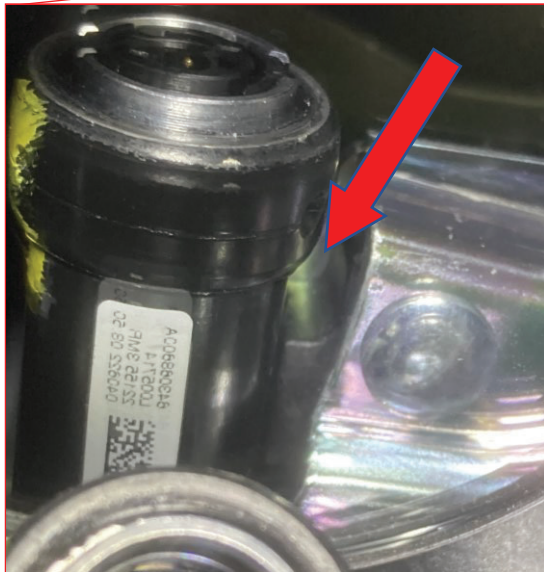
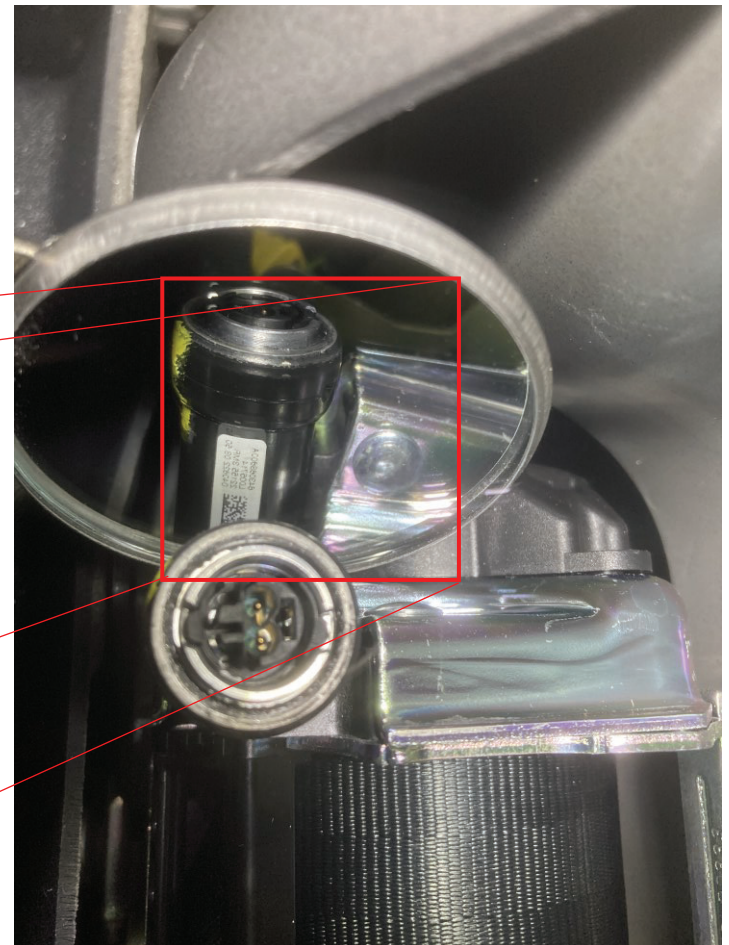
- Seatbelt pretensioner inspection
 - Using a suitable mirror, carefully inspect the pretensioner for any damage where the activator tube mounts to the seatbelt reel assembly.
 - Any sign of damage requires a seatbelt assembly replacement.
