LP Quick Connect Recall: Self check

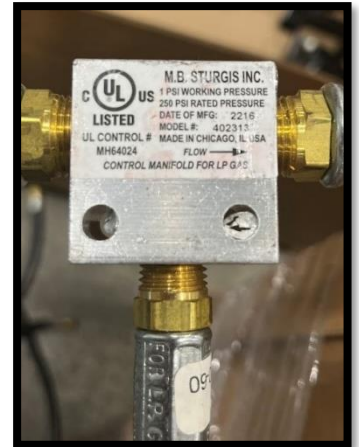
Figure 1: LP Manifold

1. Check if your VIN is in scope:
 - 7RVTV1228NA000010 to 7RVTV1220NA000062
 - 7RVTV1221NA000085 to 7RVTV1227NA000110
 - 7RVTV1207NA000591 to 7RVTV1207NA000638
2. If your VIN is in scope, that does not necessarily mean your quick connect is defective.
3. Inspect one of the LP manifolds located beneath the coach. If the manifold is labeled with "M.B. Sturgis INC", this unit does not require replacement of the quick connect.
4. If step 3 is unsuccessful, inspect the quick connect. The quick connect will not require replacement if the flow lever or coupler is labeled with M.B. Sturgis,
5. The quick connect will require replacement if:
 - MH60896 is visible on the body of the fitting
 - If "ENERCO" or "76290W" is visible on the coupler

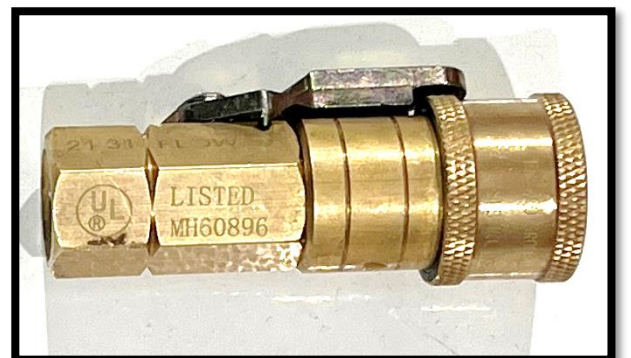
Figure 3: Enerco / Flextech Quick Disconnect

Note: these markings may be difficult to see and may require brass cleaner or tracing with a black felt marker. The coupler for the Flextech/Enerco quick connect is commonly brass
6. After completing steps 3 through 6:
 - Contact your dealer if your unit requires replacement of the quick connect
 - Contact Ember Ownership Experience if your unit does not require a replacement. This will remove your name from future mailings regarding this recall and assist us in tracking recall completion.
