**Recall Campaign Launch Notification**

<b>Campaign No. :</b>	<b>NHTSA ID / CA DMV :</b>	<b>Campaign Desc. :</b>
2023070012	23V445	23P4790205

**Replace Fuel Pump Delivery Module – Wave 6**

## **Replace Fuel Pump Delivery Module – Wave 6**

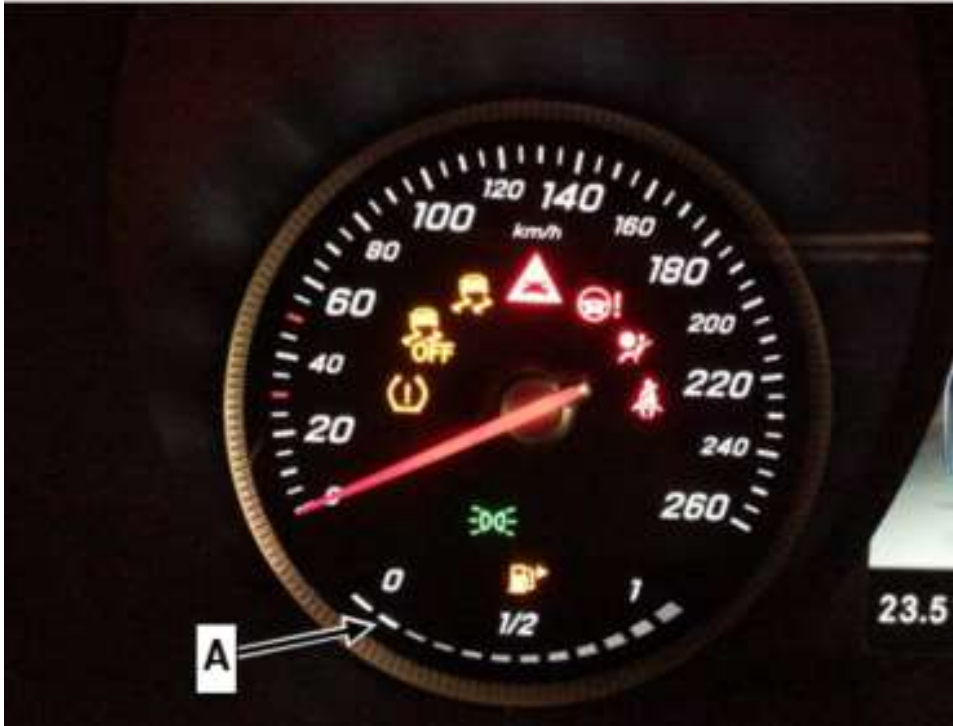
**Figure 1** (shown on model 205)

The fuel tank may only be filled up to a **maximum of 20%**.

**i** This corresponds to two lines (A) on the fuel display (**Figure 1**).

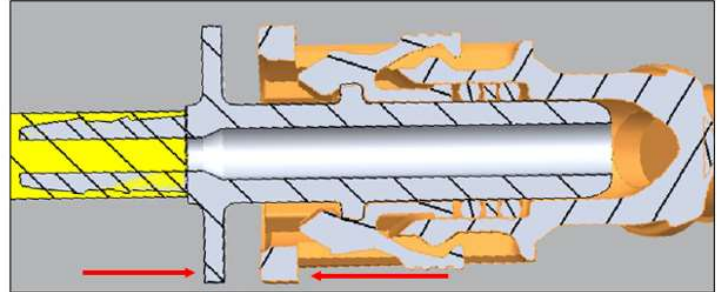
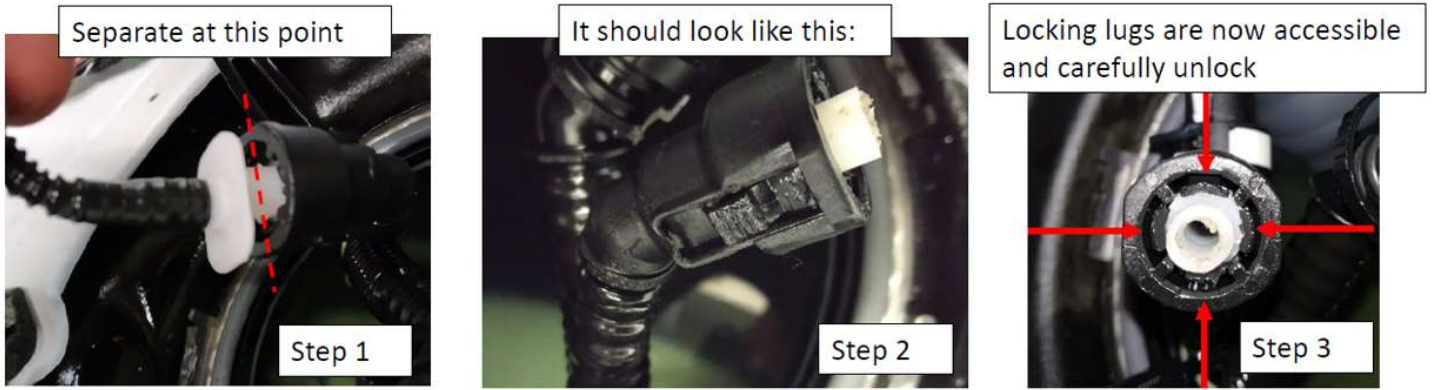
Figure 2

**i** Only model 206, 232: Note on disassembly of suction jet pump drive line quick connector. The procedure step 1-3 should only be performed when the quick disconnect is not working (Figure 2).

## MRA2 Quick Connector suction jet pump drive line

Squeeze the QC connection by at least 1mm, then unlock the latching lugs. If this is not possible. Step 1 -3
