**Recall Campaign Launch Notification**

<b>Campaign No. :</b>	<b>NHTSA ID / CA DMV :</b>	<b>Campaign Desc. :</b>
2023070012	23V445	23P4790205

**Replace Fuel Pump Delivery Module – Wave 6**

Campaign No. 2023070012, May 2024

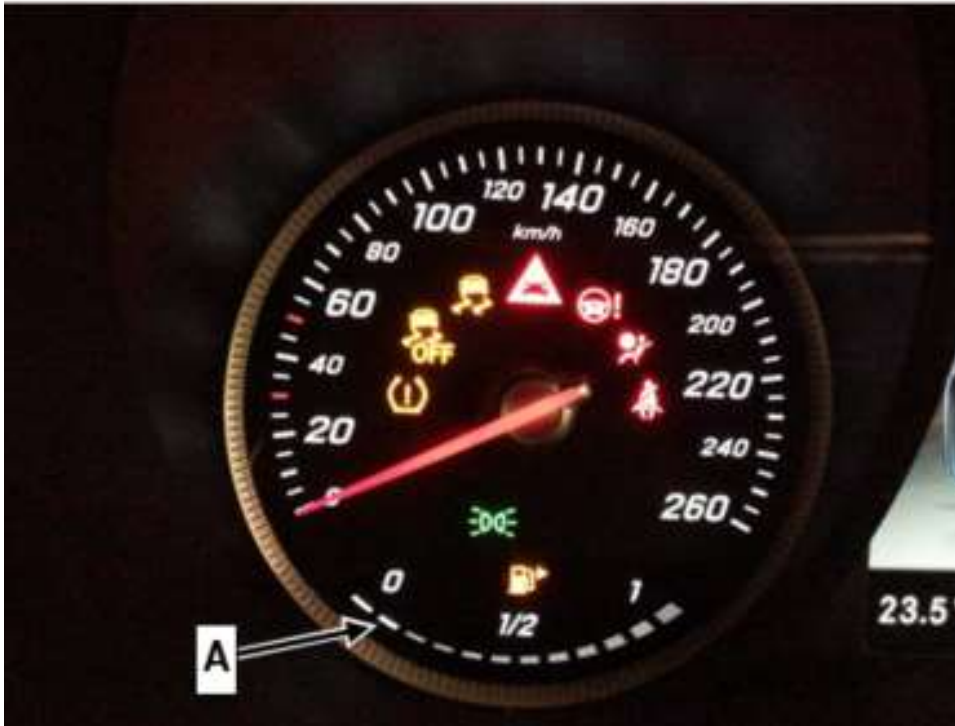
Figure 1 (shown on model 205)

**i** This corresponds to two lines (A) on the fuel display (**Figure 1**).

The fuel tank may only be filled up to a **maximum of 20%**.

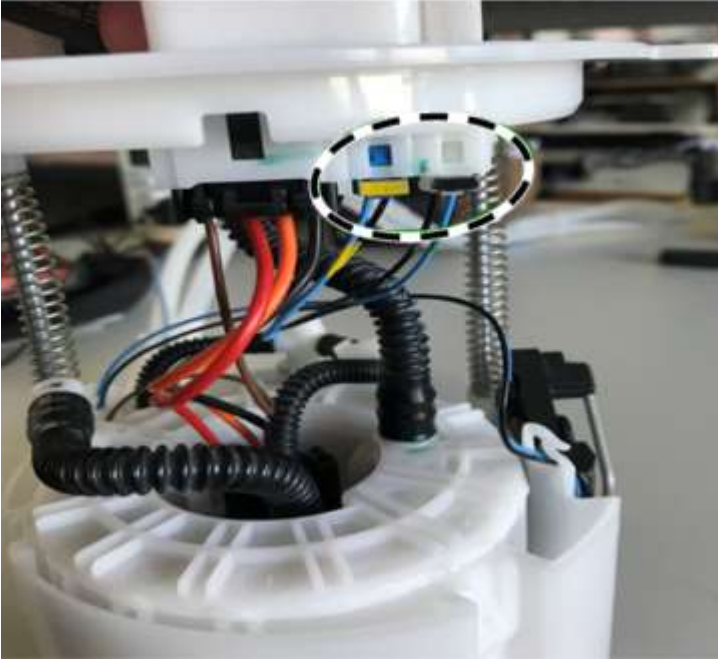
**Figure 3** (release corresponding connector and disconnect the contacts)

**i** Delivery modules that are delivered **without float-and-lever sensor** must be modified. (Figures 3-5)

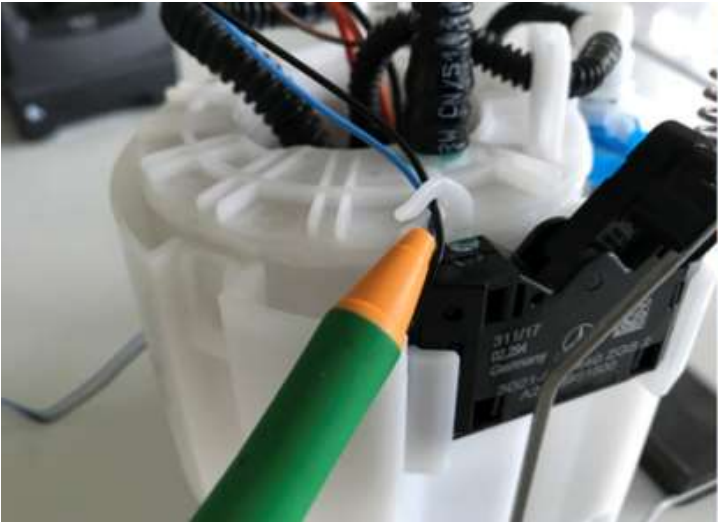
**Figure 4** (remove lines from routing clip)

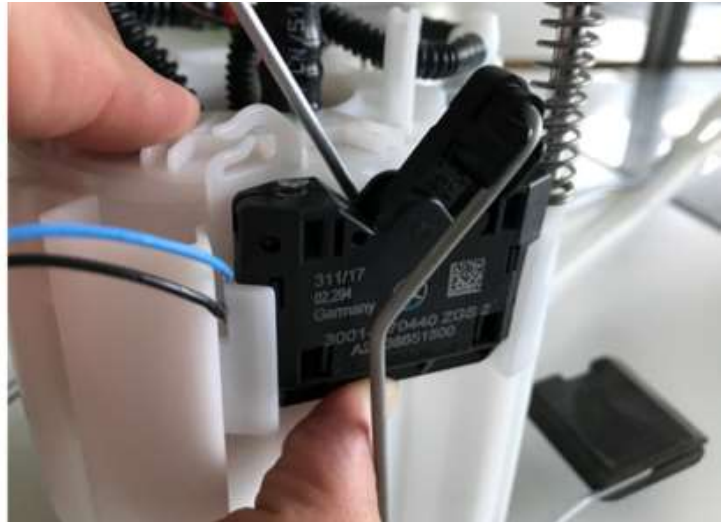
**Figure 5** (using a screwdriver, carefully push float-and-lever sensor housing away from module housing and at the same time push float-and-lever sensor housing upwards.)
