**Recall Campaign Launch Notification**

<b>Campaign No. :</b>	<b>NHTSA ID / CA DMV :</b>	<b>Campaign Desc. :</b>	<b>Replace Fuel Pump Delivery Module – Wave 6</b>
2023070012	23V445	23P4790205

Campaign No. 2023070012, May 2024

## **Replace Fuel Pump Delivery Module – Wave 6**

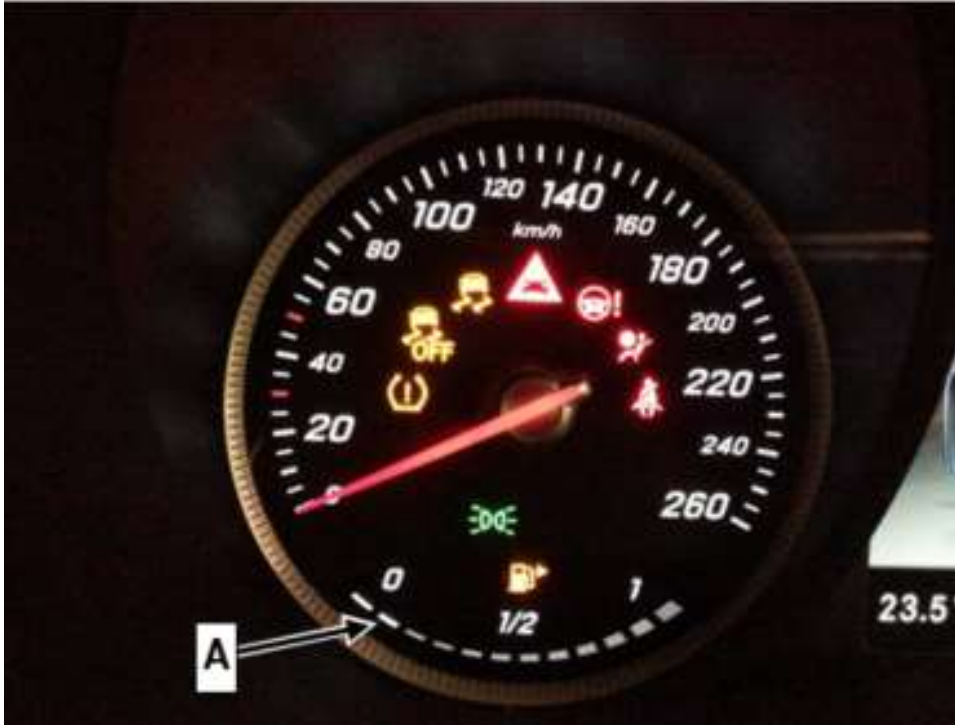
Figure 1 (shown on model 205)

The fuel tank may only be filled up to a **maximum of 20%**.

**i** This corresponds to two lines (A) on the fuel display (**Figure 1**).

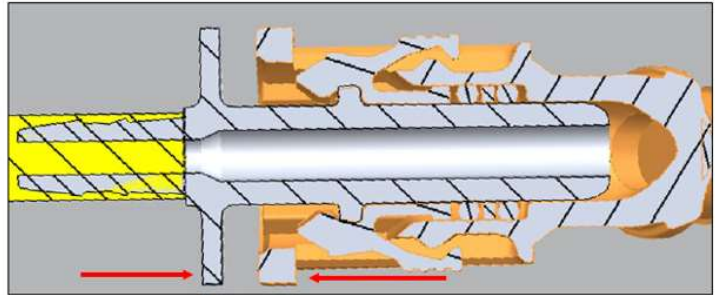
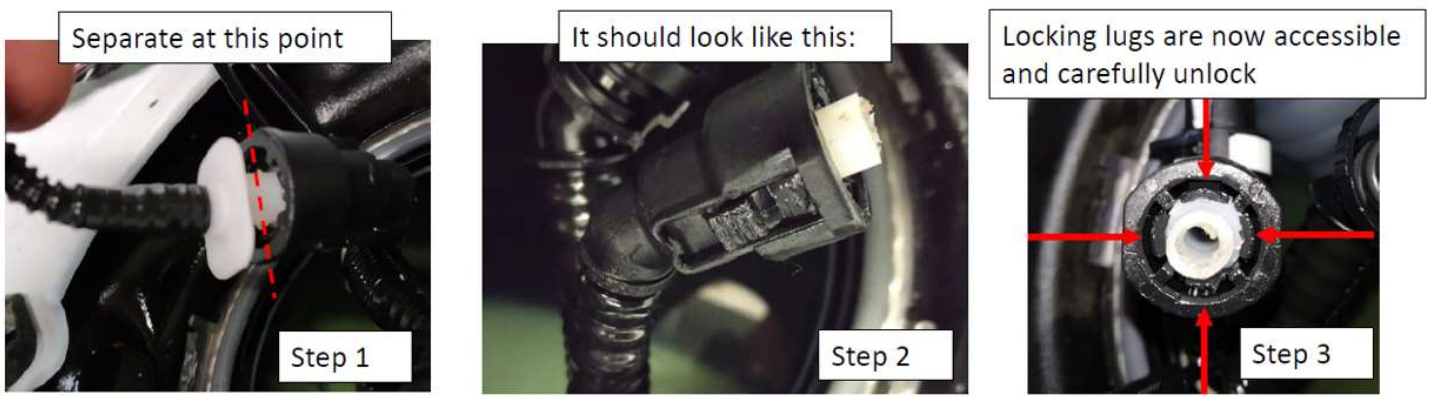
**Figure 2**

**i** Only model 206, 232: Note on disassembly of suction jet pump drive line quick connector. The procedure step 1-3 should only be performed when the quick disconnect is not working (**Figure 2**).

## MRA2 Quick Connector suction jet pump drive line

Squeeze the QC connection by at least 1mm, then unlock the latching lugs. If this is not possible. Step 1 -3

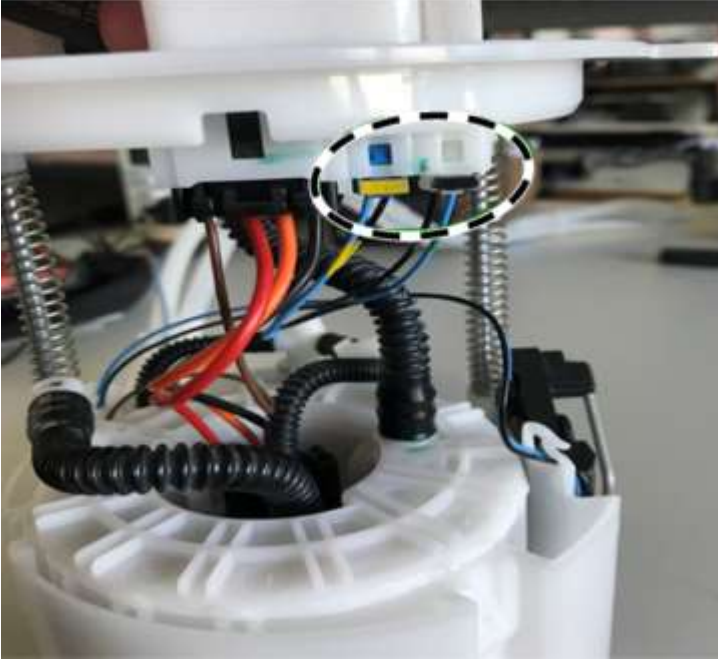
**i** Delivery modules that are delivered **without float-and-lever sensor** must be modified. (Figures 3-5)

**Figure 3** (release corresponding connector and disconnect the contacts)

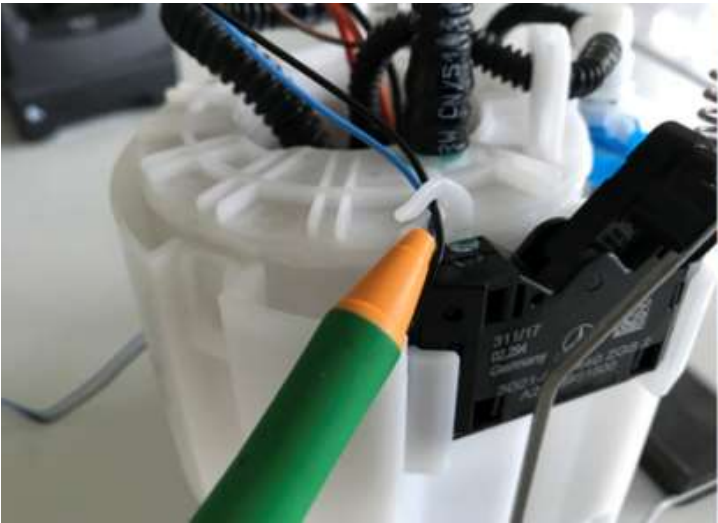
**Figure 4** (remove lines from routing clip)

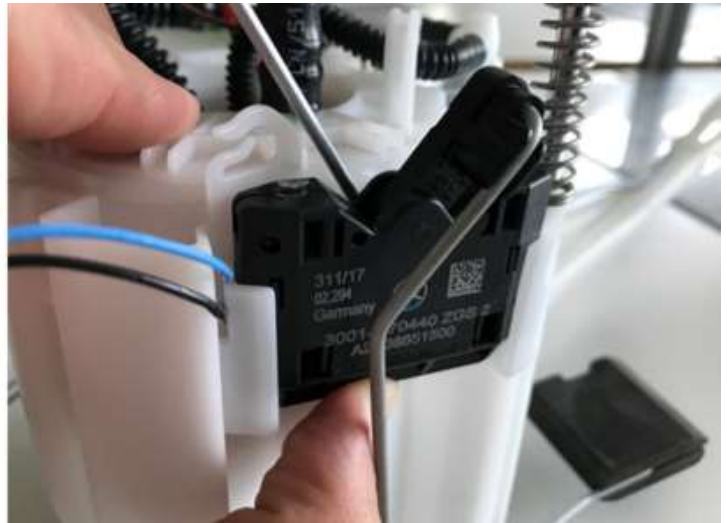
**Figure 5** (using a screwdriver, carefully push float-and-lever sensor housing away from module housing and at the same time push float-and-lever sensor housing upwards.)

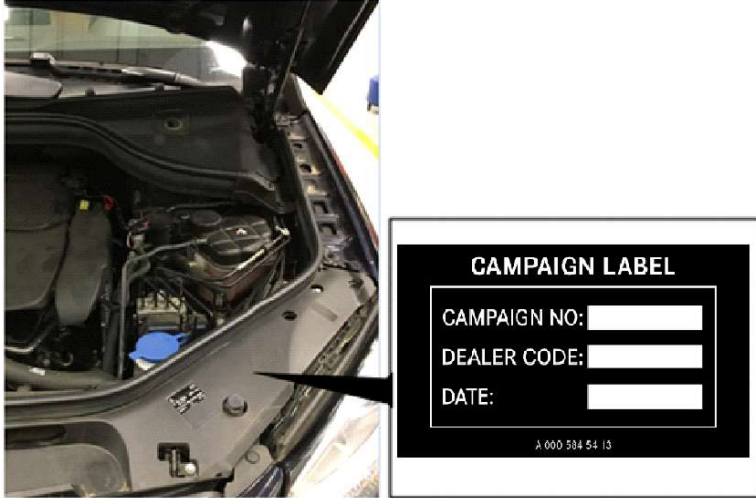
**Figure 1**

Apply Proof of Correction Label (A 000 584 54 13) to area identified in **Figure 1**. Fill in the blank areas of the label. The “**Campaign No.**” for the California Proof of Correction is unique and must be entered as such (23V445), your “**Dealer Code**”, and the “**Date**” of the repair, using a black permanent marker.

**i** Note: Clean bonding surface prior to affixing label.
