TO: Mercedes-Benz Dealer Principals, General Managers, Sales Managers, Service Managers, Parts Managers	FROM: Gregory Gunther, Senior Manager, Vehicle Compliance and Analysis, Engineering Services
RE: Recall Campaign Launch Notification Replace Fuel Pump Delivery Module - Wave 4 MY21-23 C-Class, E-Class, CLS, S-Class, SL, GT, GLC, GLE, GLS and G-Class (205/206, 213/238, 257, 223, 232, 290, 253, 167 and 463 platforms)	DATE: December 29, 2023

Replace Fuel Pump Delivery Module – Wave 4

Replace Fuel Pump Delivery Module

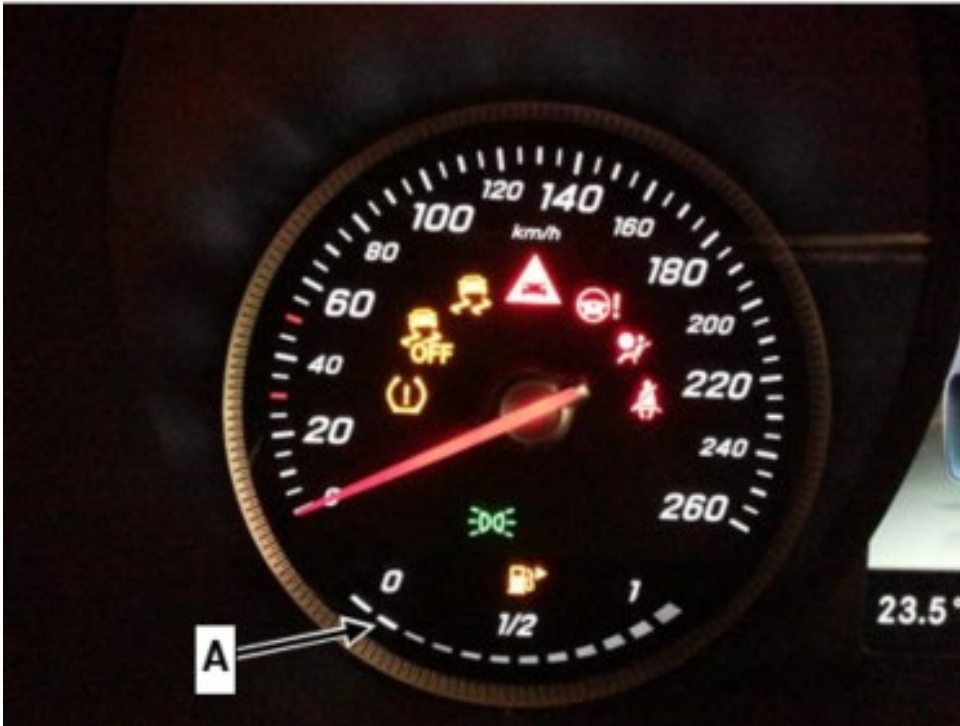
Figure 1 (shown on model 205)

- i** The fuel tank may only be filled up to a **maximum of 20%**.
- i** This corresponds to two lines (A) on the fuel display (**Figure 1**).

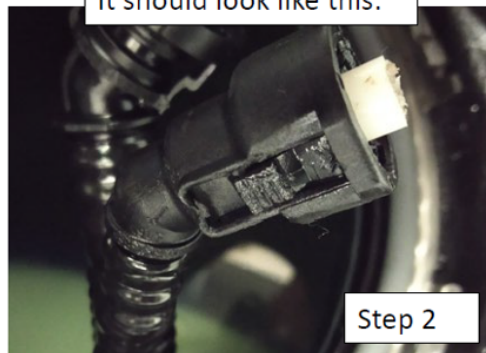
Figure 2

i **Only model 206, 232:** Note on disassembly of suction jet pump drive line quick connector.

The procedure step 1-3 should only be performed when the quick disconnect is not working (**Figure 2**).

MRA2 Quick Connector suction jet pump drive line

Squeeze the QC connection by at least 1mm, then unlock the latching lugs. If this is not possible. Step 1 -3

Min. - 1 mm

Separate at this point

Step 1

It should look like this:

Step 2

Locking lugs are now accessible and carefully unlock

Step 3

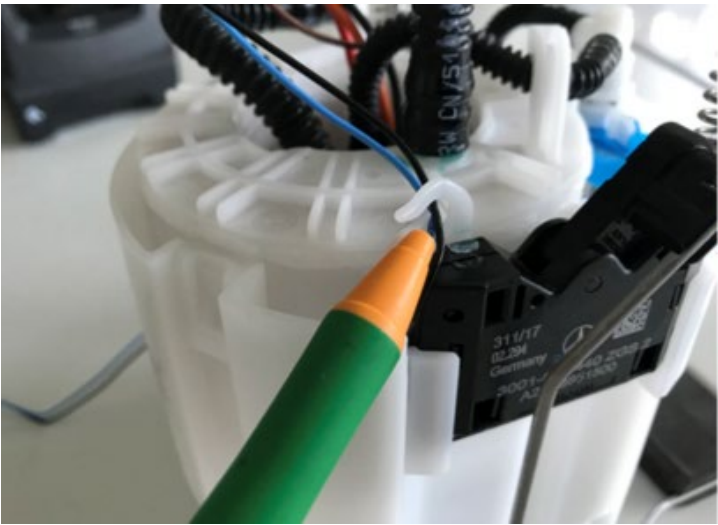
Figure 4 (remove lines from routing clip)

i Delivery modules that are delivered **without float-and-lever sensor** must be modified. (Figure 3-5)

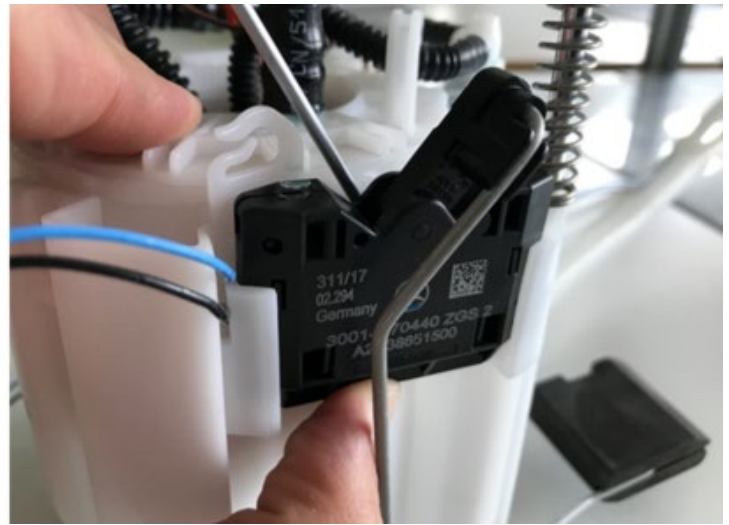
Figure 5 (using a screwdriver, carefully push float-and-lever sensor housing away from module housing and at the same time push float-and-lever sensor housing upwards.)
