Campaign No. 2024040012, June 2024

SUBJECT: **Model G-Class (463 platform)**  
**Model Year 2022 – 2023**

## **Replace Rear Axle Differential Housing – Wave 1**

Mercedes-Benz AG, the manufacturer of Mercedes-Benz vehicles, has determined that on certain MY 2022-2023 AMG G63 (463 platform) special edition 4x4<sup>2</sup> (squared) vehicles, the rear axle differential housing might not meet the strength requirements. Cracks in the rear axle differential housing might occur during vehicle operation, which may lead to differential oil leaking onto the roadway. In this case, a risk of a crash for following vehicle traffic may be increased. Further, fracturing of the housing cannot be ruled out and could lead to an interruption of the power transmission on the rear axle, in which a loss of wheel guidance and a loss of propulsion without warning cannot be ruled out. In this case, the risk of a crash or injury could be increased. An authorized Mercedes-Benz dealer will replace the rear axle on the affected vehicles.

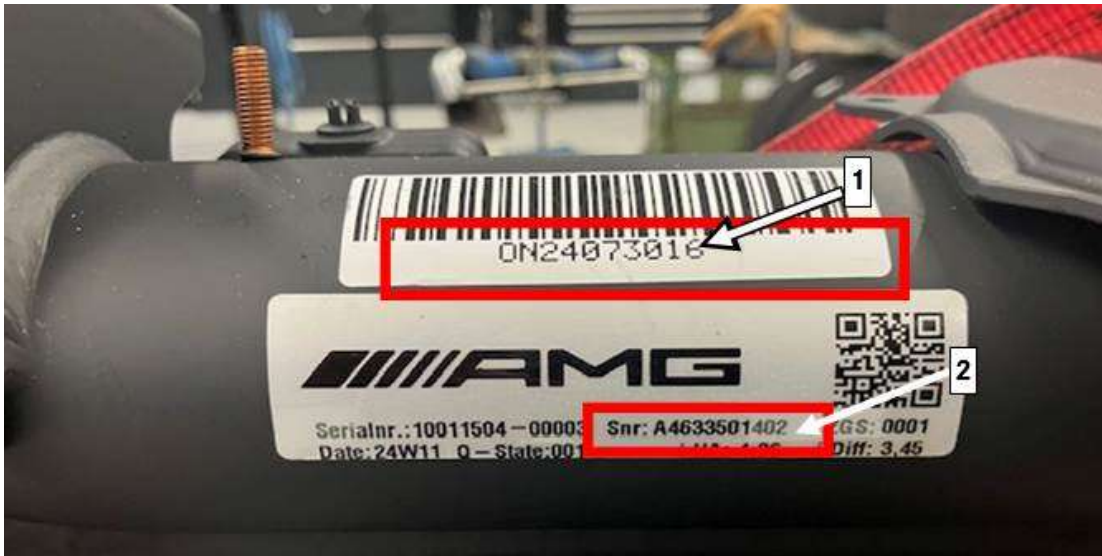
Figure 1

**i** Serial number (**Figure 1, 1**) and item number (**Figure 1, 2**).

**i** After the **rear axle centerpiece** has been replaced, the new **serial number** and **item number** must be documented in **VeDoc**. This can be done by opening a “**Vehicle Data/VeDoc**” XSF ticket and providing a picture of the new serial number and item number.

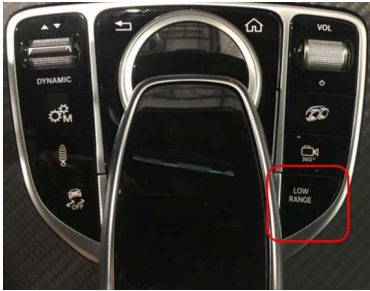
Figure 3

**i** **The rear axle must be removed with the lock actuator set to lock position.**  
**i** **To do this:** Start the engine – Release the parking brake – Engage Neutral position (N) – Engage Low Range (**Figure 3**) – Engage Drive position (D) – Engage Center Differential Lock (**Figure 4, 1**) – While wheels are rotating slowly, Engage Rear Axle Differential Lock (**Figure 4, 2**) – Ensure red confirmation light is illuminated for Center and Rear Differential Lock (**Figure 4**) – Switch 'OFF' Ignition – Disconnect electrical plug on Lock Actuator of rear axle and leave disconnected (**Figure 5**).

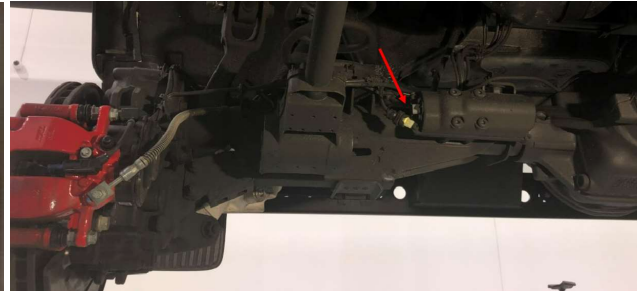
Figure 5

2. When the vehicle wheels are **lifted** off the ground, engage the rear axle differential lock actuator and then disconnect the electrical plug on the rear axle lock actuator while the lock is engaged.

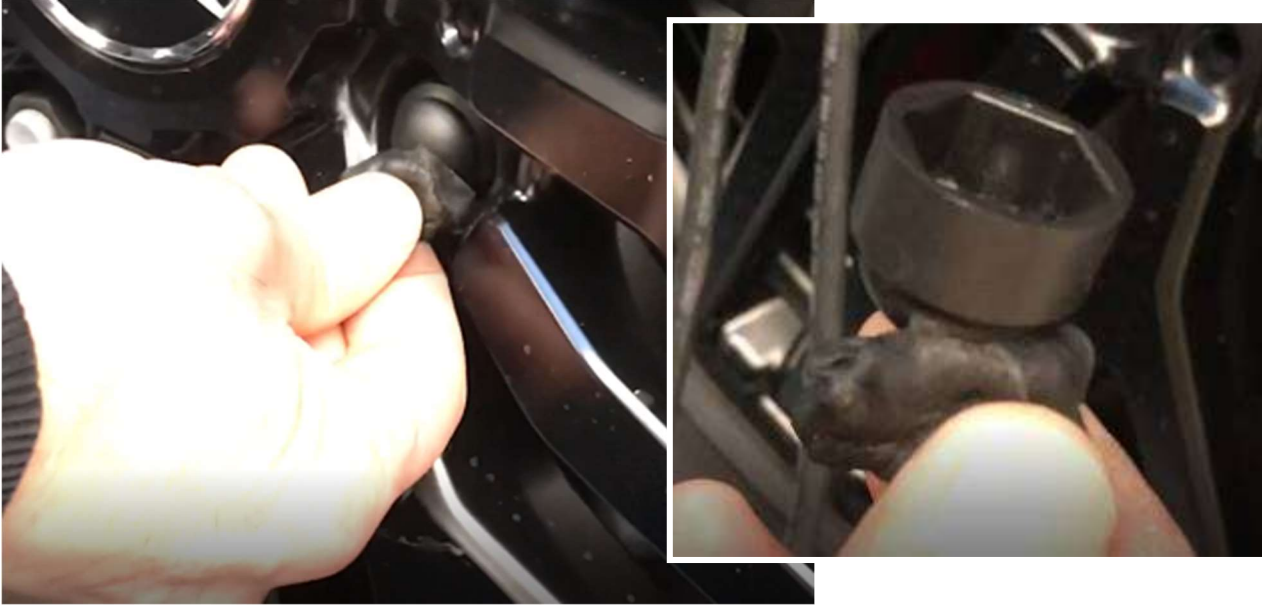
**Figure 7**

5. Remove cover caps of wheel nuts on all four wheels (**Figure 7**).

**i** To do this, clean cover caps then press Butyl Tape firmly against the cover cap and pull off the cap.

**i** Damaged cover caps must be replaced.

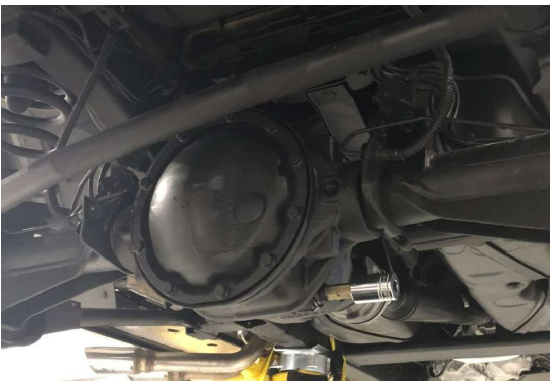
**Figure 8**

7. Drain rear axle oil (**Figure 8**).

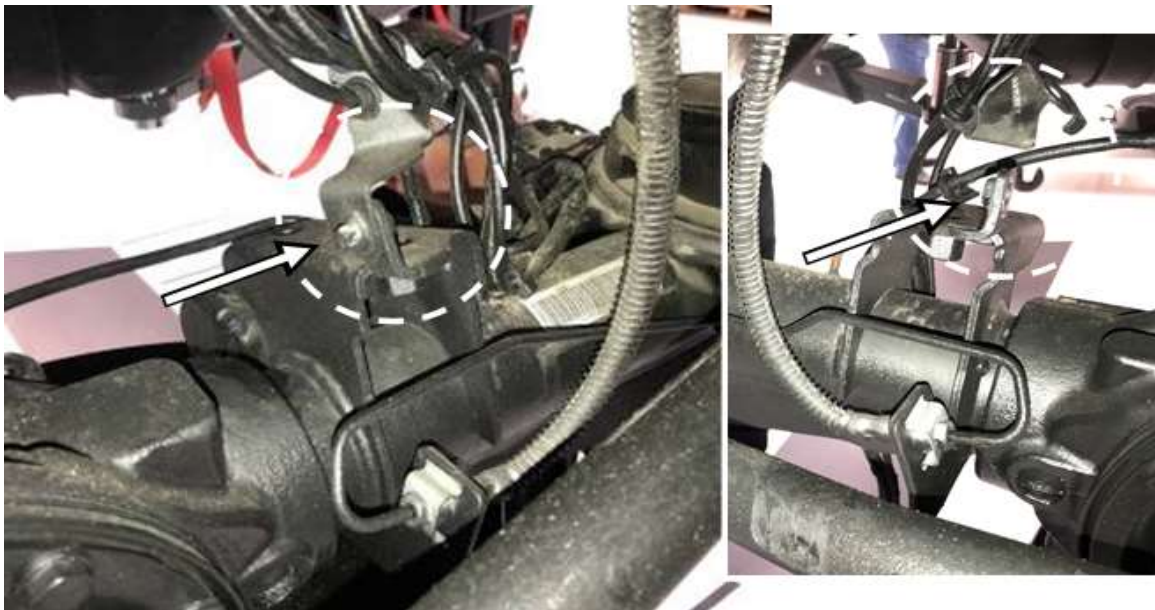
**Figure 10**

9. Unscrew the two holders for electrical wiring harness from the rear axle tube. (**Figure 10**).

Remove the complete rear axle wiring harness with holders and cable ties/clips from the rear axle and working area.

**i** Only replace defective cable ties/clips when installing the wiring harness onto the new axle bridge to ensure that the positioning of the wiring harness remains identical.

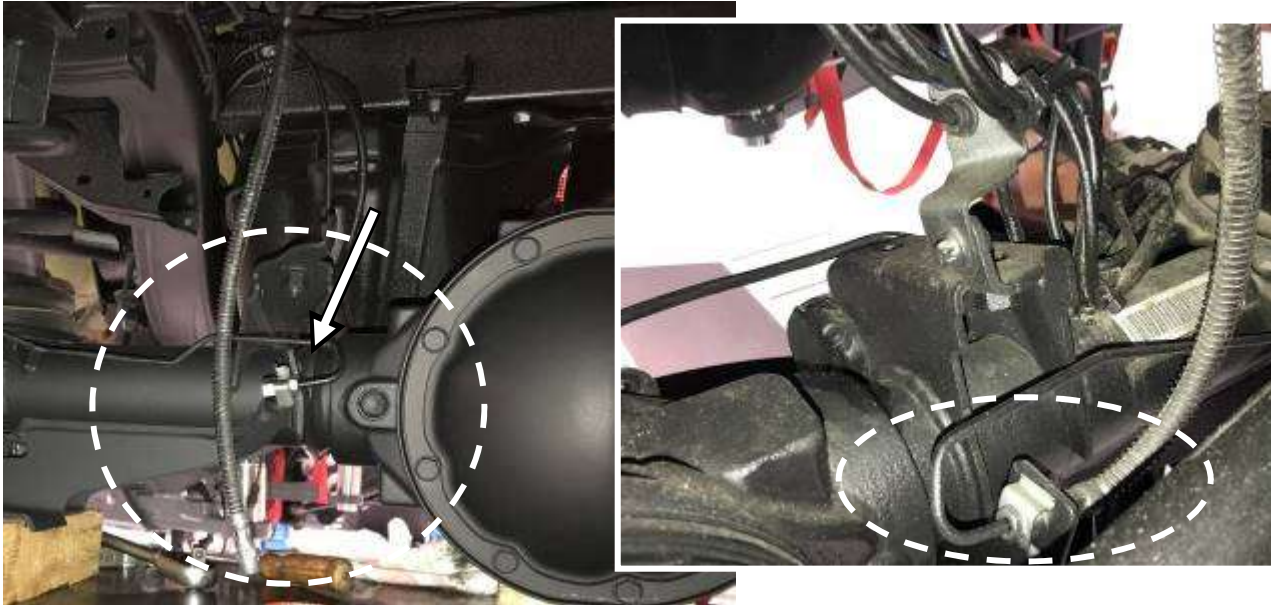
Figure 13

12. Unscrew brake hoses from brake lines on inside of axle (**Figure 13**) and seal open brake lines with suitable stop plugs (e.g. W129 589 00 91 10).

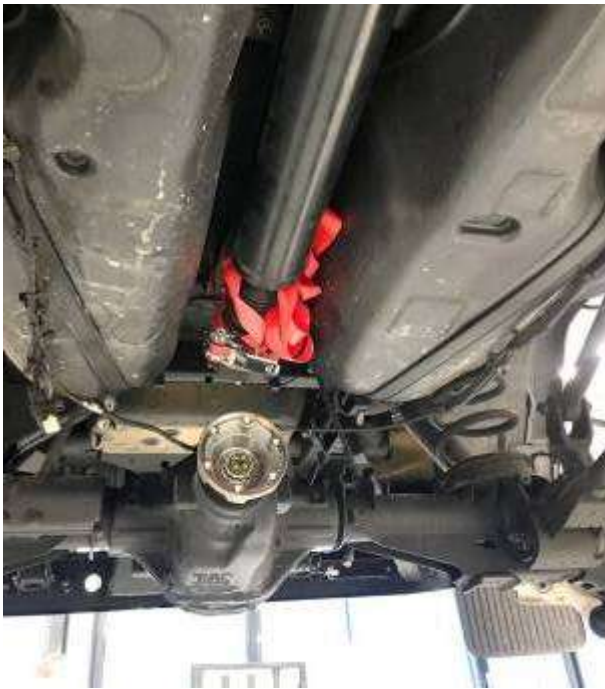
Figure 14

13. Unscrew propeller shaft at rear axle differential, and secure from falling by tying to the top (**Figure 14**).

**Nm** Propeller shaft screws at rear axle differential: **Stage 1: 40 Nm**  
**Stage 2: 90°**

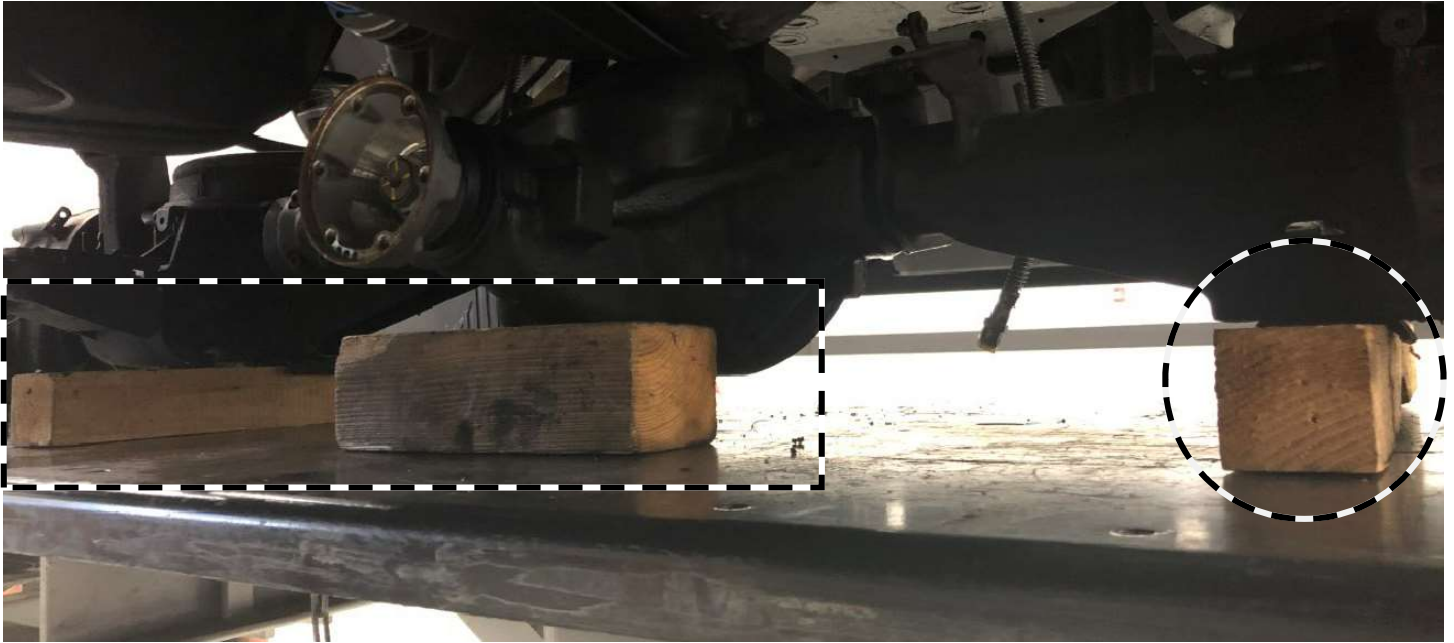
Figure 15

14. Position Lift table (W 000 588 03 62 00) under rear axle and use tension belt (**Figure 16**) to secure against falling.  
**i** Place a support block with a width of approx. 5.5 cm (e.g. a hardwood block), under the axle at the left and right and under the center front section of the differential to ensure that the rear axle is evenly supported (**Figure 15**).

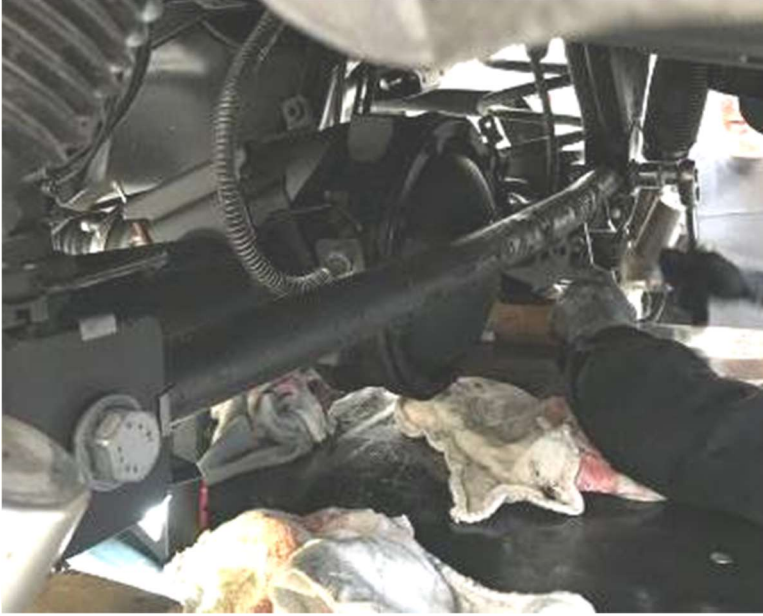
**Figure 17**

16. Remove transverse control arm of rear axle (**Figure 17**).

**Nm** Transverse control arm screw to rear axle: **Stage 1: 150 Nm**  
**Stage 2: 90°**

**Nm** Transverse control arm screw to frame: **Stage 1: 150 Nm**  
**Stage 2: 90°**

**i** During installation, the transverse control arm at the rear axle **must be fit into the bearing using a shim**.

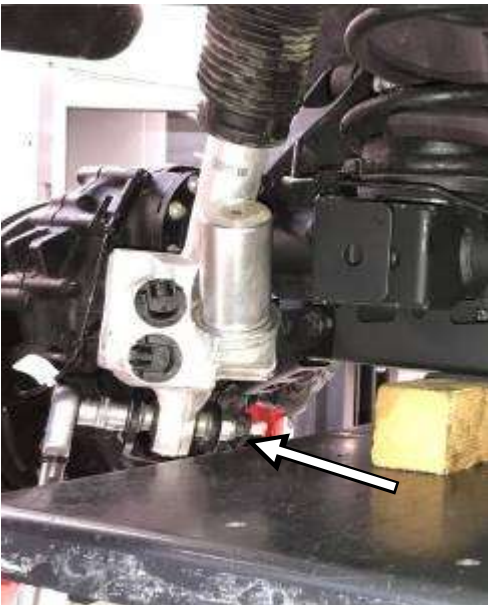
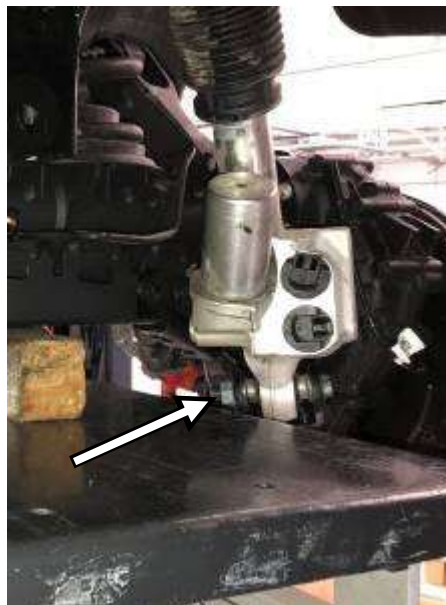
**Figure 18**

17. Unscrew left and right shock absorbers at bottom axle (**Figure 18**).

**i** The shock absorbers remain on the vehicle and need not be removed completely.

**Nm** Shock absorber screw to holder (axle tube): **Stage 1: 100 Nm**  
**Stage 2: 90°**

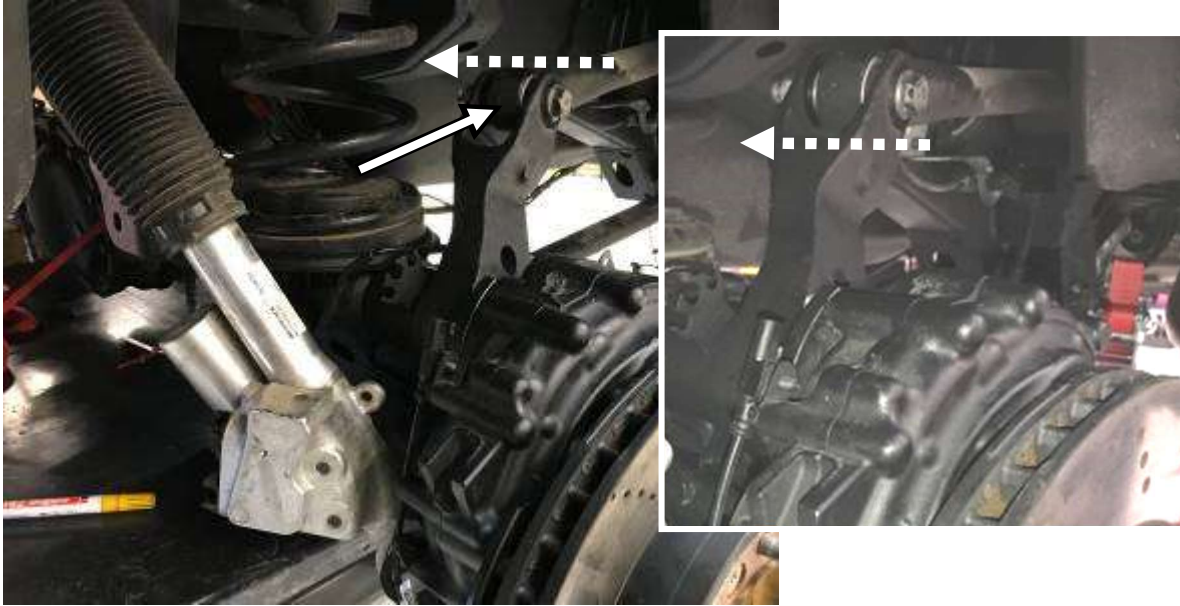
**Figure 19**

18. Release screw connection of top left and right trailing arms at rear axle (**Figure 19 and 20**).

**Nm** Upper trailing arm screw to rear axle: **Stage 1: 100 Nm**  
**Stage 2: 90°**

**i** **Important!** The **new** screw on rear axle to the upper trailing arm is inserted inwards, from wheel side towards the rear axle spring (**Figure 19**).

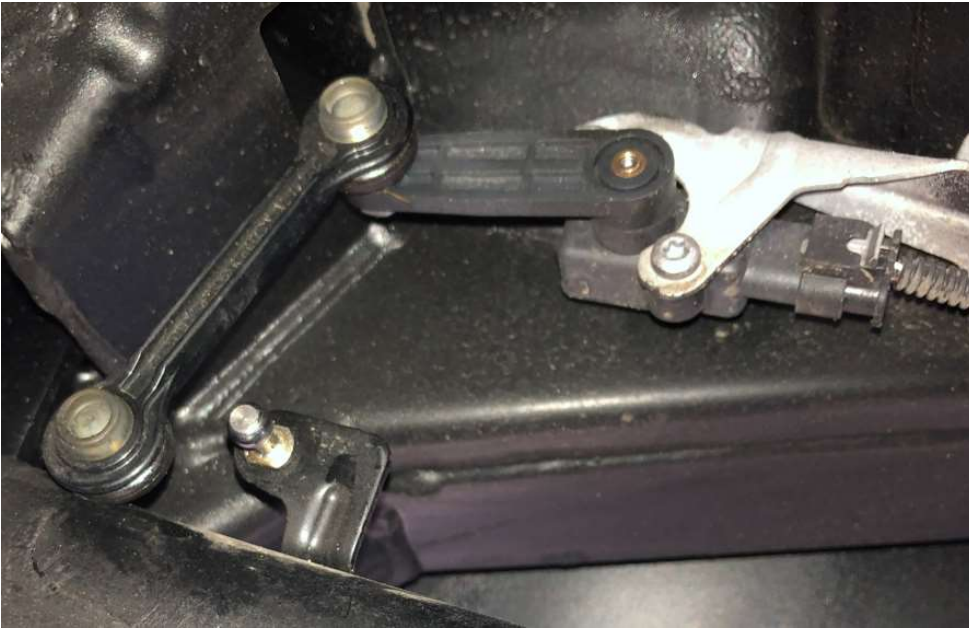
Figure 21

19. Mark adjusting plates for adjusting the drive line angle, disconnect level sensors on trailing arms (**Figure 21**) and unscrew connection of the rear axle at left and right lower trailing arms (**Figure 22**).

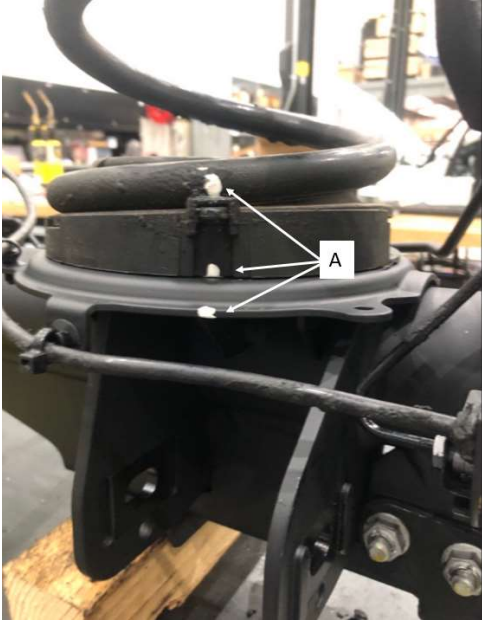
Figure 23

21. Mark the springs, as well as the upper and lower spring retainer, then remove the springs completely (**Figure 23, A**).

**i** **Installation:** Align installation position (**Figure 23, A**).

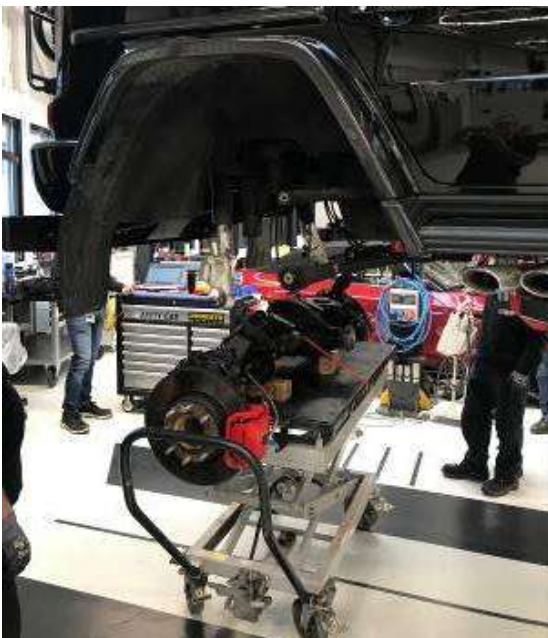
Figure 24

22. Fully lower rear axle and remove from underneath vehicle (**Figure 24**).

**i** Pay attention to surrounding component parts when lowering and lifting the rear axle.

**i** Unthread lower trailing arms while lowering.

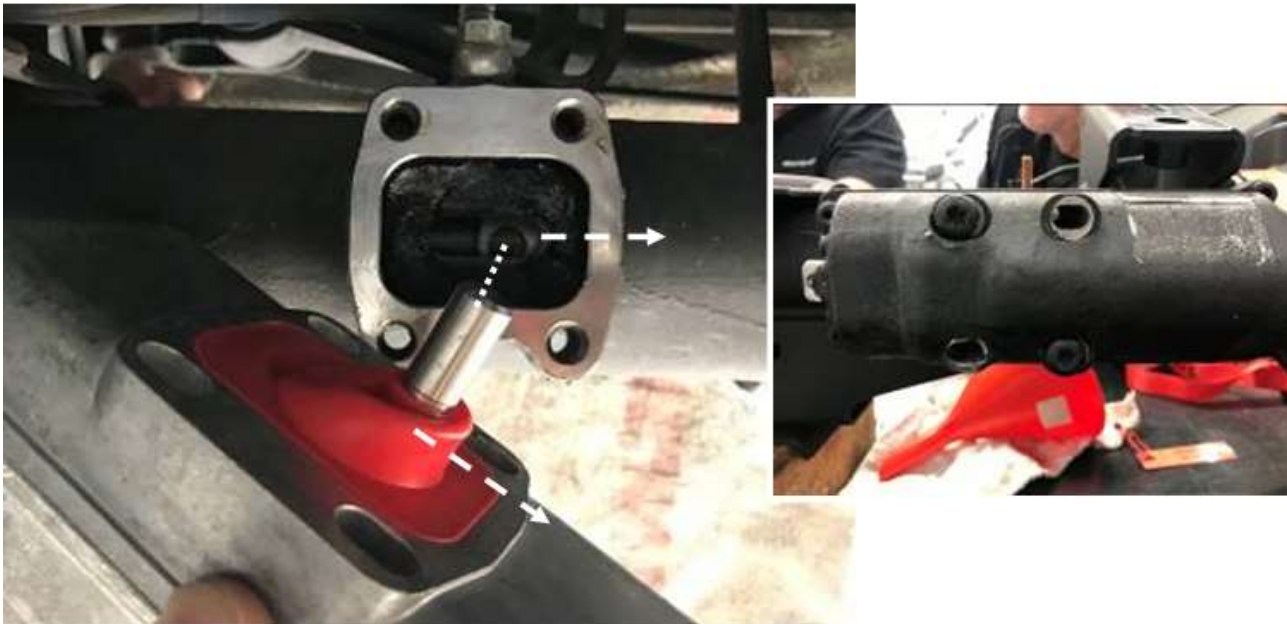
Figure 25

25. Remove rear axle actuator (**Figure 25**).

**i** Rear axle actuator is in **lock engaged position**.

**i** **Installation:** The slide in the axle tube for actuating the lock must be slid in the direction of the axle centerpiece. One of the wheel flanges must be turned at the same time.

**Nm** Locking Actuator screw to axle tube **Stage 1: 10 Nm**  
**Stage 2: 20 Nm**  
**Stage 3: 60°**

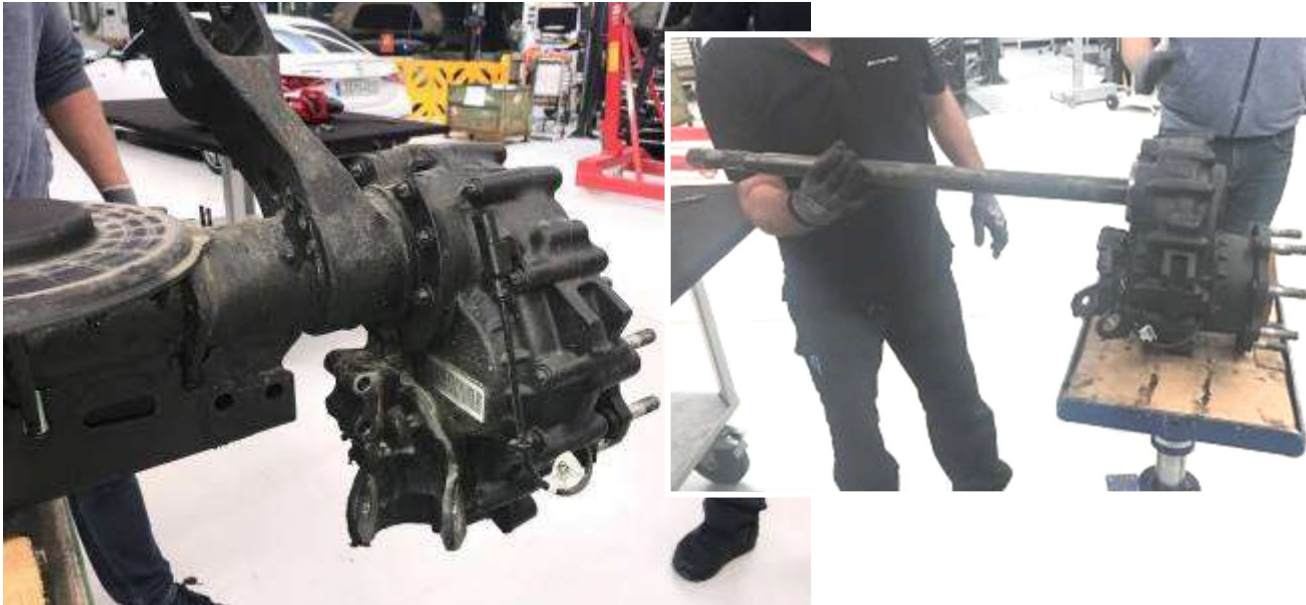
Figure 27

27. Remove left and right hub reduction gears (**Figure 27**).

**Nm** Hub reduction gear screw to axle tube: **Stage 1: 40 Nm**  
**Stage 2: 45°**

**i** **Installation:** Carefully slide hub reduction gear with axle shaft into rear axle differential while turning at the same time so that the gearing engages.

**i** **Installation:** Exercise particular caution when inserting the right (passenger side) portal axle to ensure the slide for the lock actuation is not damaged.

**i** **Installation:** To install the right-side portal axle, **position the lock actuator temporarily** so that the lock tube has better guidance into the new axle centerpiece.

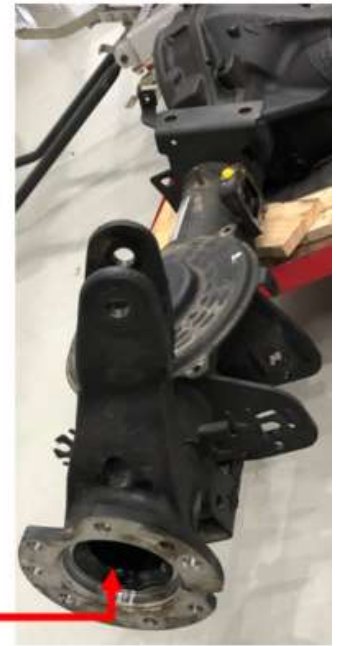
**Figure 31** (delivery condition of bolt)

**i** For the installation of the right hub reduction gear, it is required to back out the bolt (**Figure 31, A**) on the new axle until there are no threads protruding into the axle shaft housing (**Figure 32, B**).

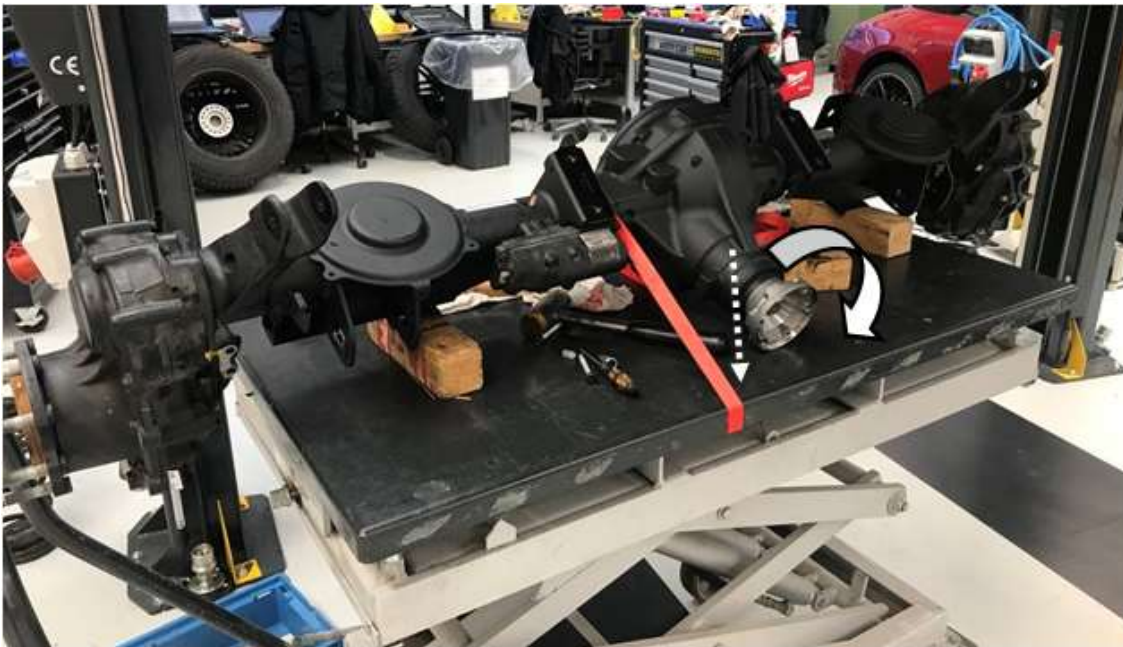
**Figure 33**

32. Fill rear axle centerpiece with 1.5 liters of oil and rotate the differential drive pinion multiple times for **at least 30 seconds** with the drive pinion tilted downward by **at least 5–10°** (**Figure 33**).

**i** **Attention, very important:** This ensures the bearing of the drive pinion is sufficiently lubricated prior to initial use.

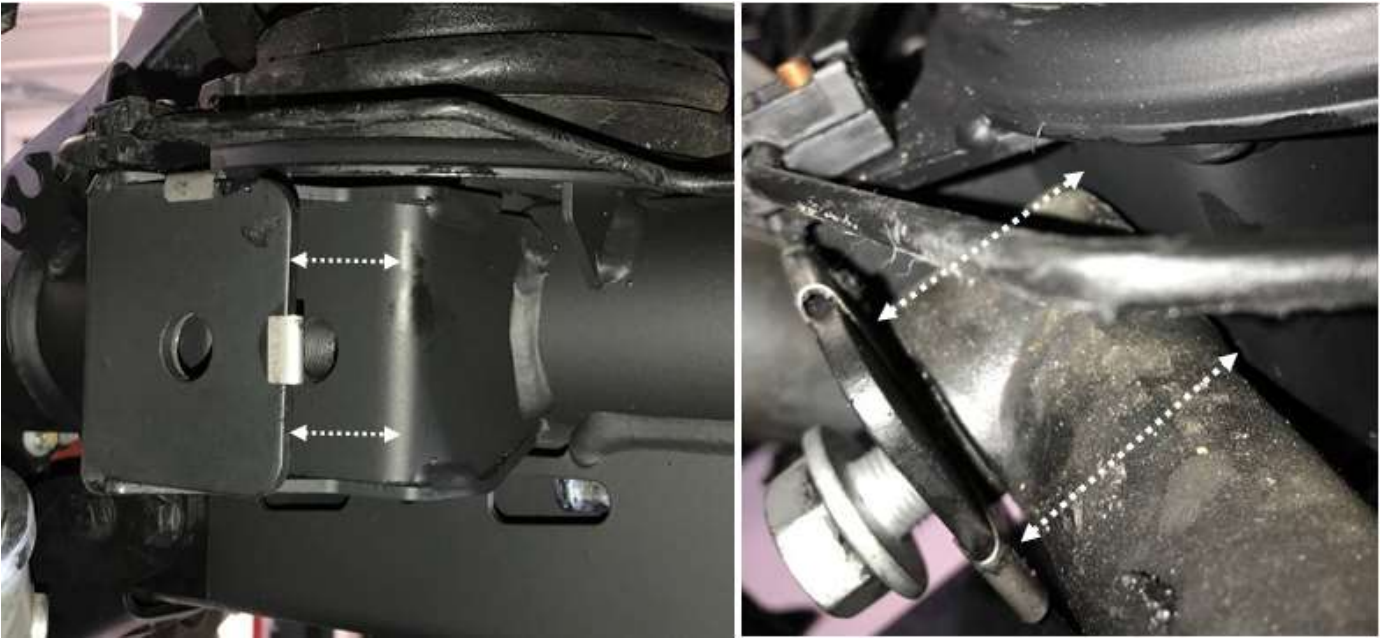
Figure 34

33. Install adjusting plate (if necessary) for transverse control arm on new axle bridge (**Figure 34, 35**).

**i** The left bearing of the transverse control arm must be installed with suction and with almost zero clearance, into the retaining tab of the axle bridge.

**i** The fit for the transverse control arm can be adjusted as required, either **without** an adjusting plate, **with a 0.5 mm** adjusting plate, or **with a 0.8 mm** adjusting plate.

**i** A maximum of one adjusting plate may be installed.

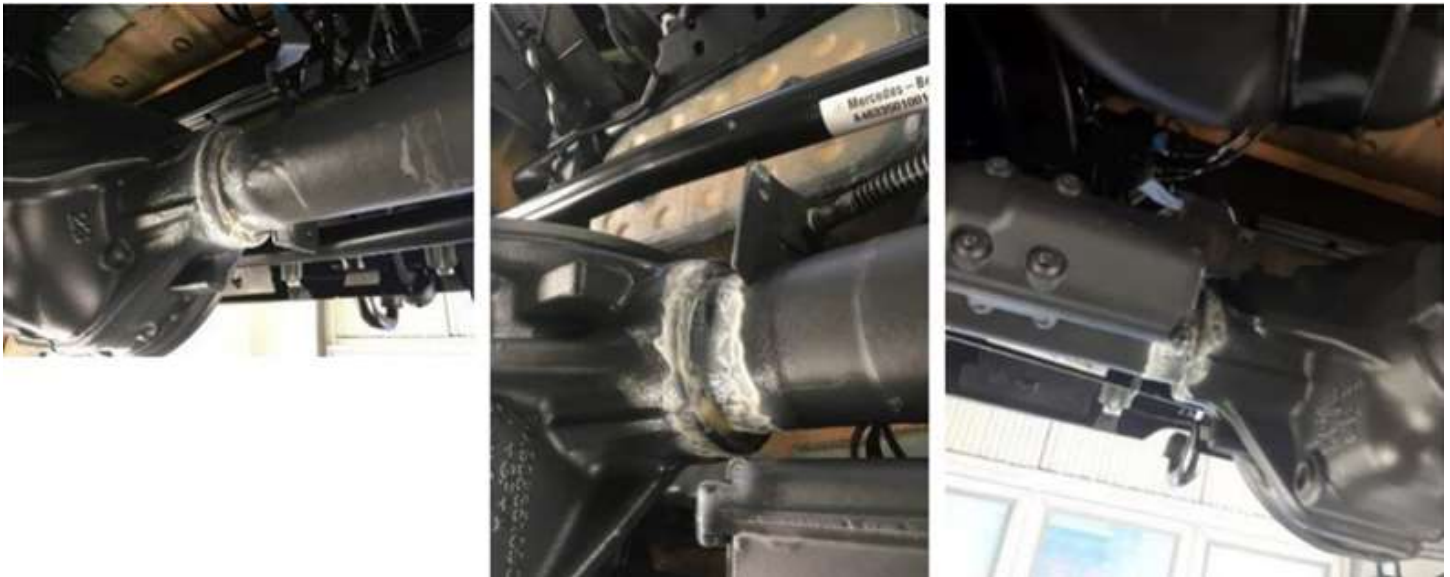
**Figure 36**

39. Apply wax **A 000 986 32 01 09** to rear axle in area between axle tube and differential (**Figure 36**).
