TO: Mercedes-Benz Dealer Principals, General Managers, Sales Managers, Service Managers, Parts Managers	FROM: Gregory Gunther, Senior Manager, Vehicle Compliance and Analysis, Engineering Services
RE: Recall Campaign - Launch Notification Replace Rear Axle Differential Housing – Wave 1 MY22-23 AMG G63 4x4 squared (463 platform)	DATE: June 7, 2024

Campaign No. 2024050005, June 2024

SUBJECT: **Model G-Class (463 platform)**
Model Year 2022 – 2023

Replace Rear Axle Differential Housing – Wave 1

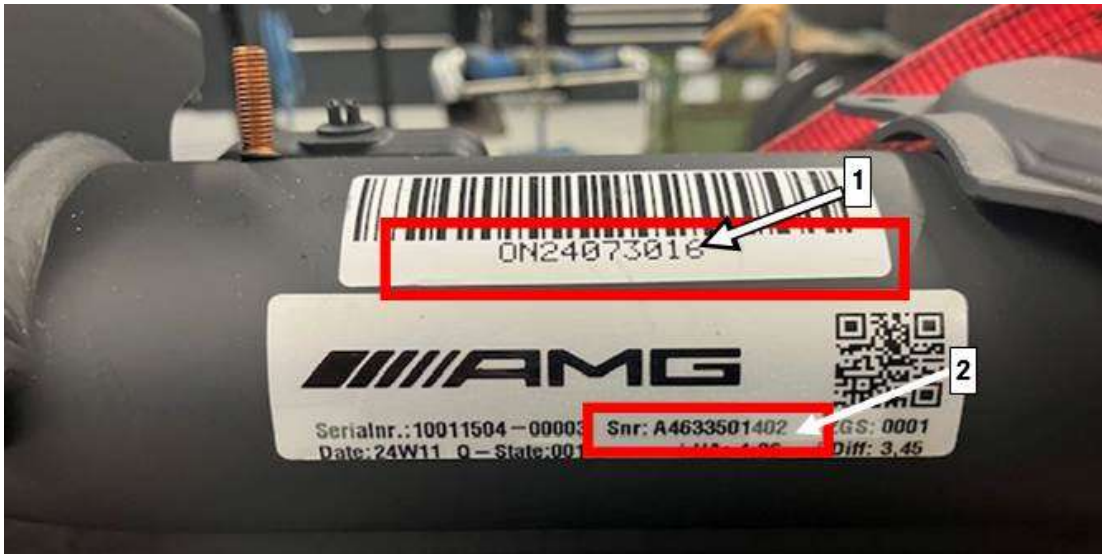
Figure 1

i Serial number (**Figure 1, 1**) and item number (**Figure 1, 2**).

i After the **rear axle centerpiece** has been replaced, the new **serial number** and **item number** must be documented in **VeDoc**. This can be done by opening a “**Vehicle Data/VeDoc**” XSF ticket and providing a picture of the new serial number and item number.

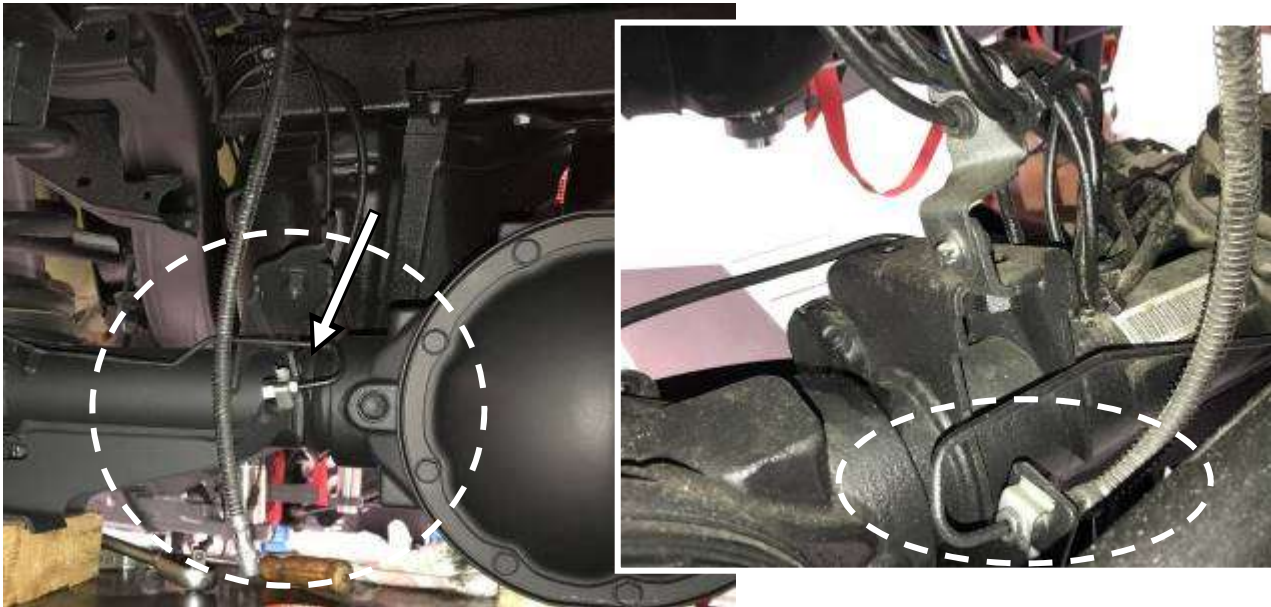
Figure 13

12. Unscrew brake hoses from brake lines on inside of axle (**Figure 13**) and seal open brake lines with suitable stop plugs (e.g. W129 589 00 91 10).

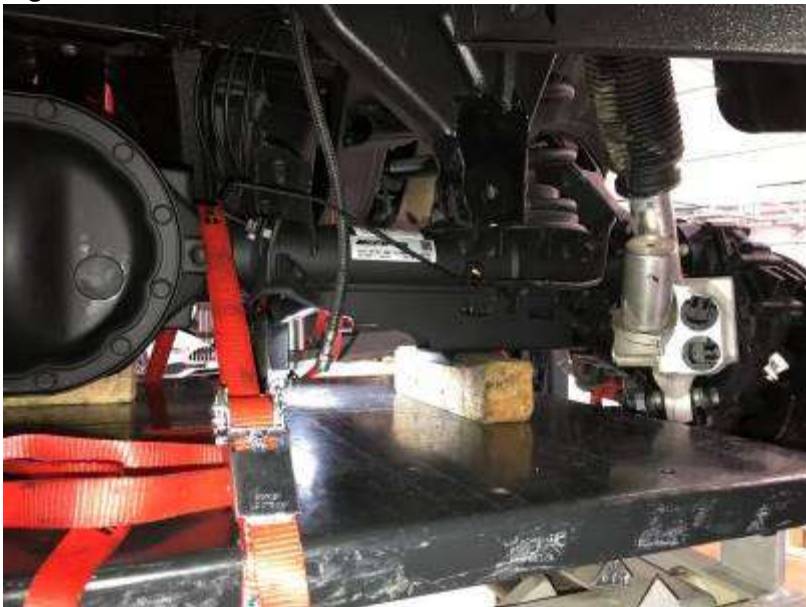
Figure 16

14. Position Lift table (W 000 588 03 62 00) under rear axle and use tension belt (**Figure 16**) to secure against falling.

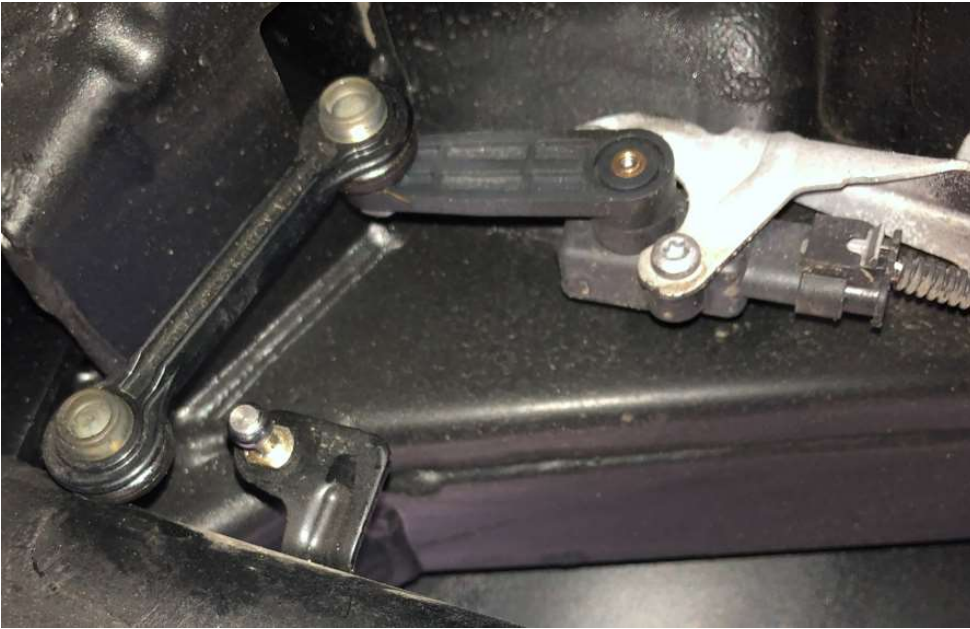
Figure 21

19. Mark adjusting plates for adjusting the drive line angle, disconnect level sensors on trailing arms (**Figure 21**) and unscrew connection of the rear axle at left and right lower trailing arms (**Figure 22**).

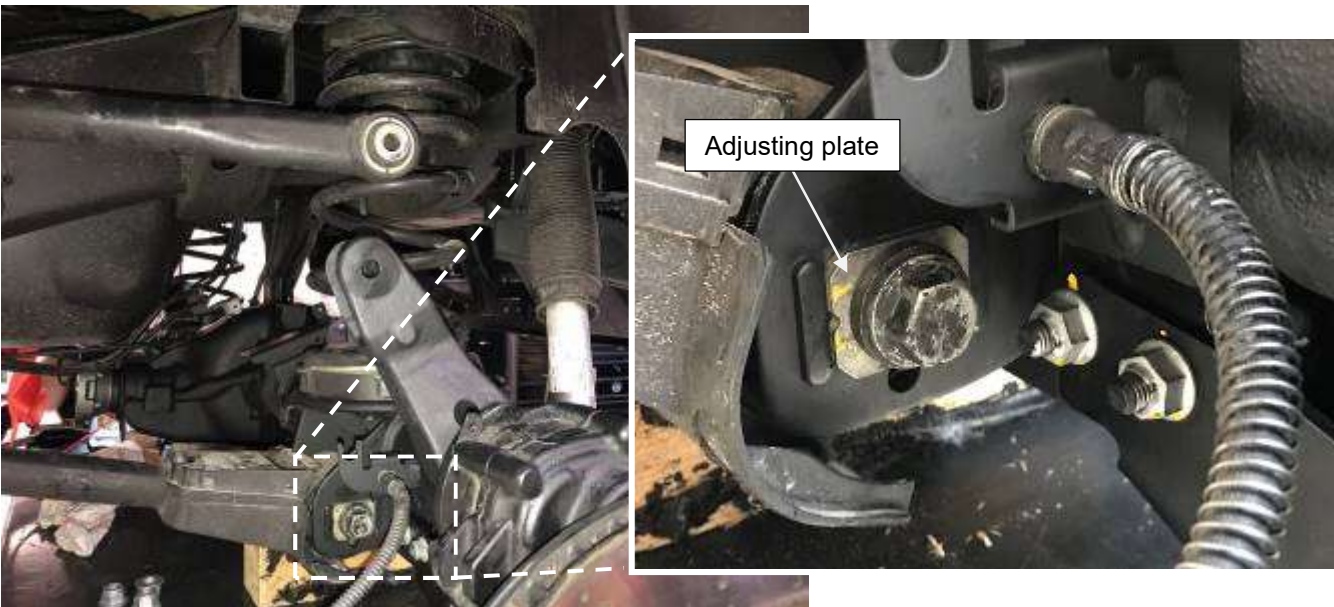
Figure 22

Nm Lower trailing arm screw to rear axle: **Stage 1: 100 Nm**
Stage 2: 180°

i **Important!** Mark adjusting plates and install in the same location and same installation position on the new axle.

i **Installation:** Install adjusting plates with opening pointing downward.

i **Installation:** The notch on the adjusting plate should point in the direction of travel.

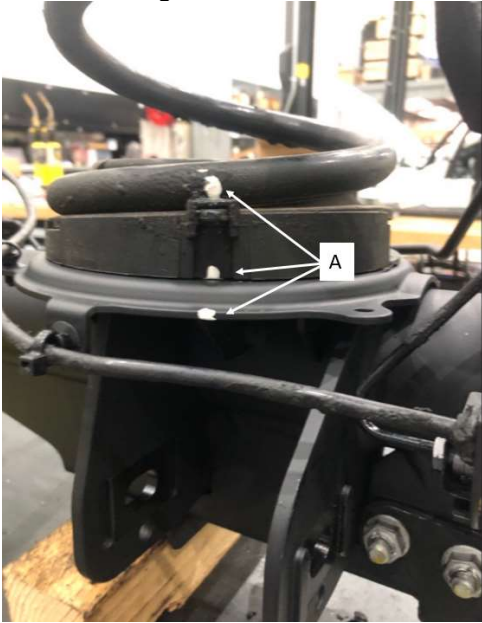
Figure 23

21. Mark the springs, as well as the upper and lower spring retainer, then remove the springs completely (**Figure 23, A**).

i **Installation:** Align installation position (**Figure 23, A**).

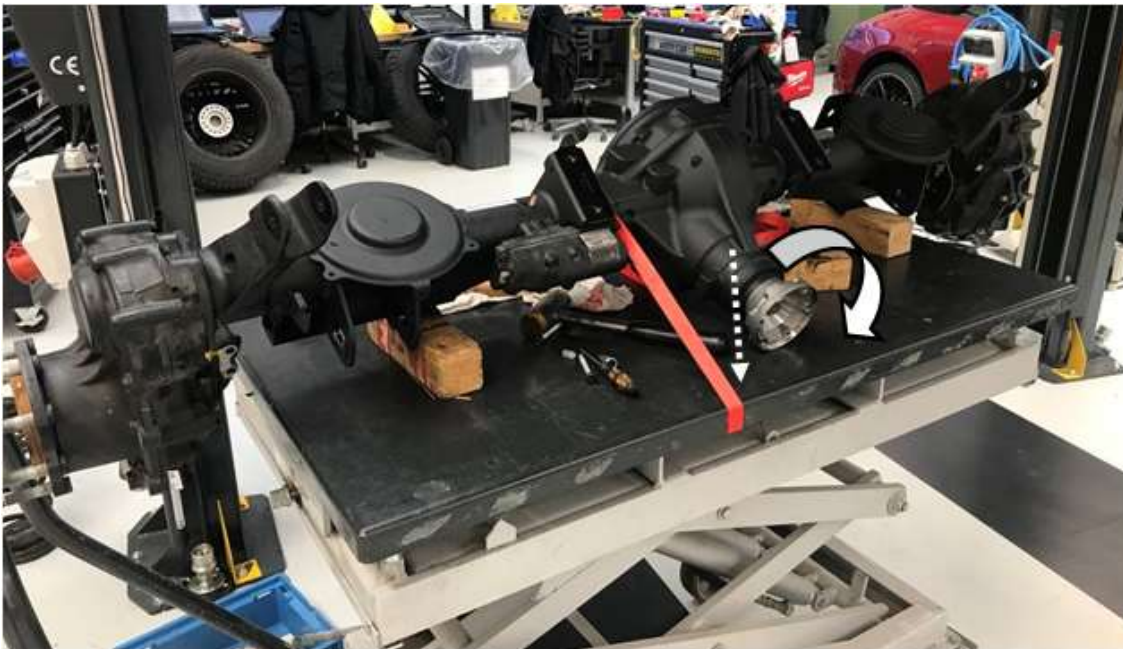
Figure 33

32. Fill rear axle centerpiece with 1.5 liters of oil and rotate the differential drive pinion multiple times for **at least 30 seconds** with the drive pinion tilted downward by **at least 5–10°** (**Figure 33**).

i **Attention, very important:** This ensures the bearing of the drive pinion is sufficiently lubricated prior to initial use.
