TO: Mercedes-Benz Dealer Principals, General Managers, Sales Managers, Service Managers, Parts Managers	FROM: Gregory Gunther, Senior Manager, Vehicle Compliance and Analysis, Engineering Services
RE: <b>Recall Campaign Launch Notification</b> <b>Replace Fuel Pump Delivery Module – Wave 1</b> <b>MY21-24 C-Class, E-Class, S-Class, SL, GT, GLC, GLE, GLS and G-Class (205/206, 213/238, 223, 232, 290, 253/254, 167 and 463 platforms)</b>	DATE: February 9, 2024

# Recall Campaign Bulletin

Campaign No. 2024010011, February 2024

## **Replace Fuel Pump Delivery Module Wave 1**

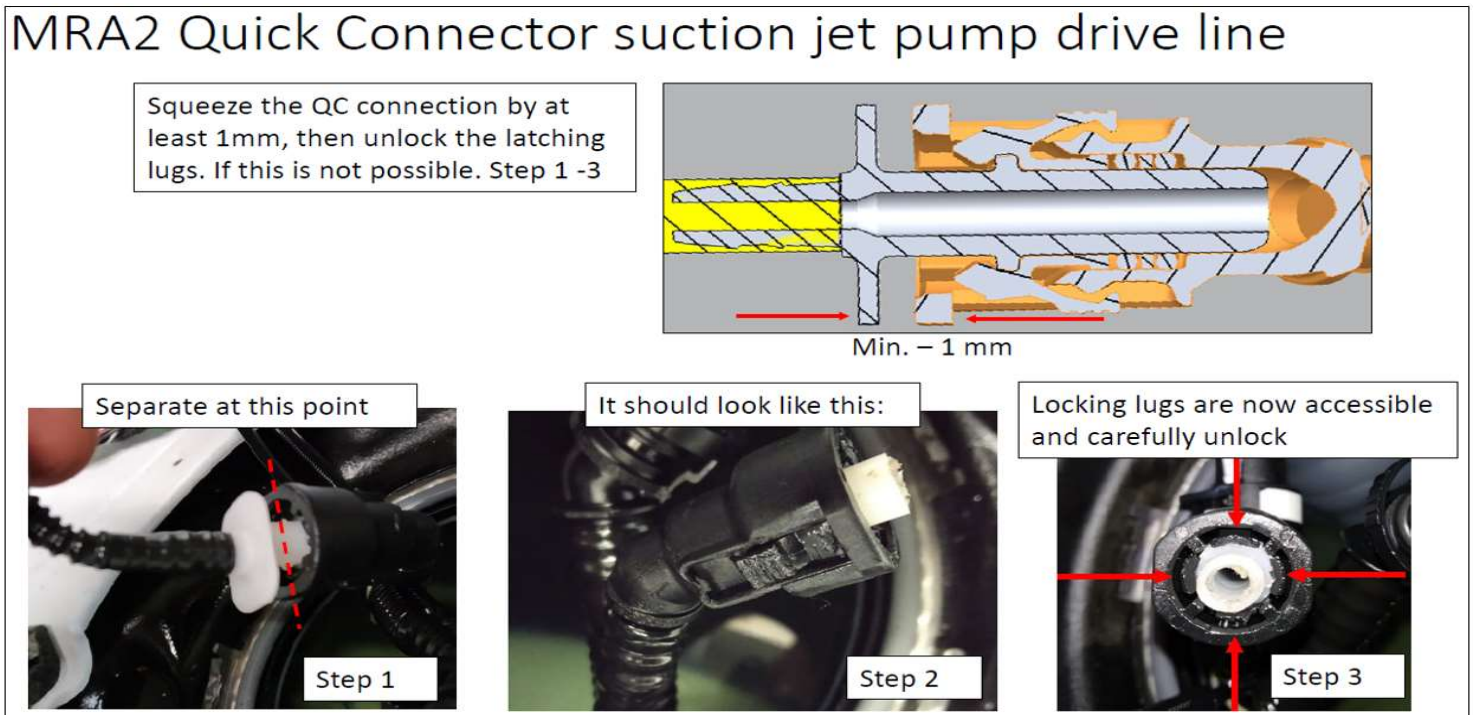
**Figure 2**

**i** **Only model 206, 232:** Note on disassembly of suction jet pump drive line quick connector.

The procedure steps 1-3 should only be performed when the quick disconnect is not working (**Figure 2**).

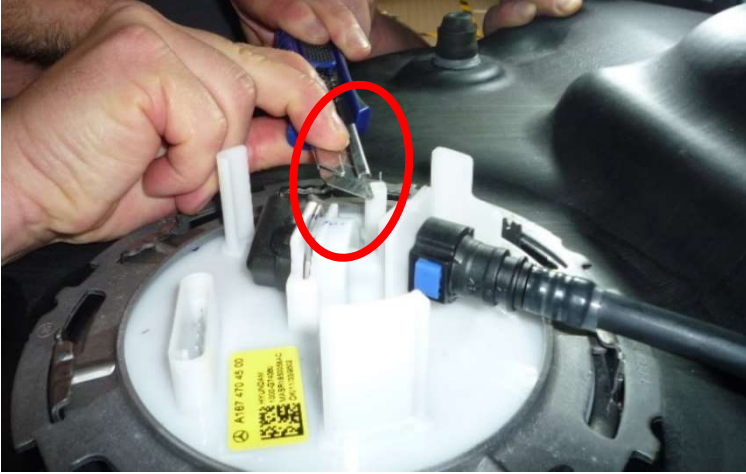
**Figure 3**

**i** For **all** vehicles with code 228 stationary heater, the connection for the fuel supply system must be cut off before installing the fuel pump (**Figure 3**).

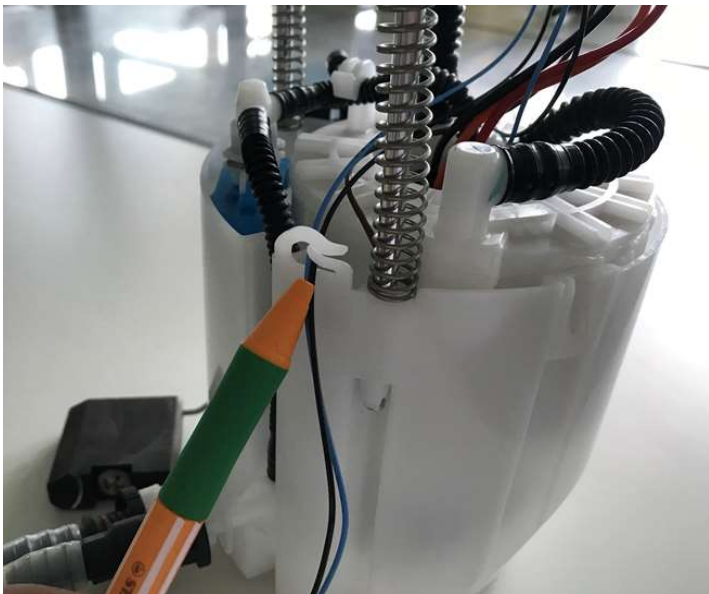
**i** Delivery modules that are delivered **without float-and-lever sensor** must be modified. (**Figure 4-7**)

**Figure 4** (remove electric lines from routing clip)

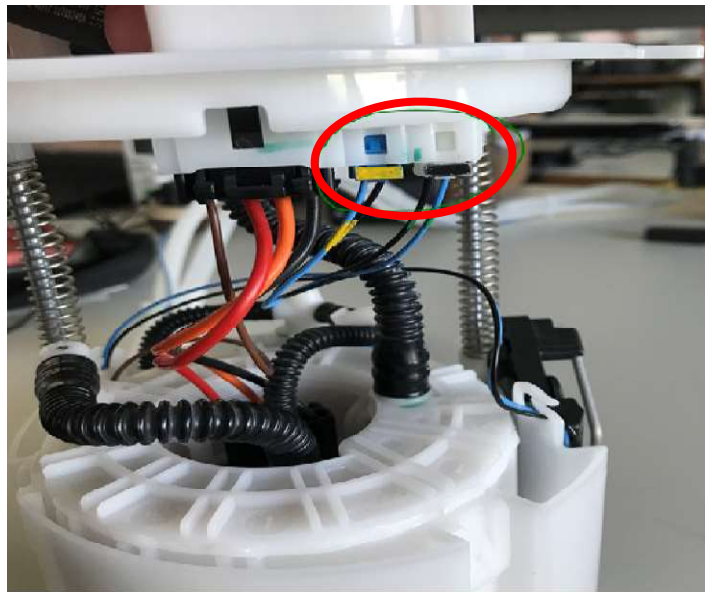
**Figure 5** (release corresponding connector and disconnect the contacts)
