TO: Mercedes-Benz Dealer Principals, General Managers, Sales Managers, Service Managers, Parts Managers	FROM: Gregory Gunther, Senior Manager, Vehicle Compliance and Analysis, Engineering Services
RE: <b>Recall Campaign Launch Notification</b> <b>Replace Fuel Pump Delivery Module – Wave 4</b> <b>MY21-24 C-Class, E-Class, S-Class, SL, GT, GLC, GLE, GLS and G-Class (205/206, 213/238, 223, 232, 290, 253/254, 167 and 463 platforms)</b>	DATE: August 6, 2024

Campaign No. 2024010011, July 2024

SUBJECT: **Various Models**  
**Model Year 2021-2024**

## **Replace Fuel Pump Delivery Module – Wave 4**

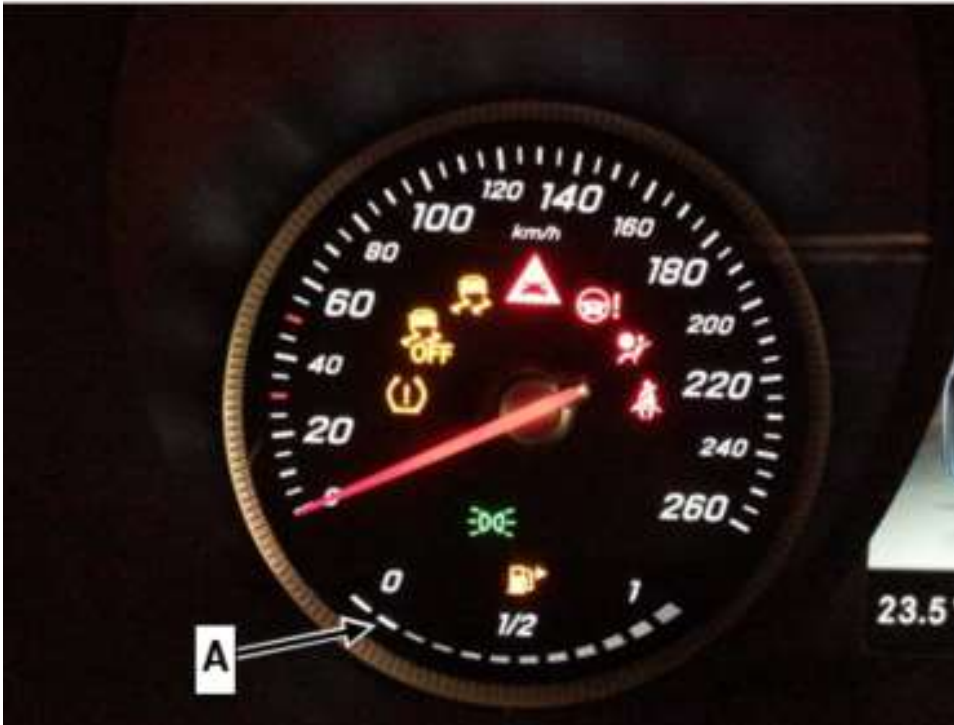
Figure 1 (shown on model 205)

- i** The fuel tank may only be filled up to a **maximum of 20%**.
- i** This corresponds to two lines (A) on the fuel display (**Figure 1**).

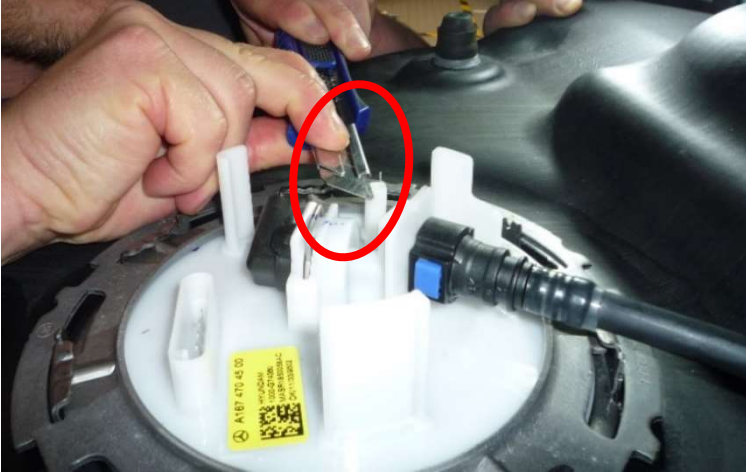
**Figure 3**

**i** For **all** vehicles with code 228 stationary heater, the connection for the fuel supply system must be cut off before installing the fuel pump (**Figure 3**).

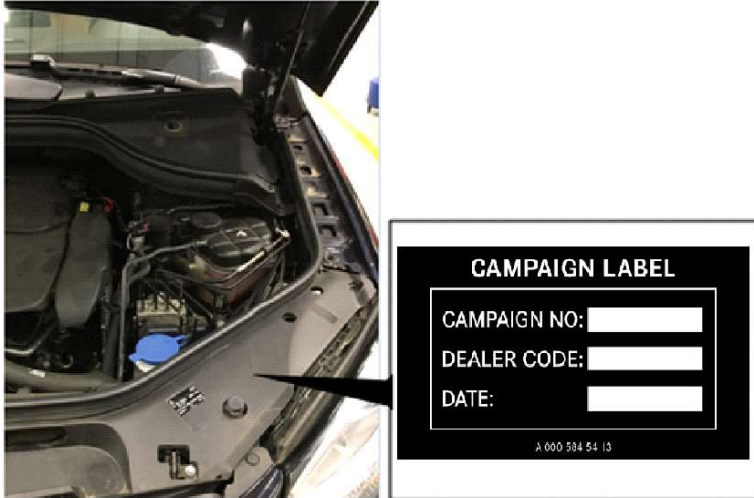
**Figure 1**

Apply Proof of Correction Label (A 000 584 54 13) to area identified in **Figure 1**. Fill in the blank areas of the label. The “**Campaign No.**” for the California Proof of Correction is unique and must be entered as such (23V880), your “**Dealer Code**”, and the “**Date**” of the repair, using a black permanent marker.

**i** Note: Clean bonding surface prior to affixing label.
