Load Carrying Capacity Modification (Addendum) Label (SET23A)

NHTSA Recall No. 23V680

IMPORTANT SAFETY RECALL

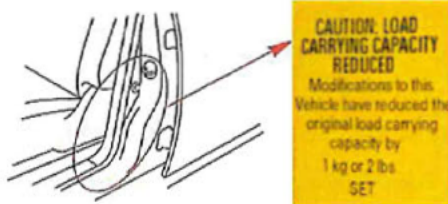
The Addendum Label is a yellow label (see diagram below) located on the driver's side center pillar. The Addendum Label takes into account the net weight of accessories added to your vehicle by SET after it was manufactured and updates the occupant and cargo carrying capacity of your vehicle. The vehicle occupant and load carrying capacity is located on the Tire and Loading Information Label.

In the affected vehicles, the current Addendum Label is not correct. This could result in a driver overloading the vehicle, which may increase the risk of a crash.

Enclosed, you will find a new Addendum Label for your specific vehicle (VIN listed above).

Please assist us by affixing the enclosed Addendum Label to your vehicle. Installation instructions are located on the following page. If you need assistance, your local dealer can affix the label, free of charge.

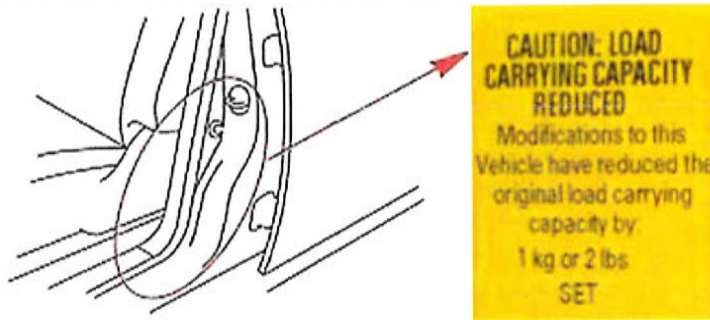
- a. Locate the Addendum Label currently installed on your vehicle, see illustration below.

(Addendum Label size and location may vary by model)

- b. Clean the Addendum Label currently installed on your vehicle and the surrounding areas with a clean, dry cloth to remove any dust or dirt.
- c. Affix the new Addendum Label on top of the current label installed on your vehicle.

Note: If you have a larger Addendum Label and the new label provided is a smaller version, you may alternatively remove the original Addendum Label and apply the new one in its place.
