Load Carrying Capacity Modification (Addendum) Label (SET23B)

NHTSA Recall No. 23V757

IMPORTANT SAFETY RECALL

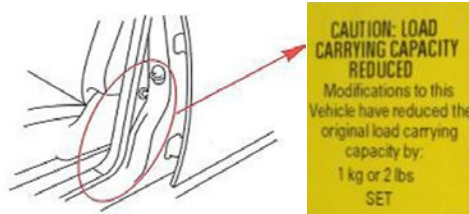
The Addendum Label is a yellow label (see diagram below) located on the driver's side center pillar. The Addendum Label takes into account the net weight of accessories added to your vehicle by SET after it was manufactured and updates the occupant and cargo carrying capacity of your vehicle. The vehicle occupant and load carrying capacity is located on the Tire and Loading Information Label.

In the affected vehicles, the current Addendum Label is not correct. This could result in a driver overloading the vehicle, which may increase the risk of a crash.

Enclosed, you will find a new Addendum Label for your specific vehicle (VIN listed above).

Please assist us by affixing the enclosed Addendum Label to your vehicle. Installation instructions are located on the following page. If you need assistance, your local dealer can affix the label, free of charge.

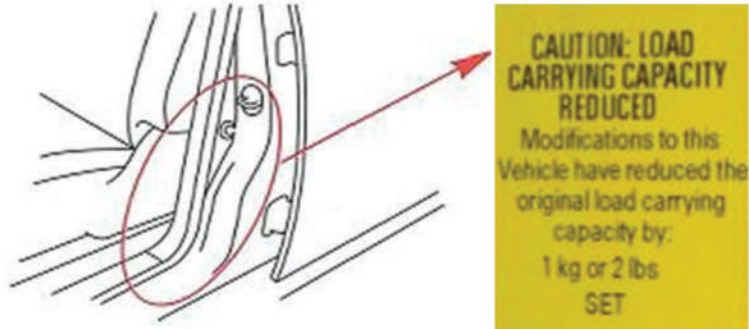
- a. Locate the Addendum Label currently installed on your vehicle, see illustration below.

(Addendum Label size and location may vary by model)

- b. Clean the Addendum Label currently installed on your vehicle and the surrounding areas with a clean, dry cloth to remove any dust or dirt.
- c. Affix the new Addendum Label on top of the current label installed on your vehicle.

Note: If you have a larger Addendum Label and the new label provided is a smaller version, you may alternatively remove the original Addendum Label and apply the new one in its place.
