RECALL 23V015 / 2023-014 REMEDY INSTRUCTIONS

Make(s): AMERA-LITE CARGO TRAILER
 Model(s): MANY, SEE BELOW
 Model Year(s): 2016 - 2017

Concern:
 The drawbars welded to the vehicle may be out of specification for the vehicles' Gross Vehicle Weight Rating ("GVWR").

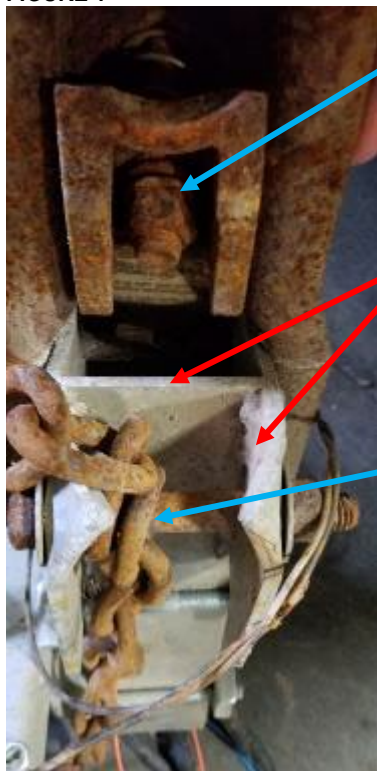
- LOOK UNDER THE COUPLER AT THE OPEN END OF THE DRAWBAR WHICH THE COUPLER IS BOLTED TO AND MATCH IT TO EITHER FIGURE 1 OR FIGURE 2;
- TAKE CLEAR PHOTO'S SHOWING THE OPEN END OF THE DRAWBAR TUBE THAT THE COUPLER IS BOLTED TO;

COUPLER

ALUMINUM DRAWBAR

SAFETY CHAINS & BOLT

STEP 1: IF THE DRAWBAR MATCHES FIGURE 1 – THE DRAWBAR **NEEDS** TO BE REPLACED;
